# **City of Deer Park Municipal Court and Theater Building**

1302 Center St.

**Tremco Incorporated**

September 11, 2015

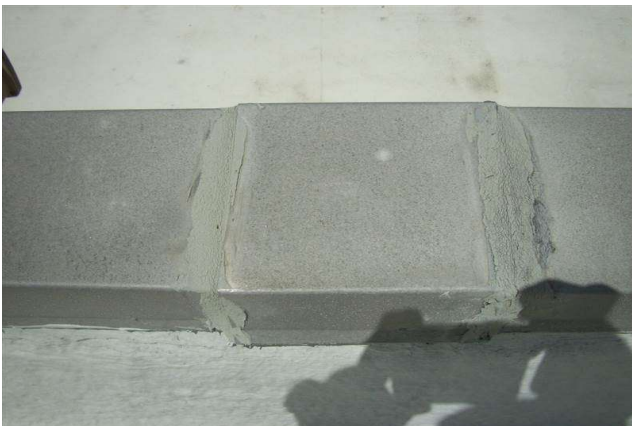
Open wall joints.

Work Performed	
TremCare	Sealed open wall joints.

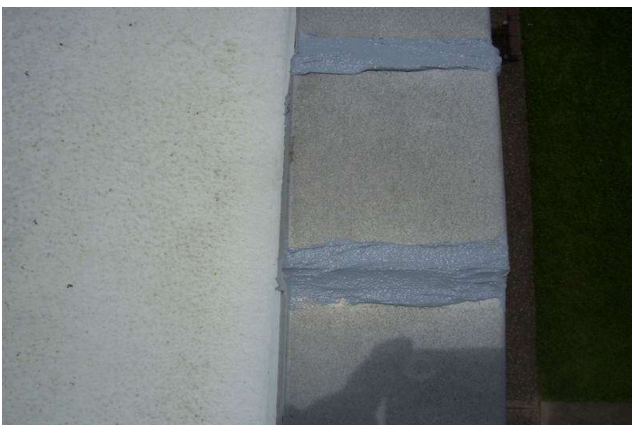
Sealed wall joints.

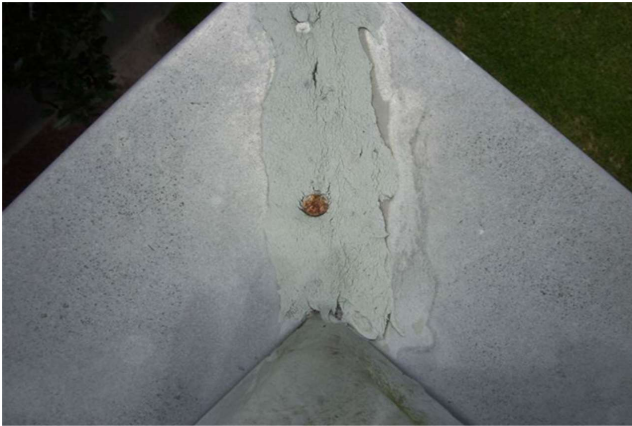
Open coping joint.

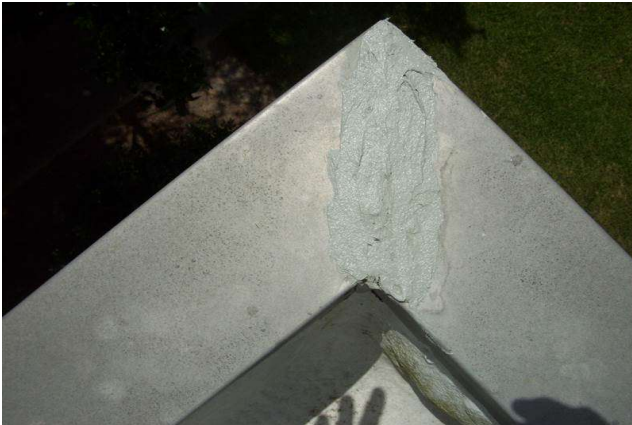
Sealed coping joint.

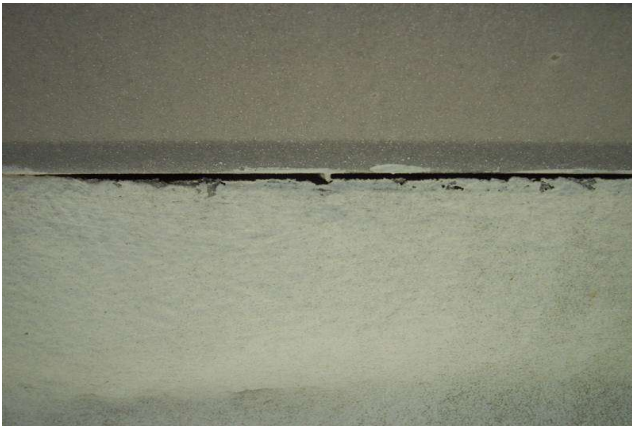
Open wall joint.

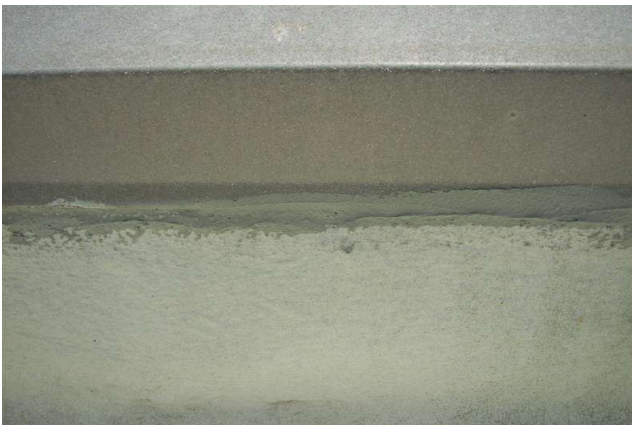
Sealed wall joint.

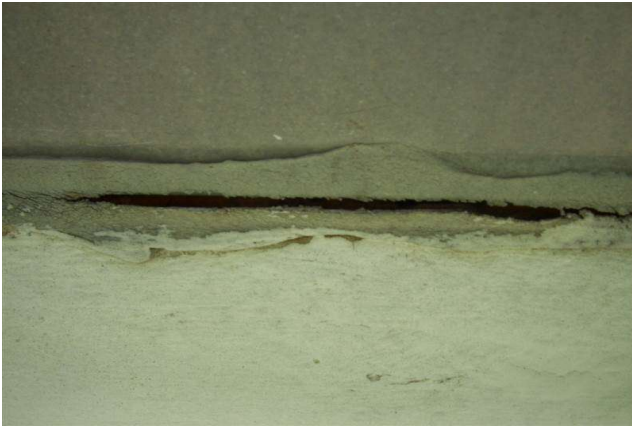
Open wall joint.

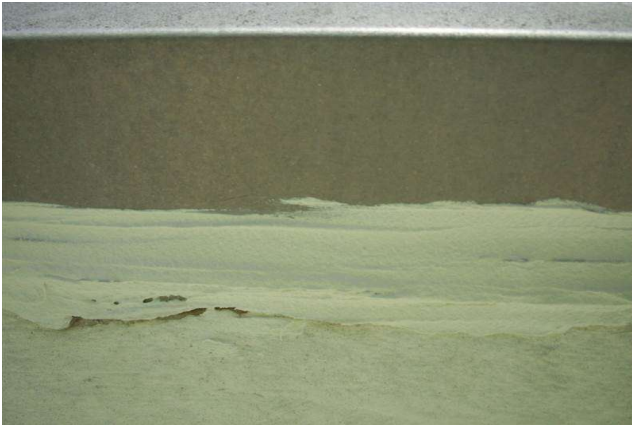
Sealed wall joint.

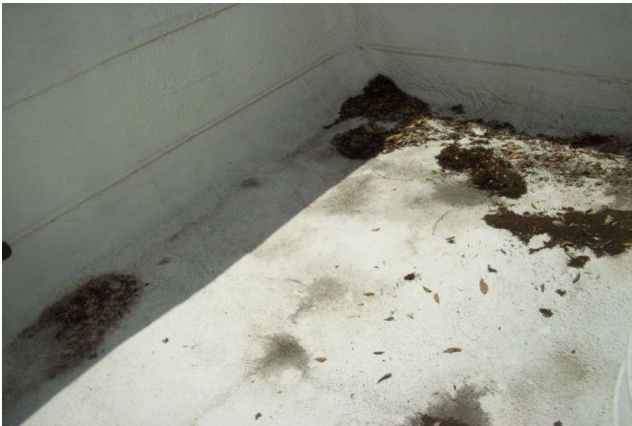
Debris.

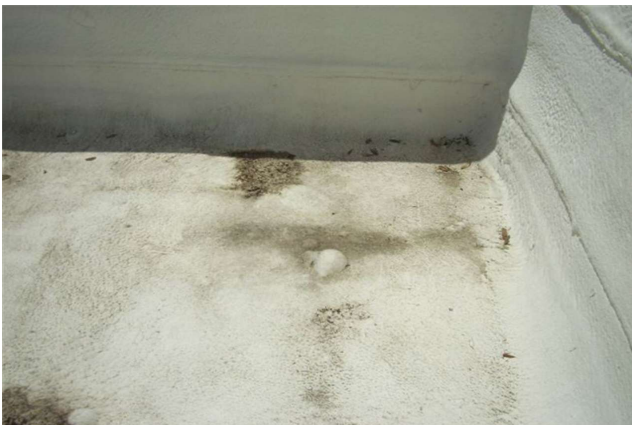
Removed debris.

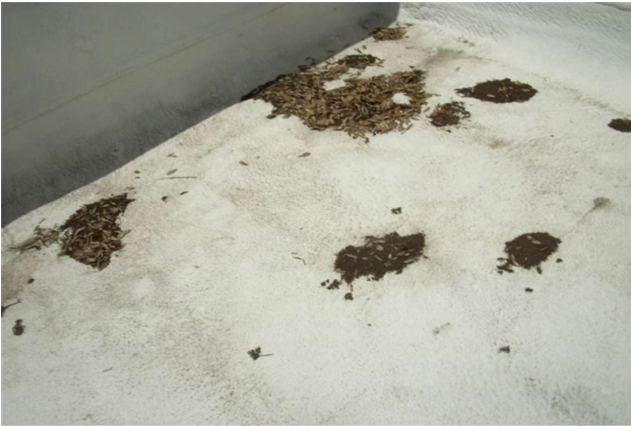
Debris.

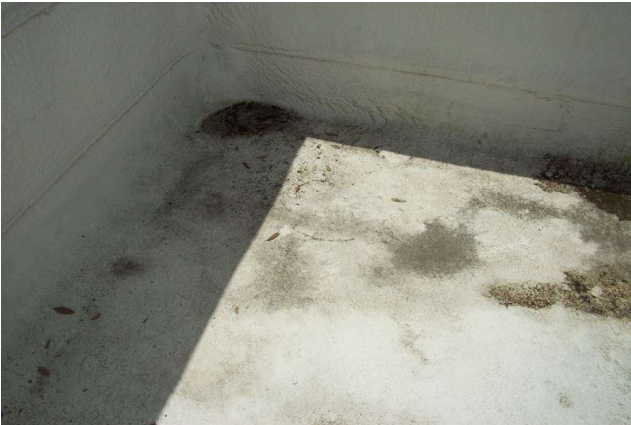
Removed debris.

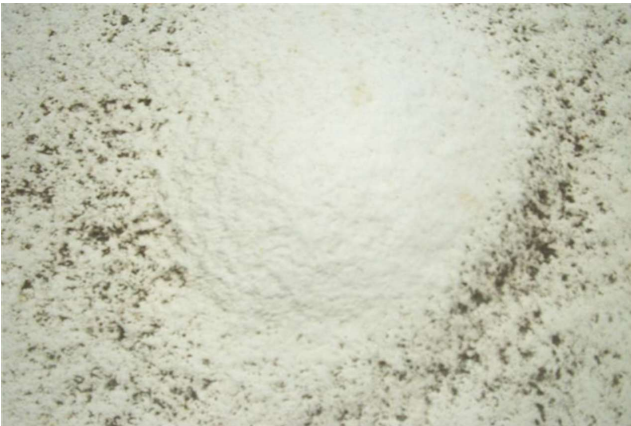
Inspection Comments        Insulation fasteners are backing out minor at this time monitor at this time. Roof has minor blistering monitor at this time.

Blister.

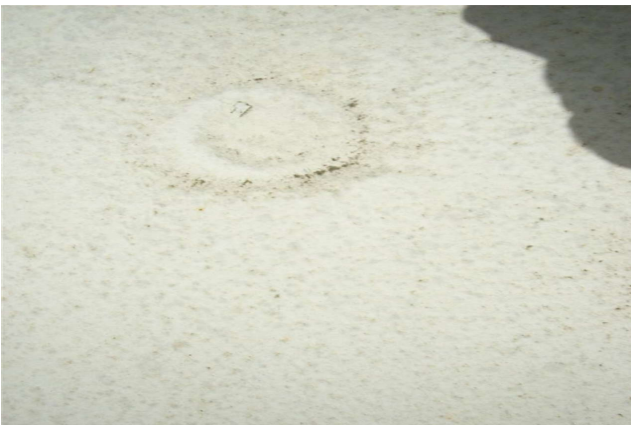
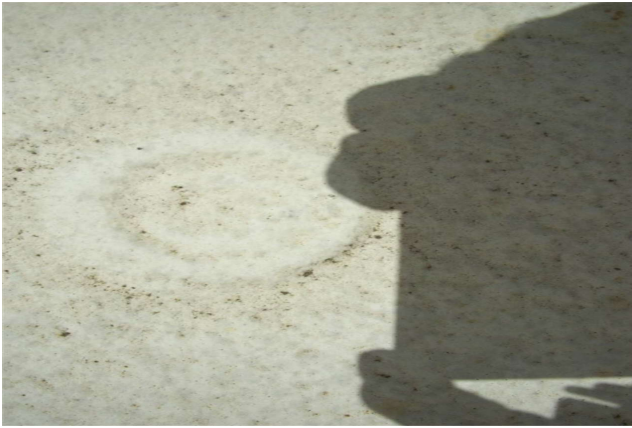
Fastener backout.
