PROJECT:
DEER PARK GATEWAY

CLIENT:
CITY OF DEER PARK
710 E. SAN AUGUSTINE
DEER PARK, TX 77536

SHEET TITLE
LAYOUT PLAN

| SHEET NAME: TOWER WALL & DETAILS | |

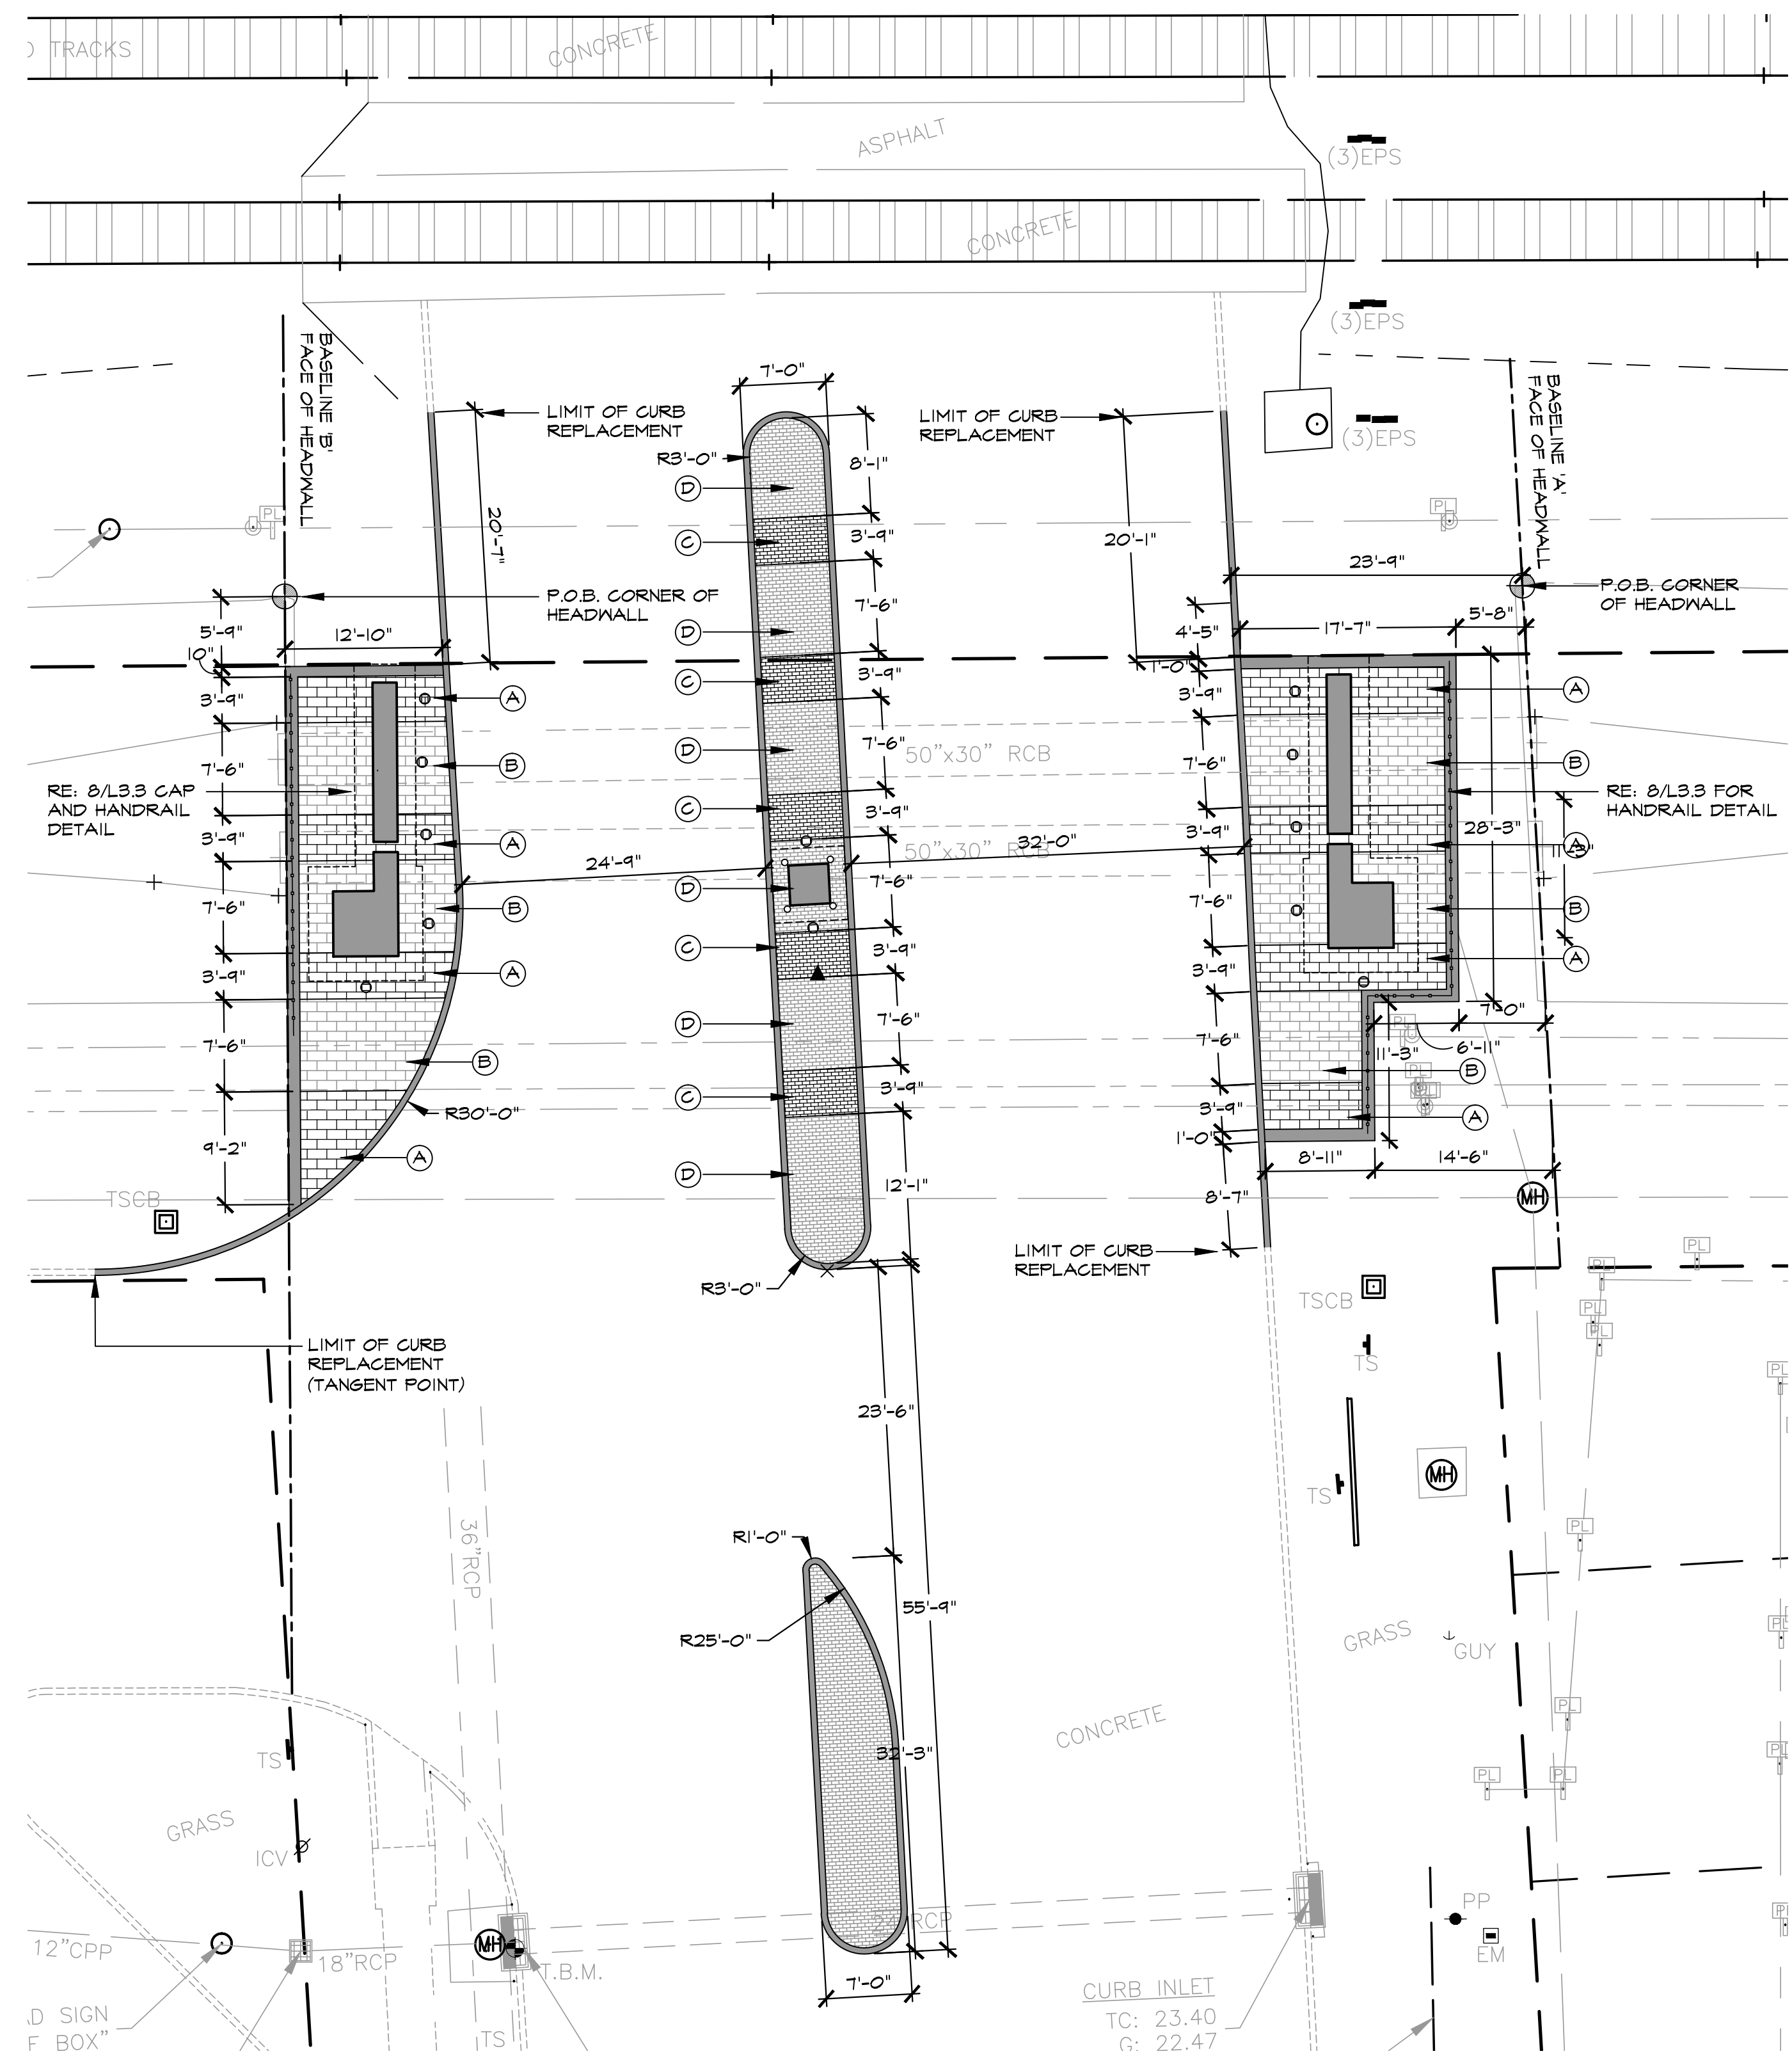
1 PAVING LAYOUT PLAN

Replacement of stone (205 sf total)
Type A - 90 sf
Type B - 115 sf

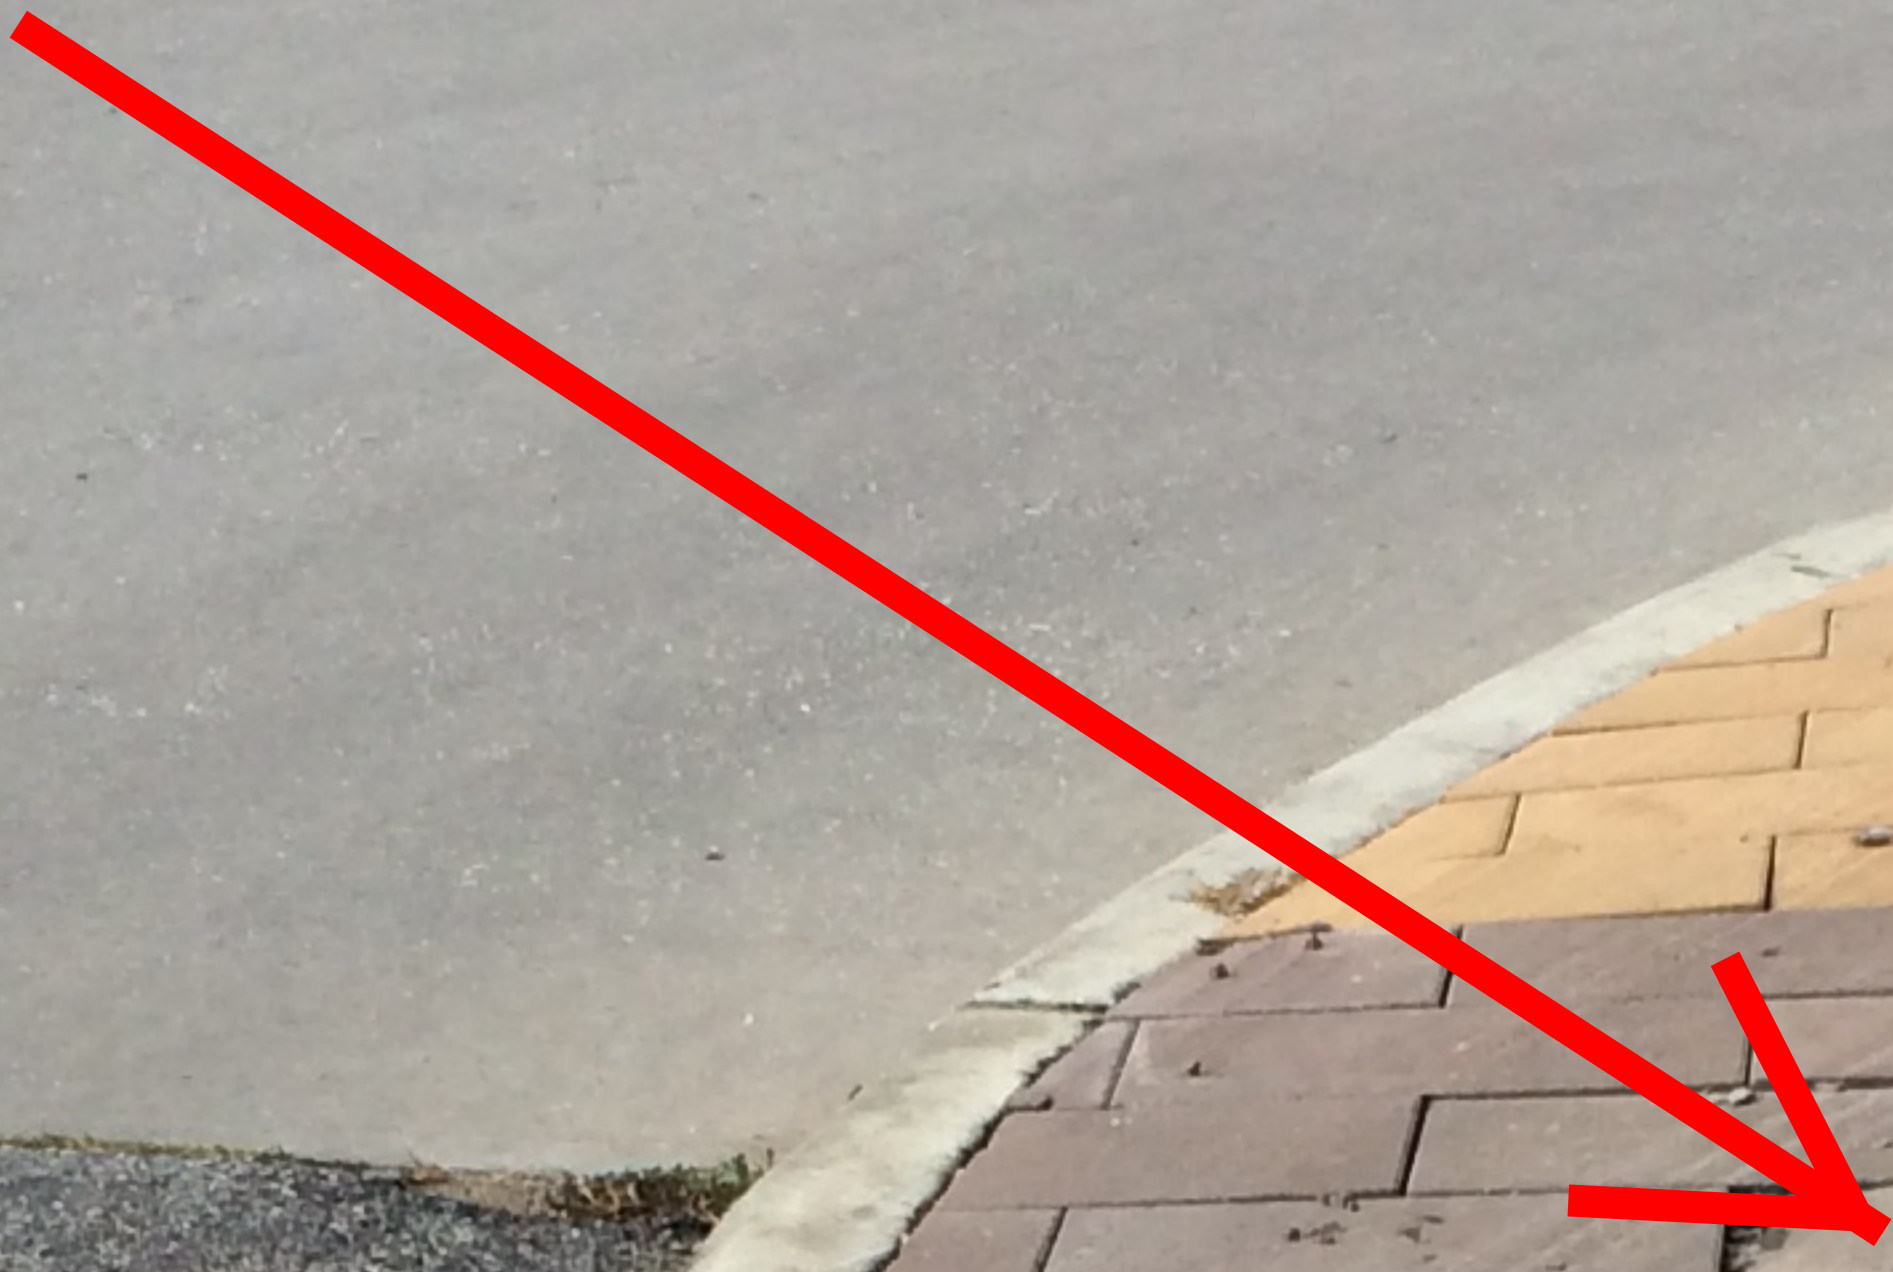
APPROXIMATELY 20-25 PAVESTONE ARE
CHIPPED OR CRACKED. DAMAGE CAUSED
BY TRUCK TIRES

REPLACE CONCRETE
PAVERS FROM THIS
POINT FORWARD

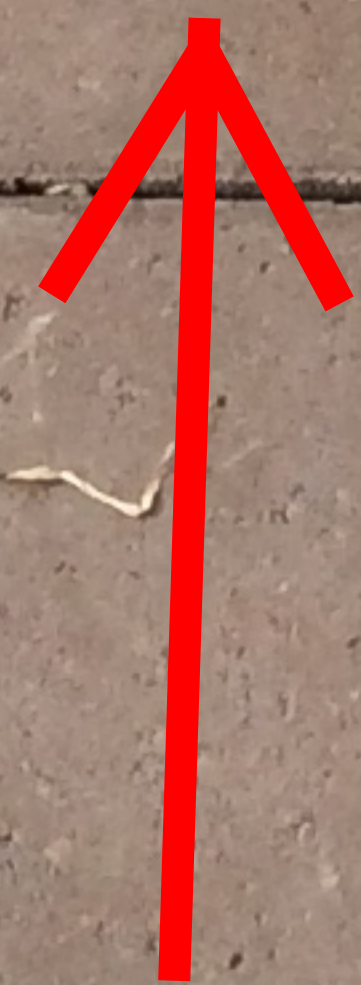
DAMAGE TO CONCRETE PAVERS, SURFACE
CRACKS, CHIPS AND BASE FAILURE

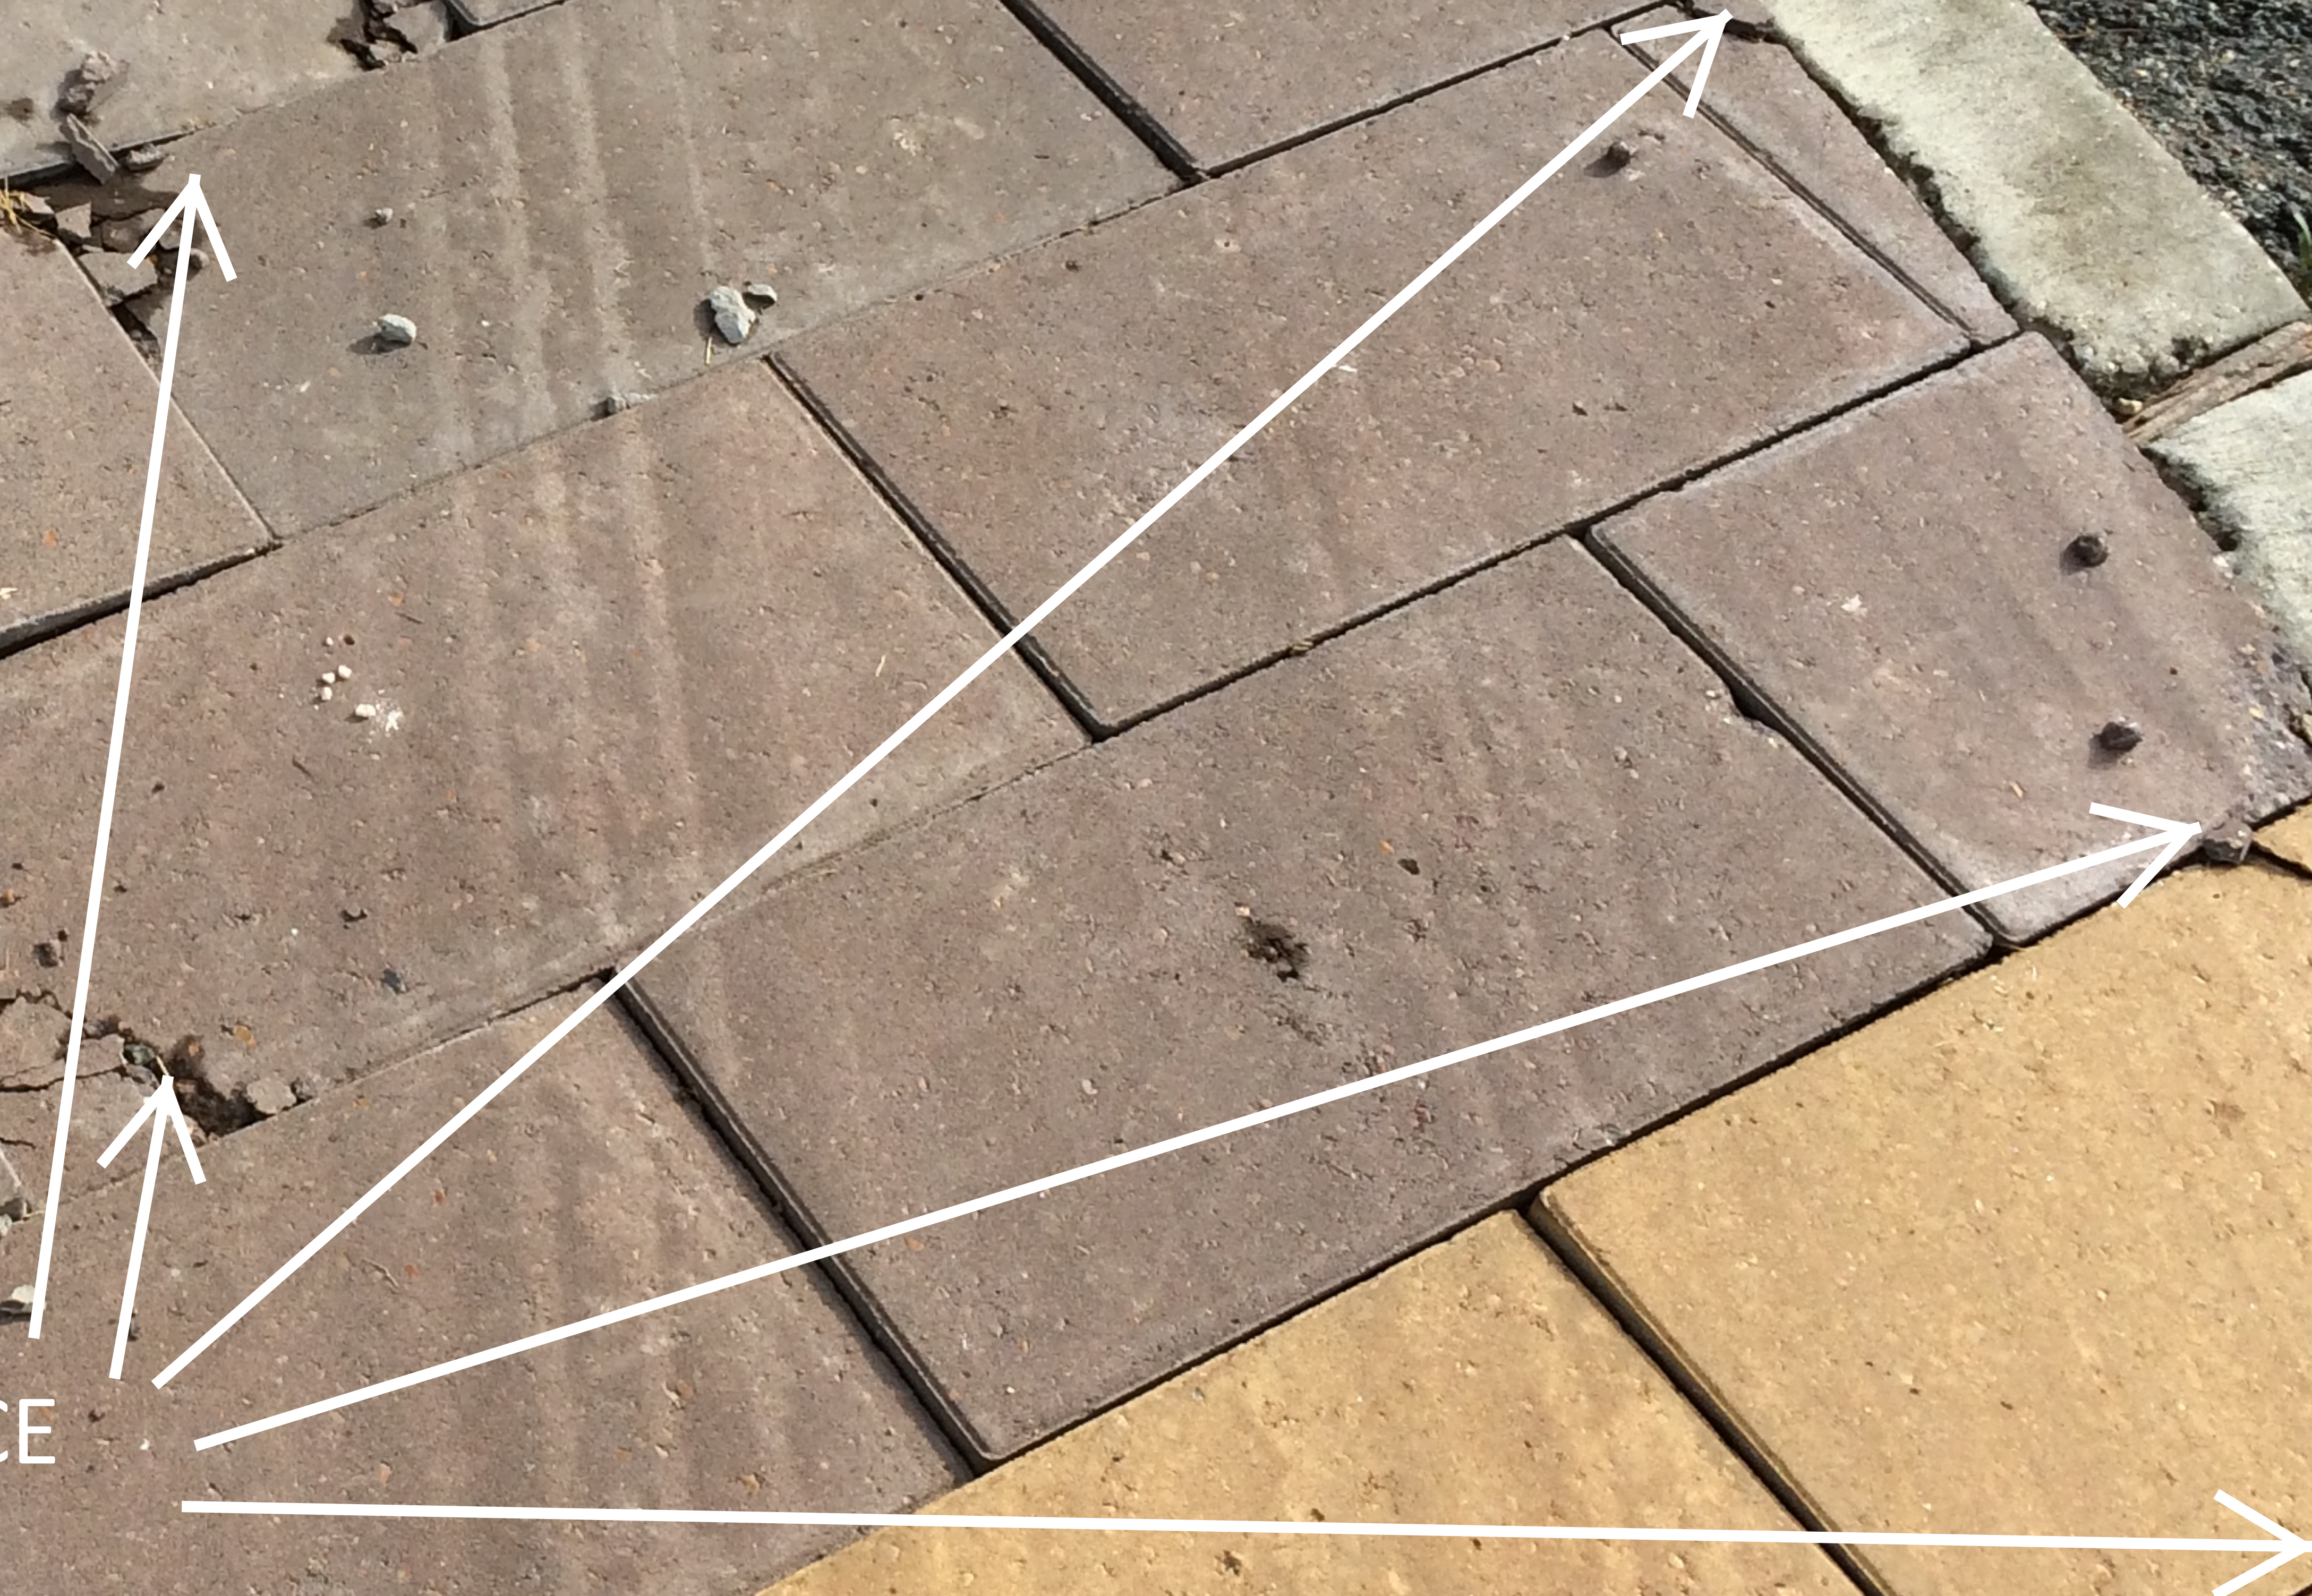
STAR MOUNTING ANCHORS RIPPED FROM WALL CAUSING DAMAGE TO SURROUNDING STONE AND GROUT JOINTS (MULTIPLE LOCATIONS)

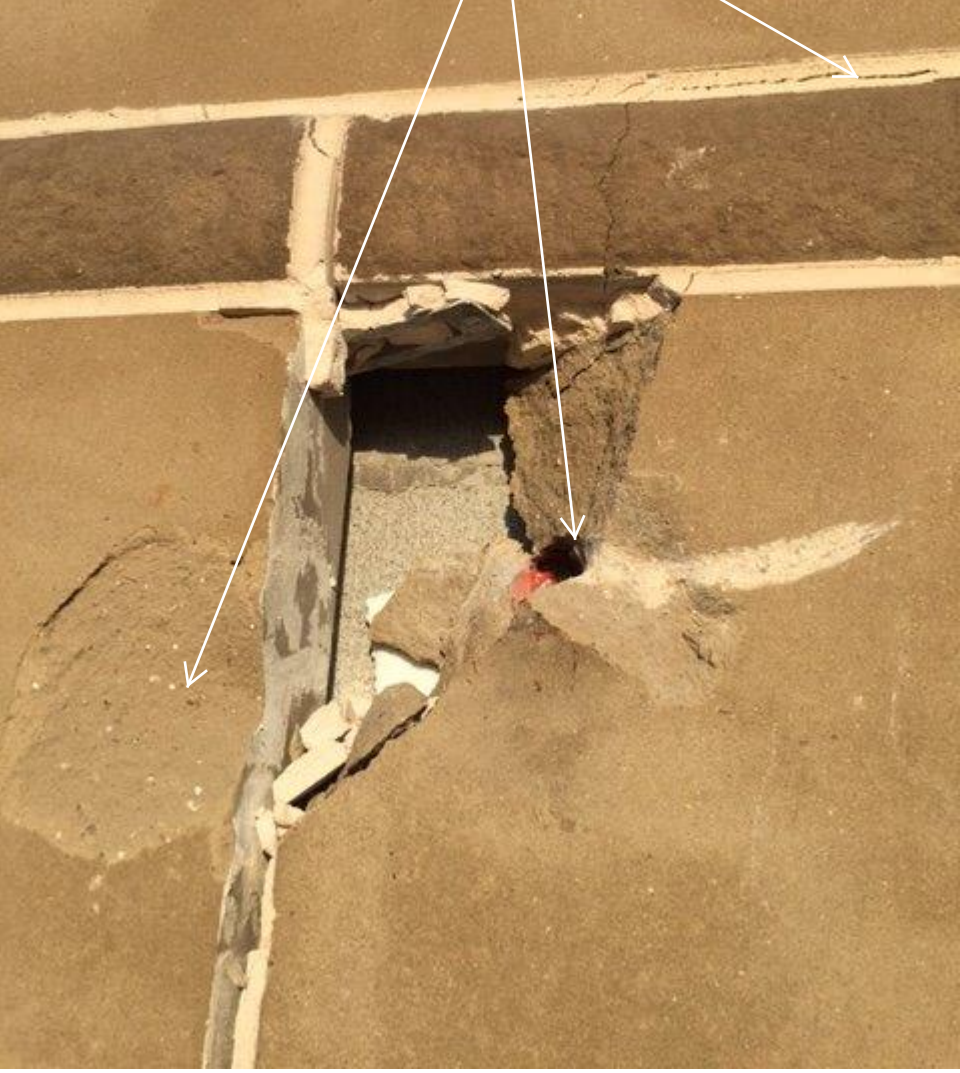
DAMAGE CAUSED TO
CAST STONE FROM STAR
PULLING AWAY FROM
CAST STONE

TOTAL FAILURE OF STONE
ATTACHMENT TO WALL IN
SEVERAL PLACES
