# Building Observations Survey ©2016

## Deer Park Community Center Deer Park, Texas

**Building Survey for Deer Park Community Center,  
610 East San Augustine Street, Deer Park, Texas**

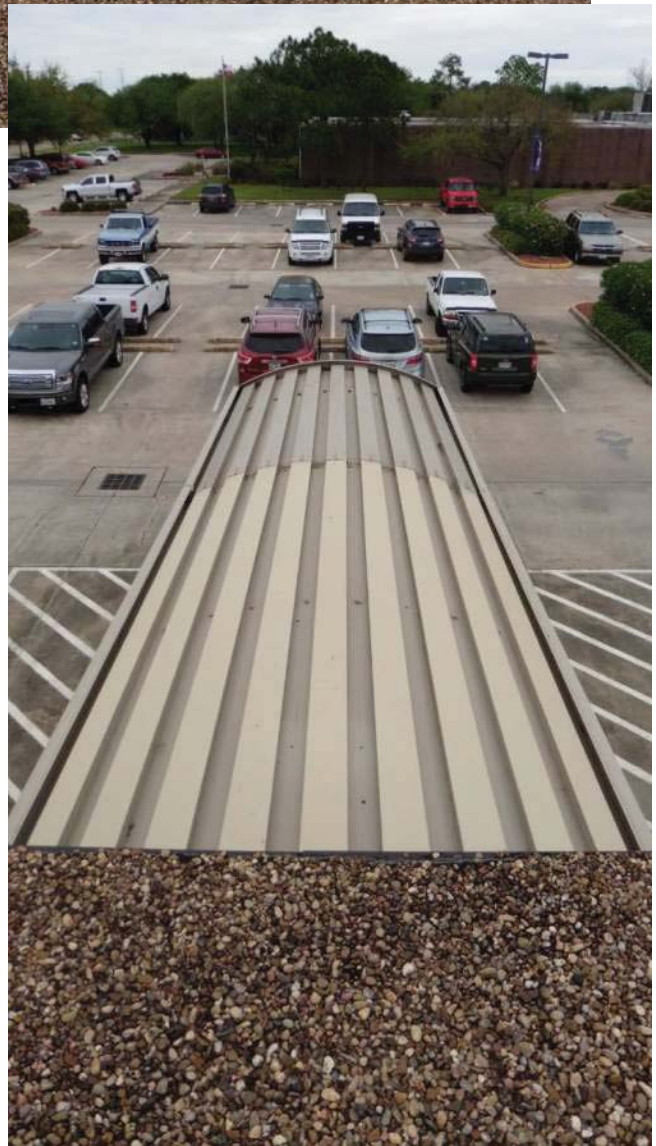
Condition of roof at addition

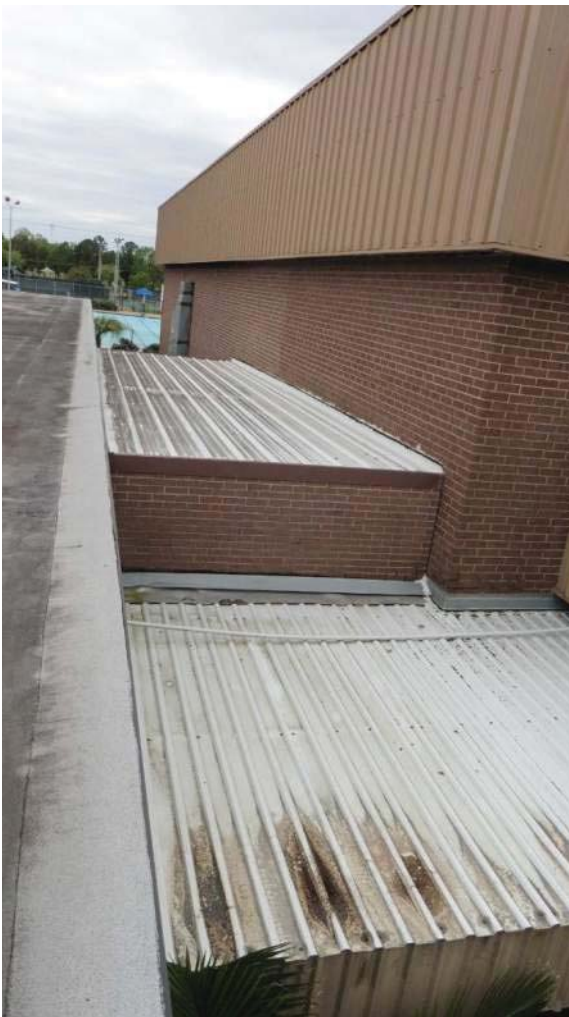
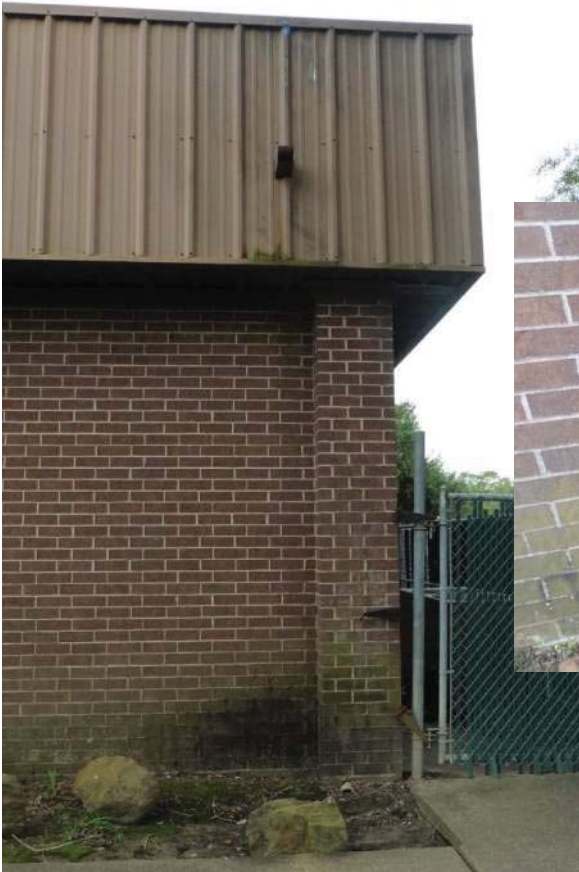
Condition of lower gym roof

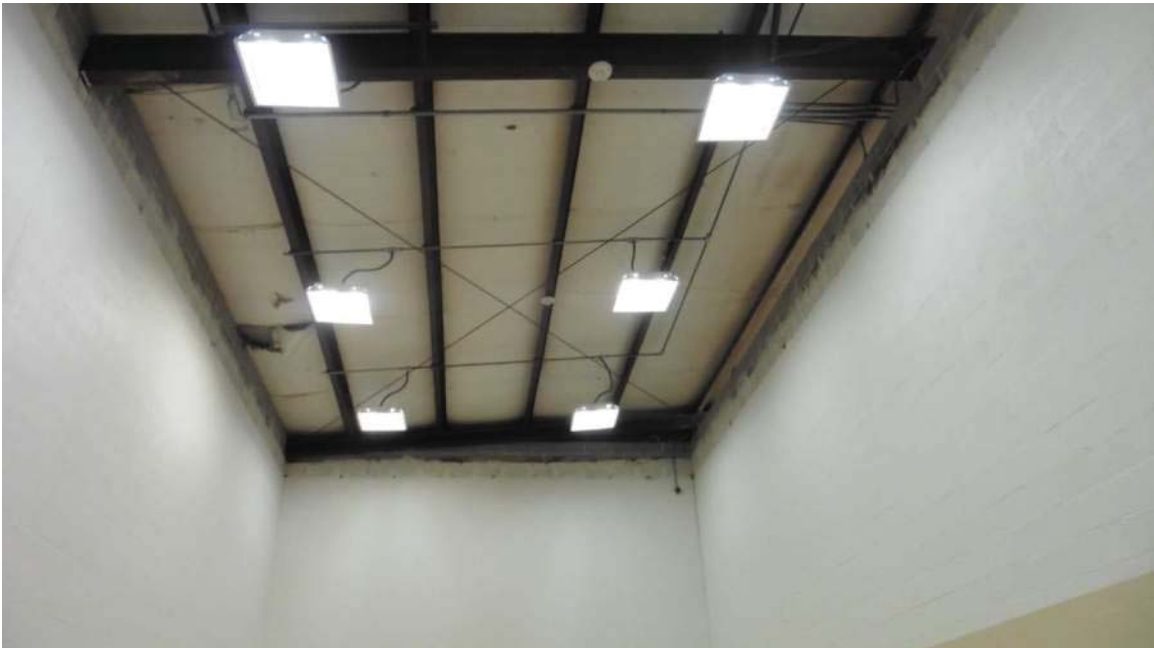
Examples of damaged “over-the-purlin” gym roof insulation

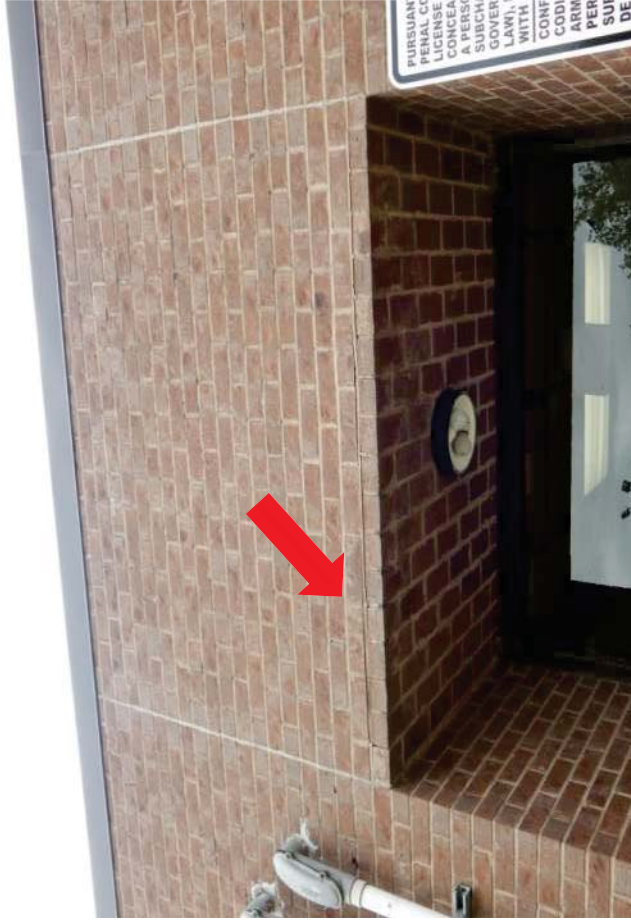
**#30** Photo at same location as photo #29 at the corner of the inset brick Panel. Repaired crack goes up through control joint above inset panel

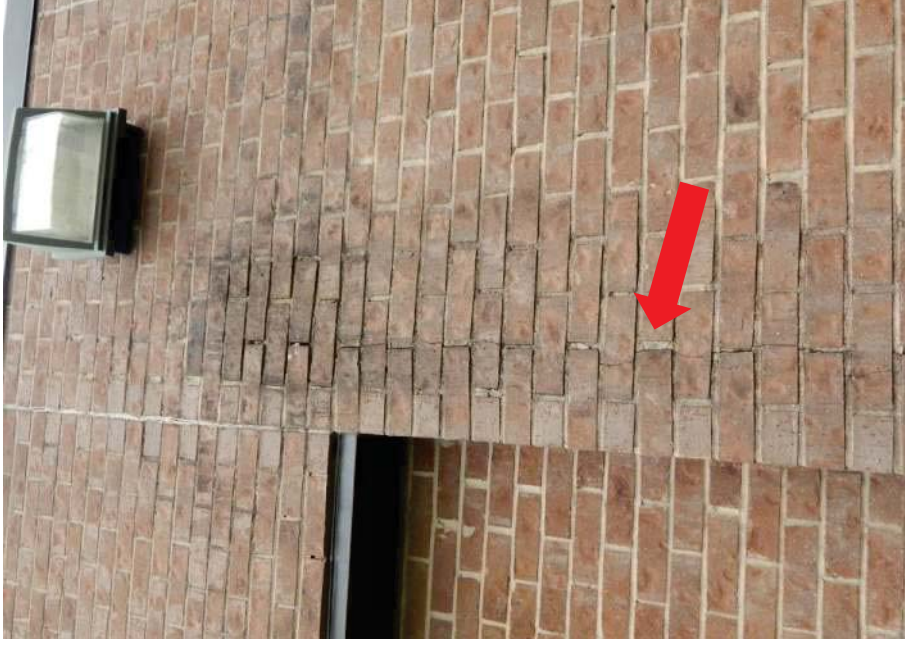
#31 Horizontal crack above soffit brick The same as described in photo #13

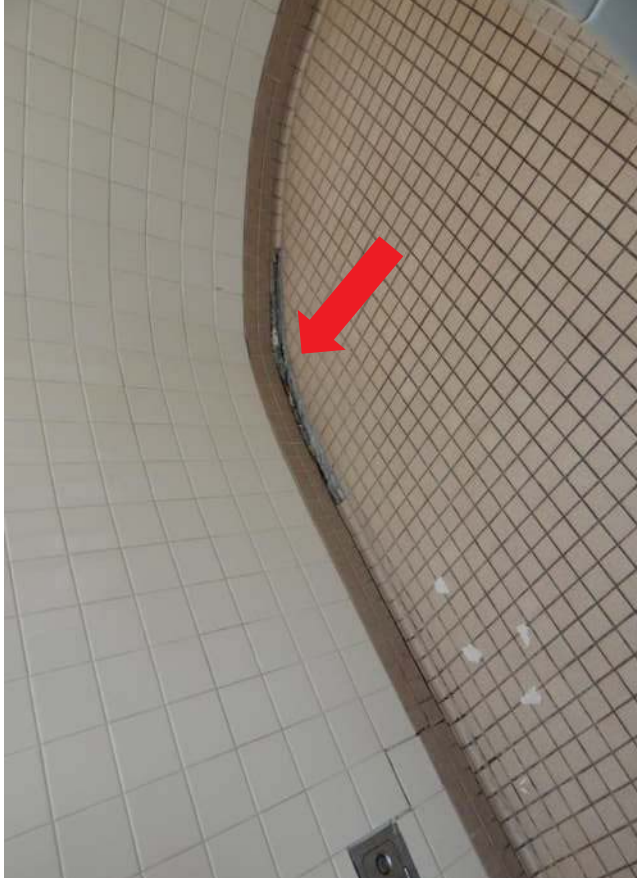
#33 Separation of base of wall to floor

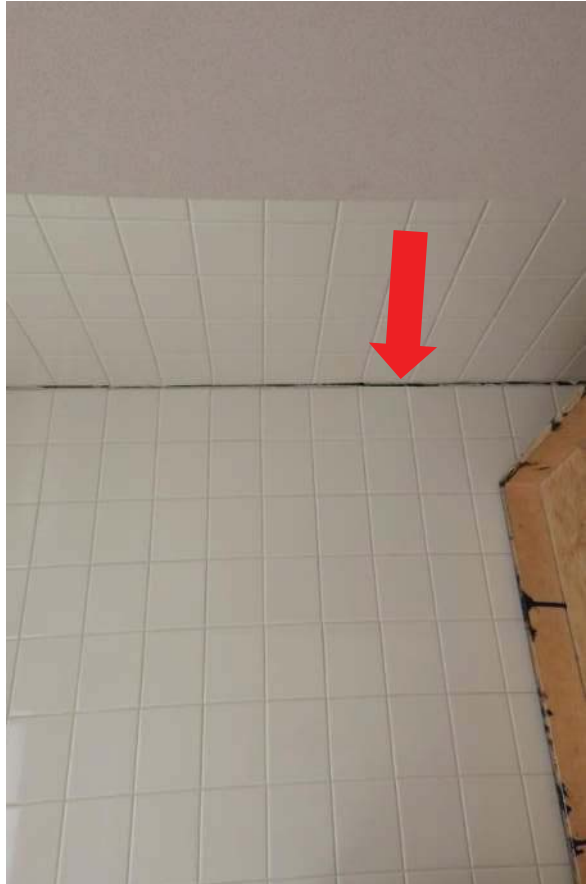
#35 Cracking in sheetrock wall and tile in bathroom

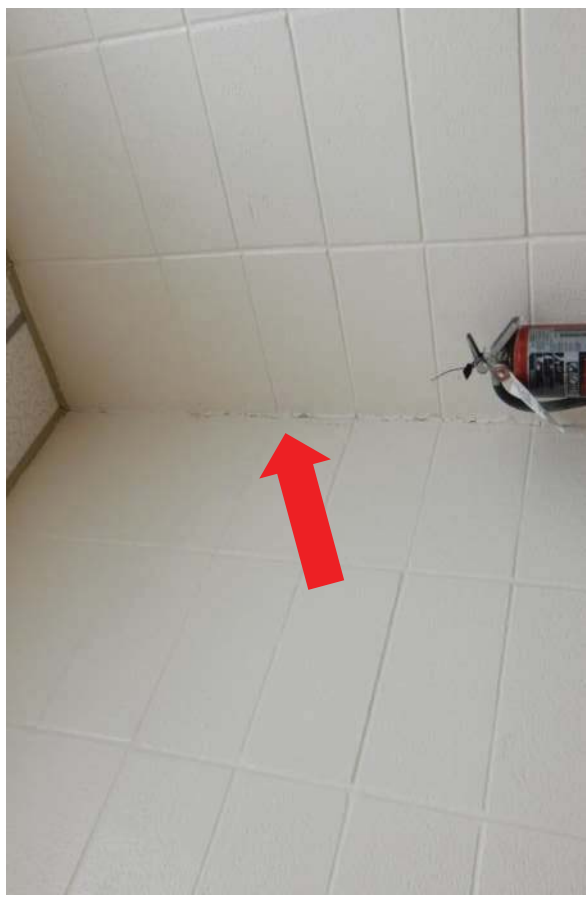
#44 Crack in corner of CMU wall

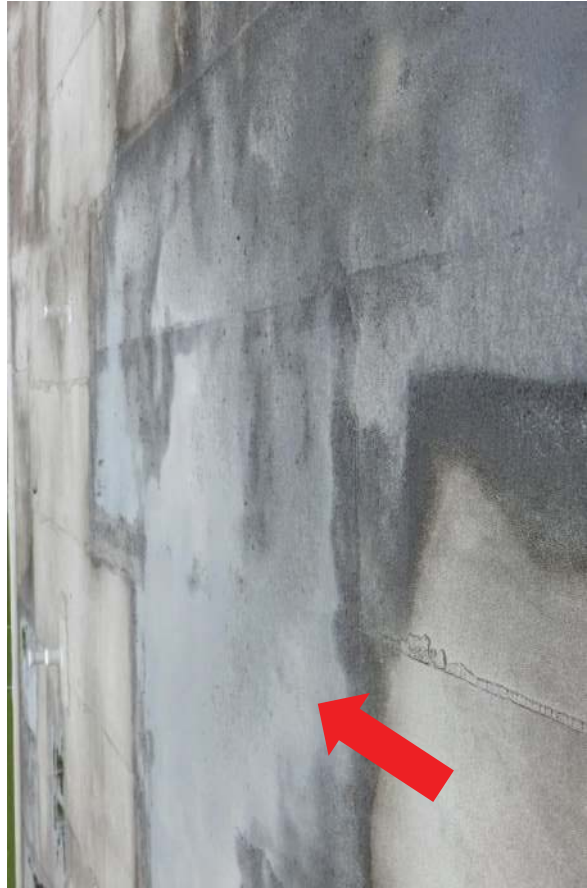
#50 Vertical crack in CMU wall

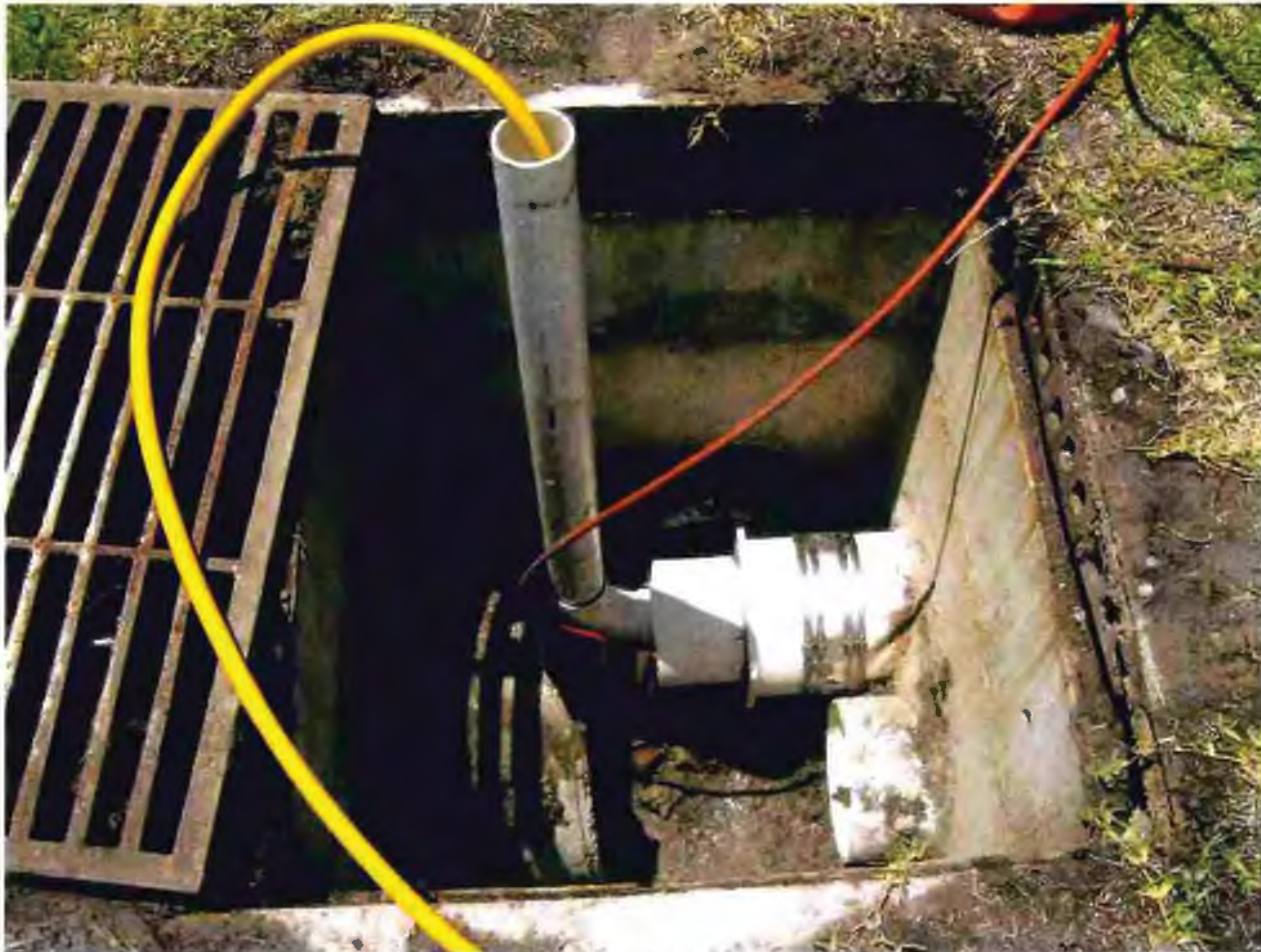
Photo 7. Leak testing of underground 10-inch diameter main roof drain for addition.
