EVALUATION OF THE 250,000 GALLON WELDED STEEL SINGLE-PEDESTAL SPHEROID

**“AVON STREET TANK”
DEER PARK, TEXAS**

THE CITY OF DEER PARK

July 25, 2023

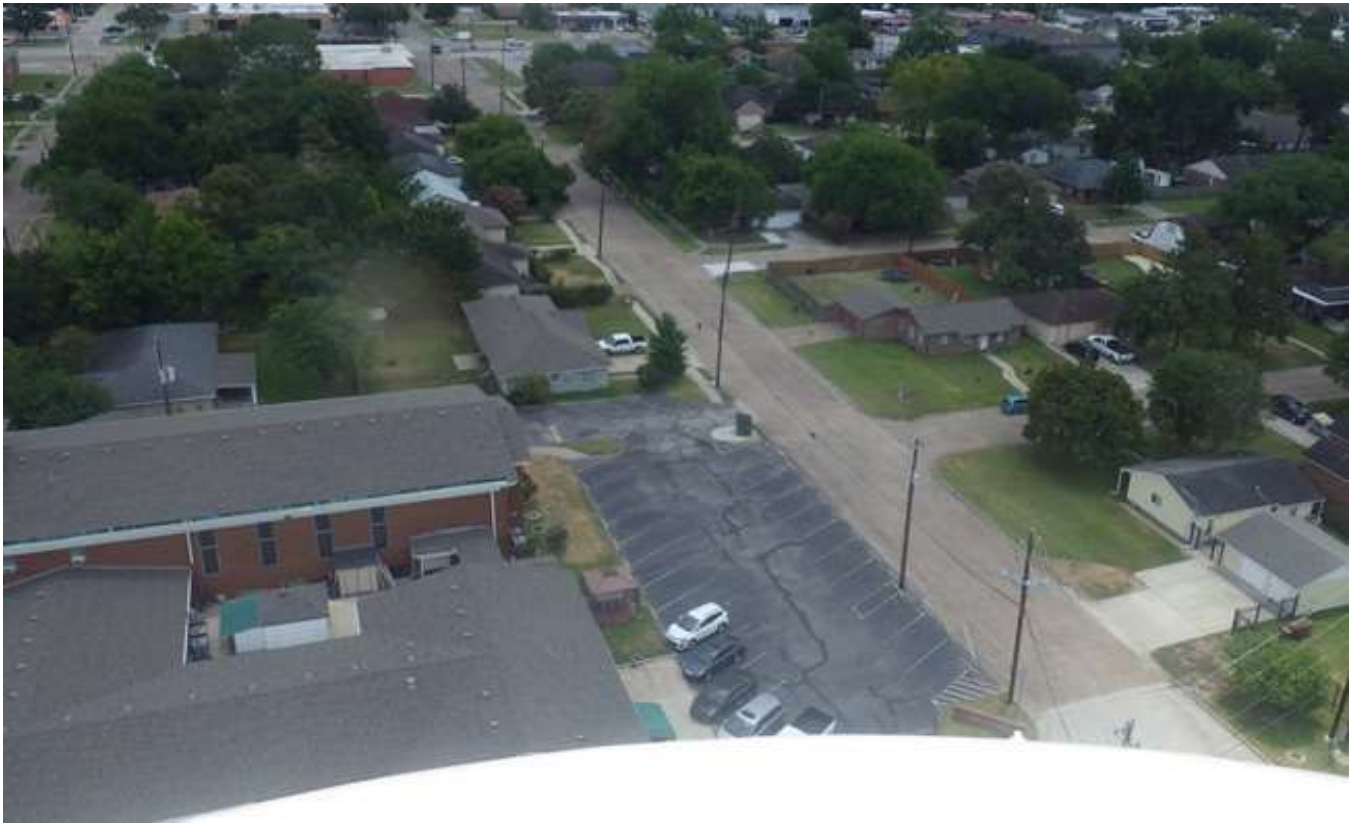
3. Surrounding area.

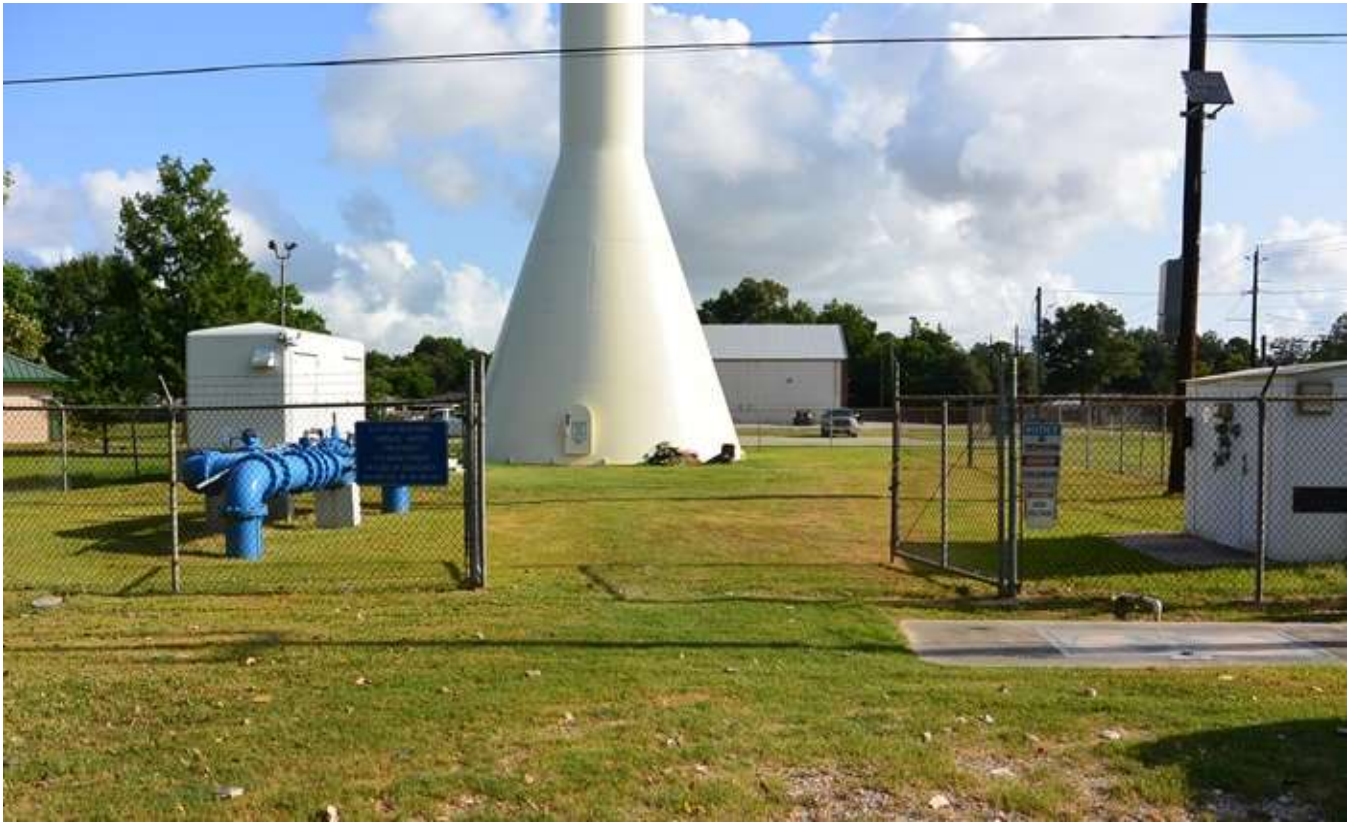
5. Site gate. Note information and warning signs on the fence.

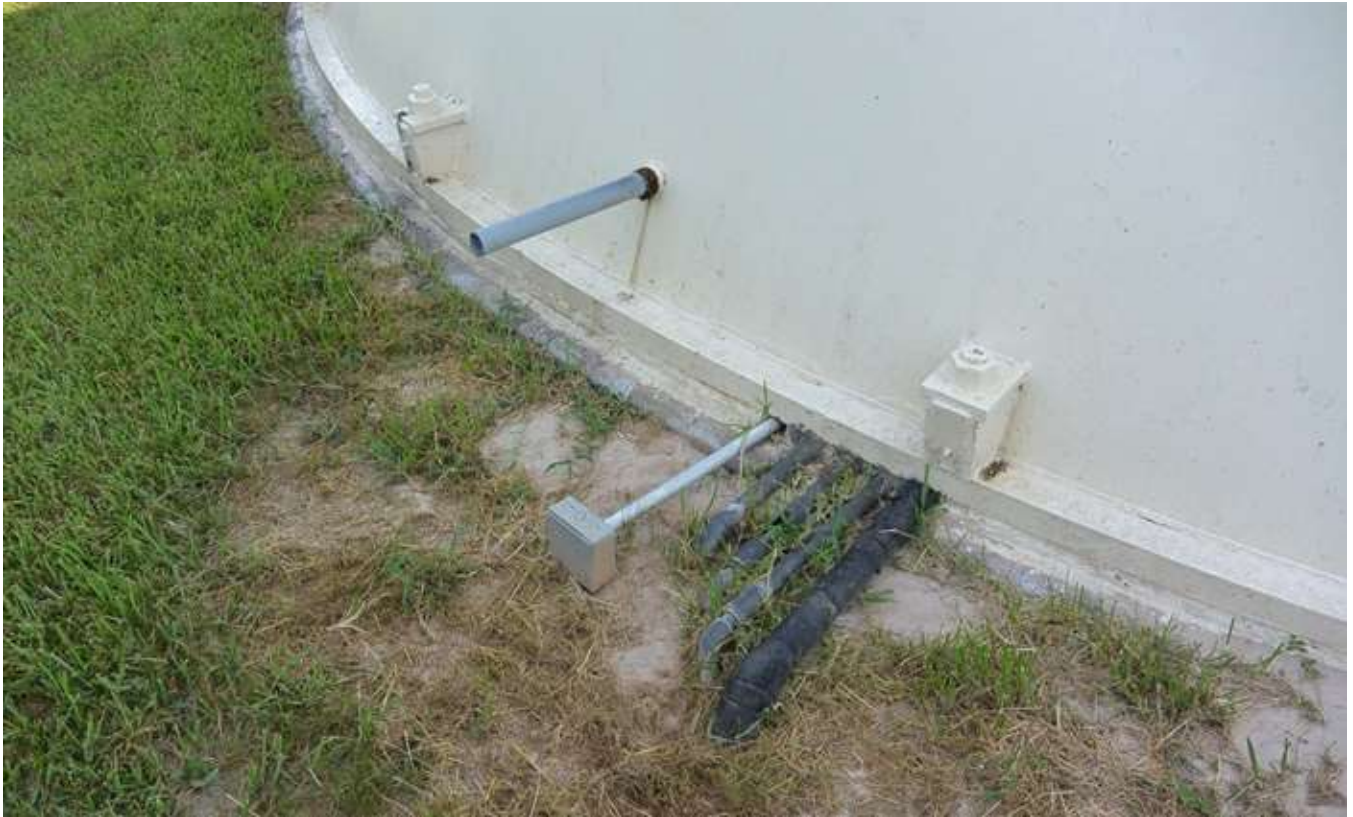
7. Conduits and piping extending from below grade and penetrating the foundation and pipe projecting from near the bottom of the base cone.

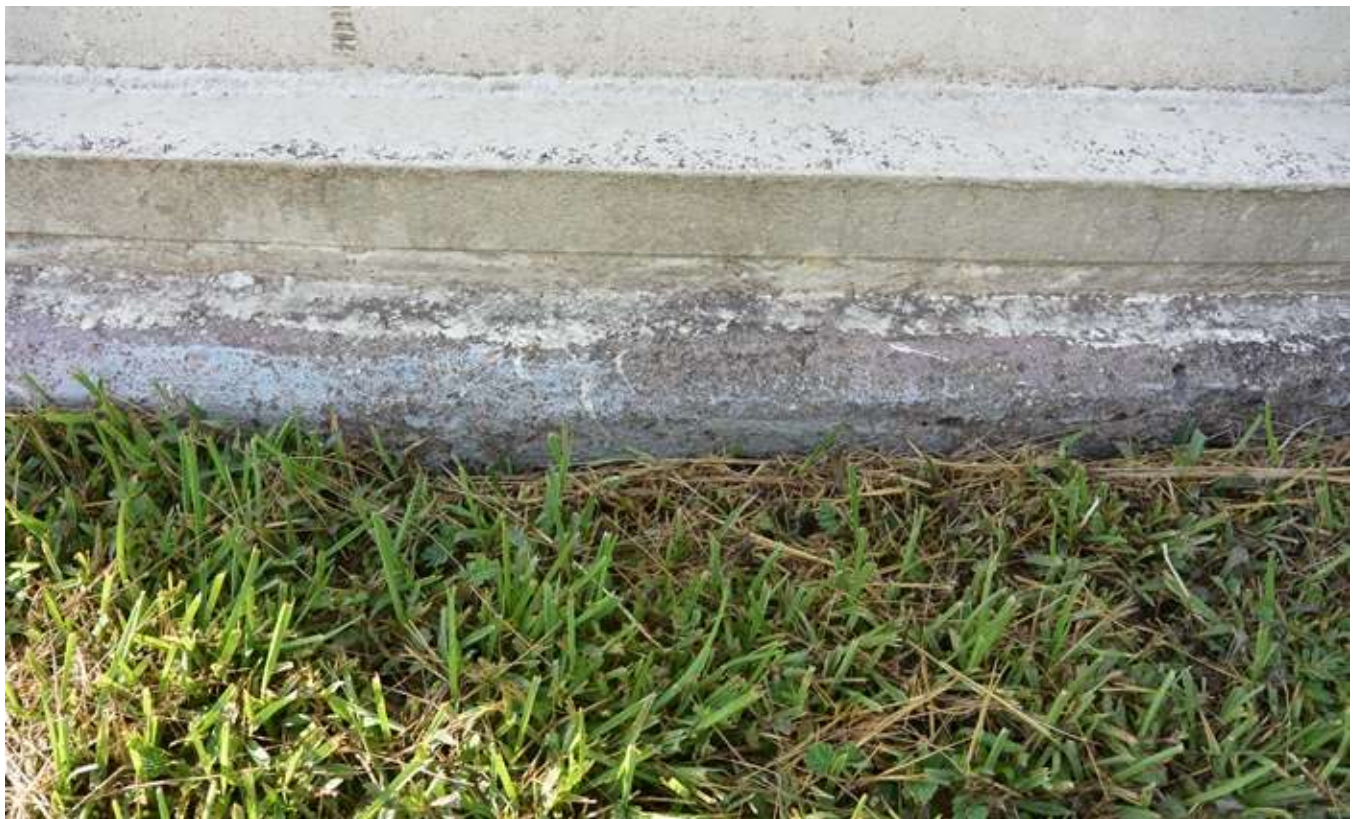
4. **Grout:** There was a pad of grout between the tank base plate and the concrete foundation. The grout appeared to be in adequate condition but was undercut in areas. White coating was visible on the grout. There was no sealant located at the grout-to-base plate interface. (See photos 8-11)

8. Foundation, grout, and base plate.

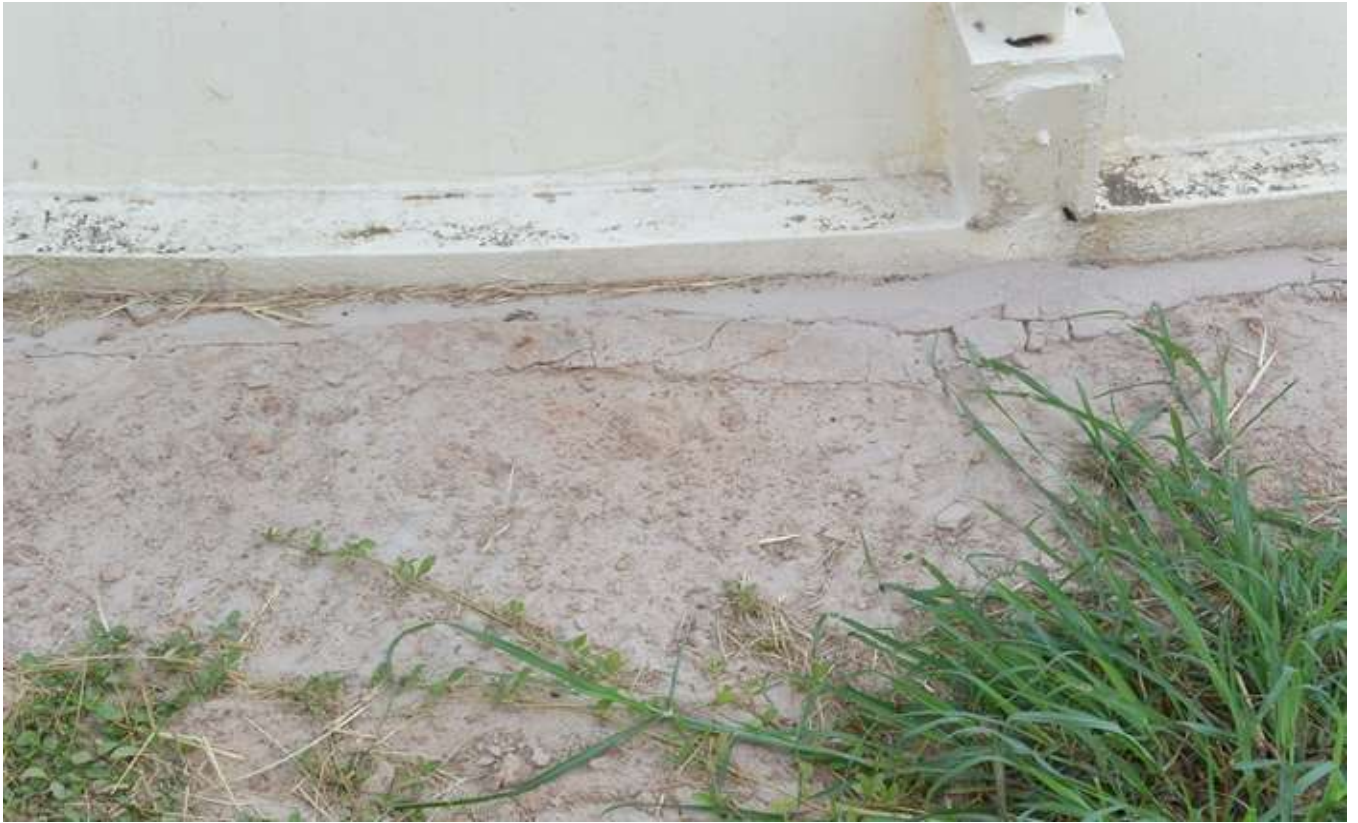
9. Buried foundation, grout, base plate, and anchor bolt chair.

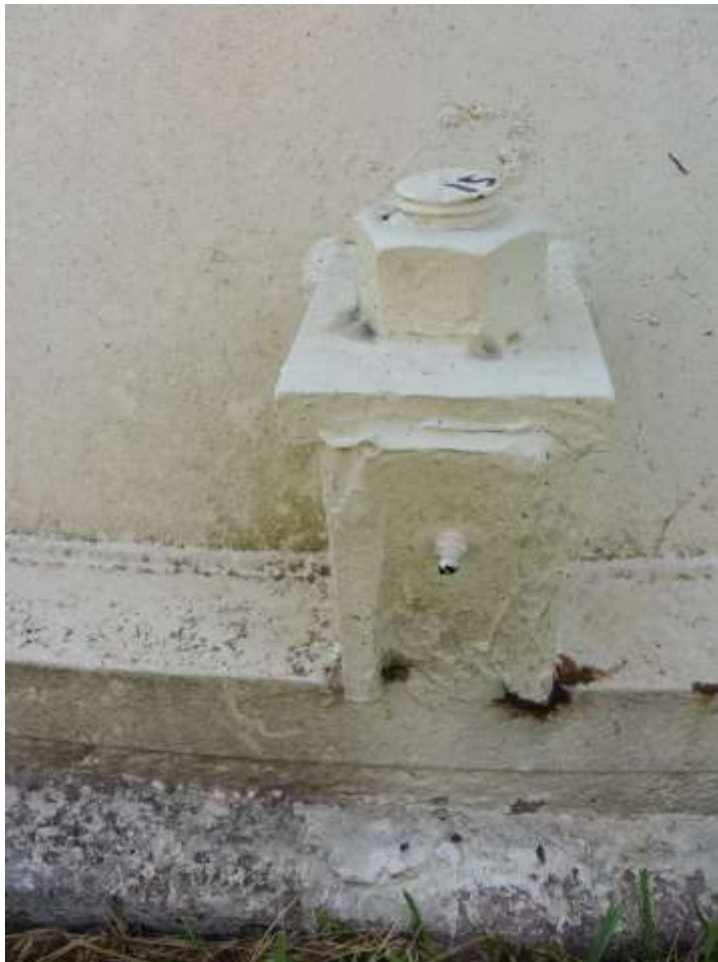
3. **Anchor Bolts and Chairs:** The tank was equipped with twenty anchor bolts and anchor bolt chairs. No significant coating failure or corrosion was observed on the anchor bolts. The chairs were sealed with a welded steel front plate. Minor coating failure and corrosion were observed on the top plate of the chairs. (See photos 10-11)

10. Foundation, grout, base plate, anchor bolt, and chair.

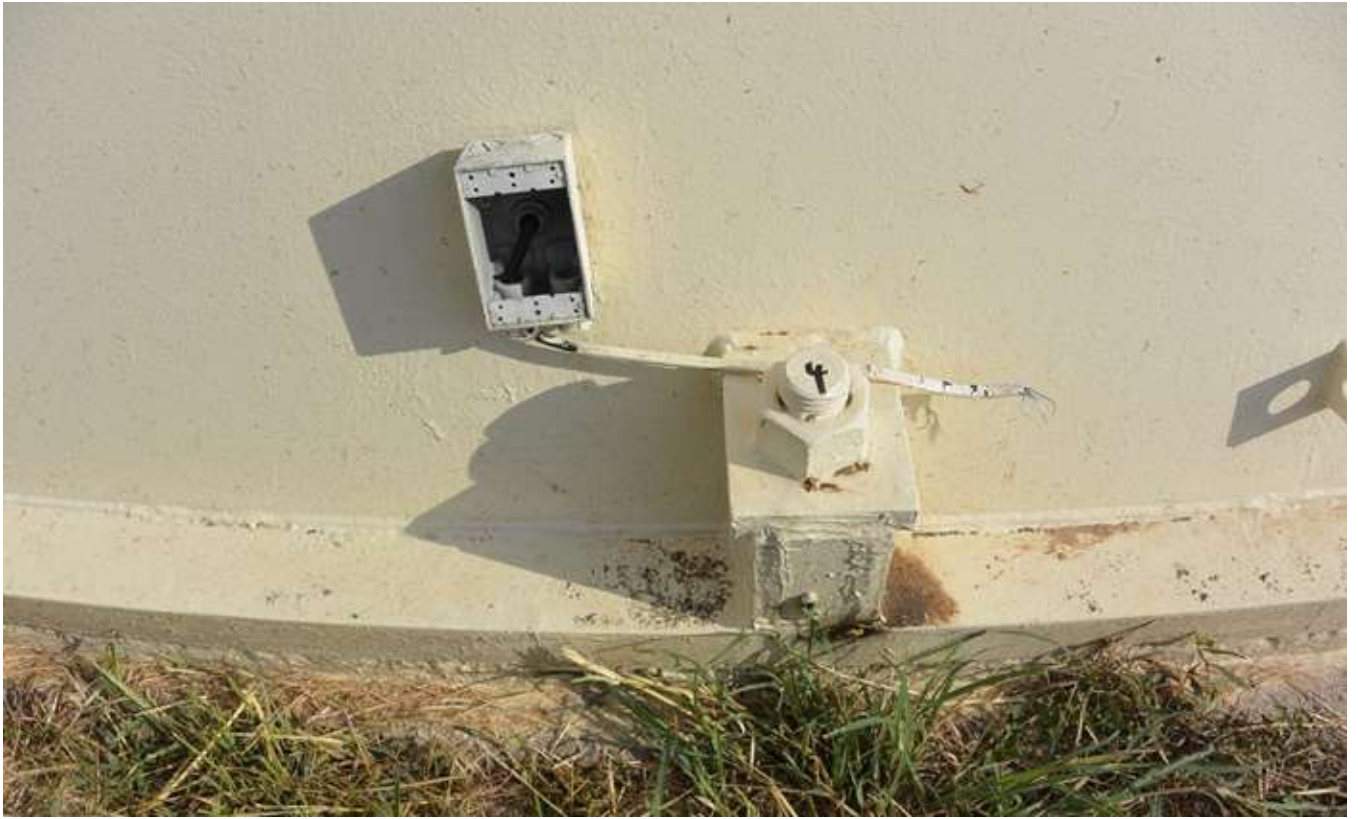
4. **Base Cone Condition:** **There was a safety-related deficiency noted: the uncovered conduit junction box and broken conduit near the bottom of the base cone exposed wiring.** The base cone appeared to be in nearly its original structural condition at the time of the field evaluation. No significant coating failure or corrosion was observed on the base cone. The exterior base cone coating had good adhesion to the steel. Dirt and mildew was observed on areas of the base cone. The base cone was equipped with a locked personnel access door on the south side. Information and warning signs were located on the access door. An uncovered conduit junction box connected to a broken conduit was located near the bottom of the base cone on the southeast side. A PVC pipe projected from near the bottom of the base cone on the west side. (See photos 7, 11-16)

11. Uncovered conduit junction box and broken conduit exposing wiring.

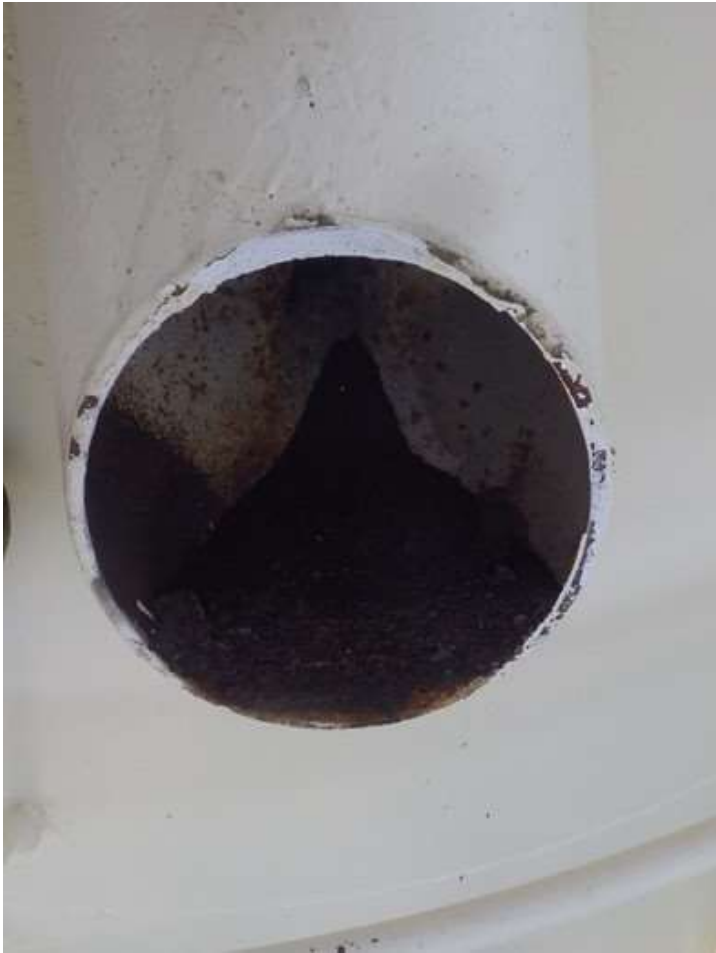
5. **Overflow Pipe:** **There were sanitary, AWWA, TCEQ, and operational deficiencies noted: (1) the overflow pipe discharged near the top of the support column which allowed the potential of accelerated corrosion on the support column and base cone and the erosion of the soil due to effluent discharge, (2) the 6 in. overflow pipe projection from the support column did not meet the minimum required 12 in., and (3) the discharge end of the overflow pipe was not equipped with protective screening.** The overflow pipe exited near the top of the support column and immediately discharged. The discharge end was equipped with a flap gate but was not screened. Corrosion was observed on the interior of the overflow pipe discharge. (See photos 20-21)

21. Corrosion on the interior of the overflow pipe discharge.

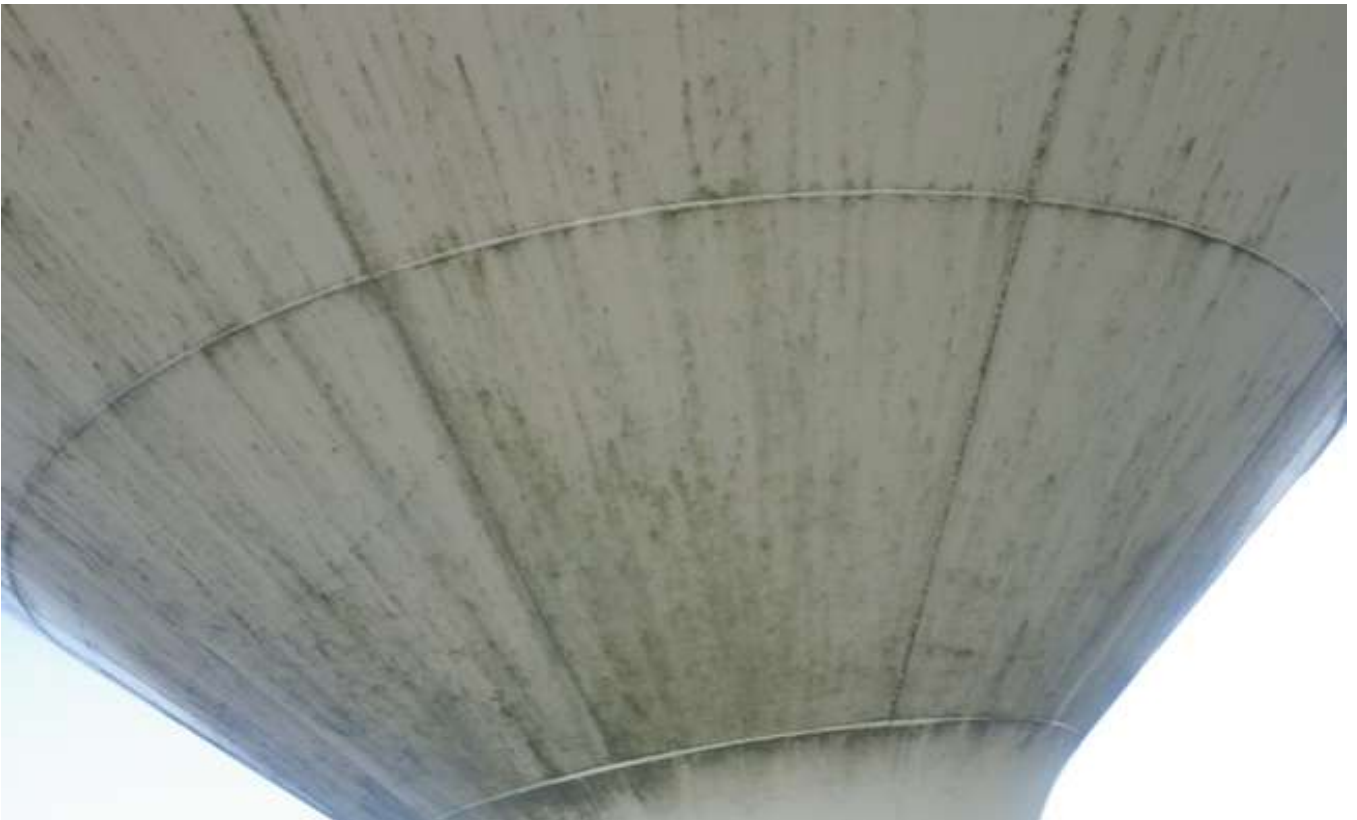
7. **Bowl Condition:** The coating on the bowl appeared to be in good overall condition with no significant coating failure or corrosion observed. The coating on the bowl had very good adhesion to the steel. Mildew was observed on the bowl. (See photos 22-24)

22. Mildew on the bowl exterior.

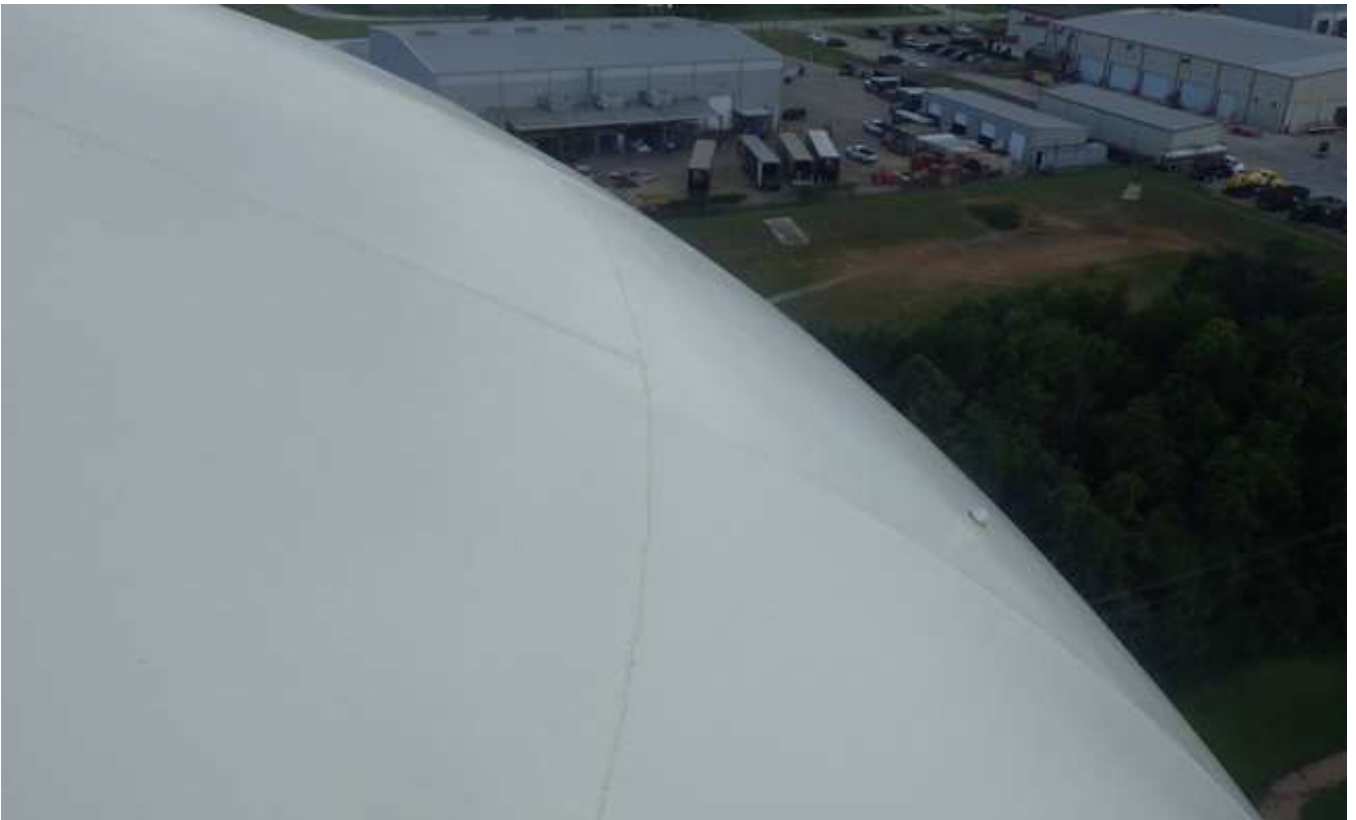
10. **Roof Condition: There was a sanitary deficiency noted: the coupling with the broken plug and an open coupling in the roof would allow the ingress of rain water run-off, birds, and insects into the tank.** The contour of the roof was irregular as several indentations were observed in the roof. Minor corrosion was observed on isolated areas of the roof. The coating on the roof had chalked but had good adhesion to the steel. Twenty-four couplings were located in the roof. One of the couplings was open which would allow the ingress of rain water run-off, birds, and insects into the tank. The remaining couplings were threaded and plugged, but one of the plugs was broken which would allow the ingress of insects into the tank. Pitting which had occurred prior to the last repainting was observed on the roof around one of the threaded and plugged couplings. (See photos 28-33)

28. Threaded and plugged coupling in the roof exterior.

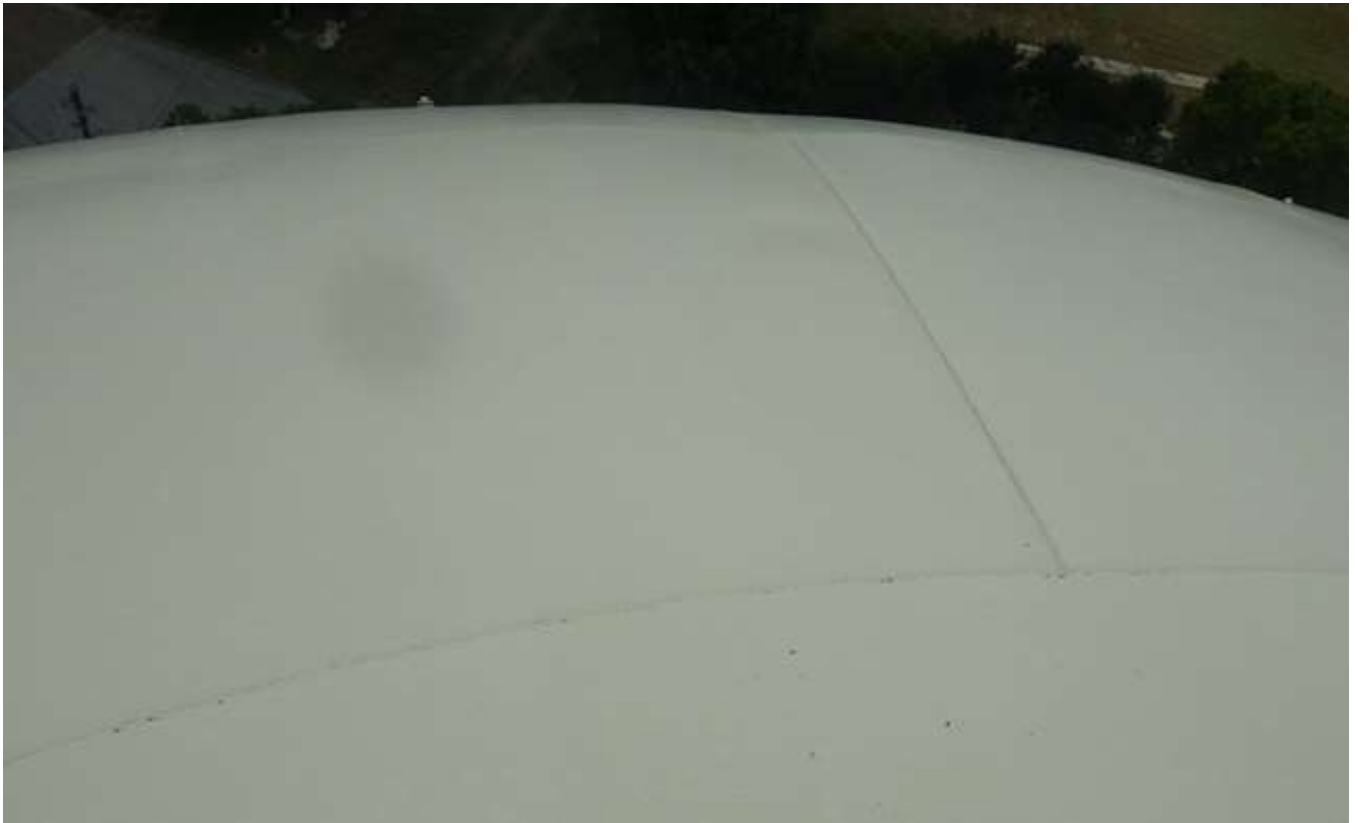
29. Irregular roof contour. Note threaded and plugged couplings in the roof.

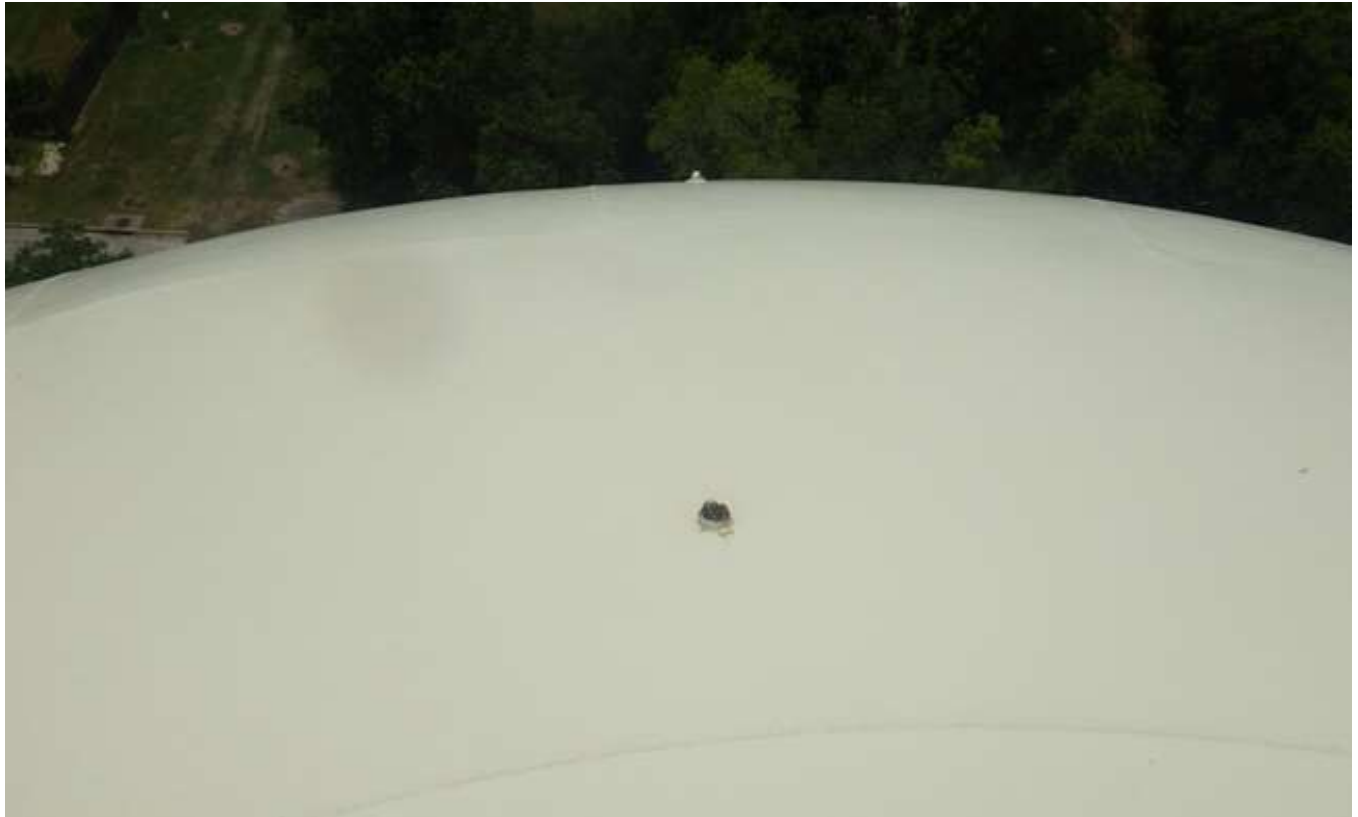
30. Roof exterior. Note corrosion on open coupling in the roof.

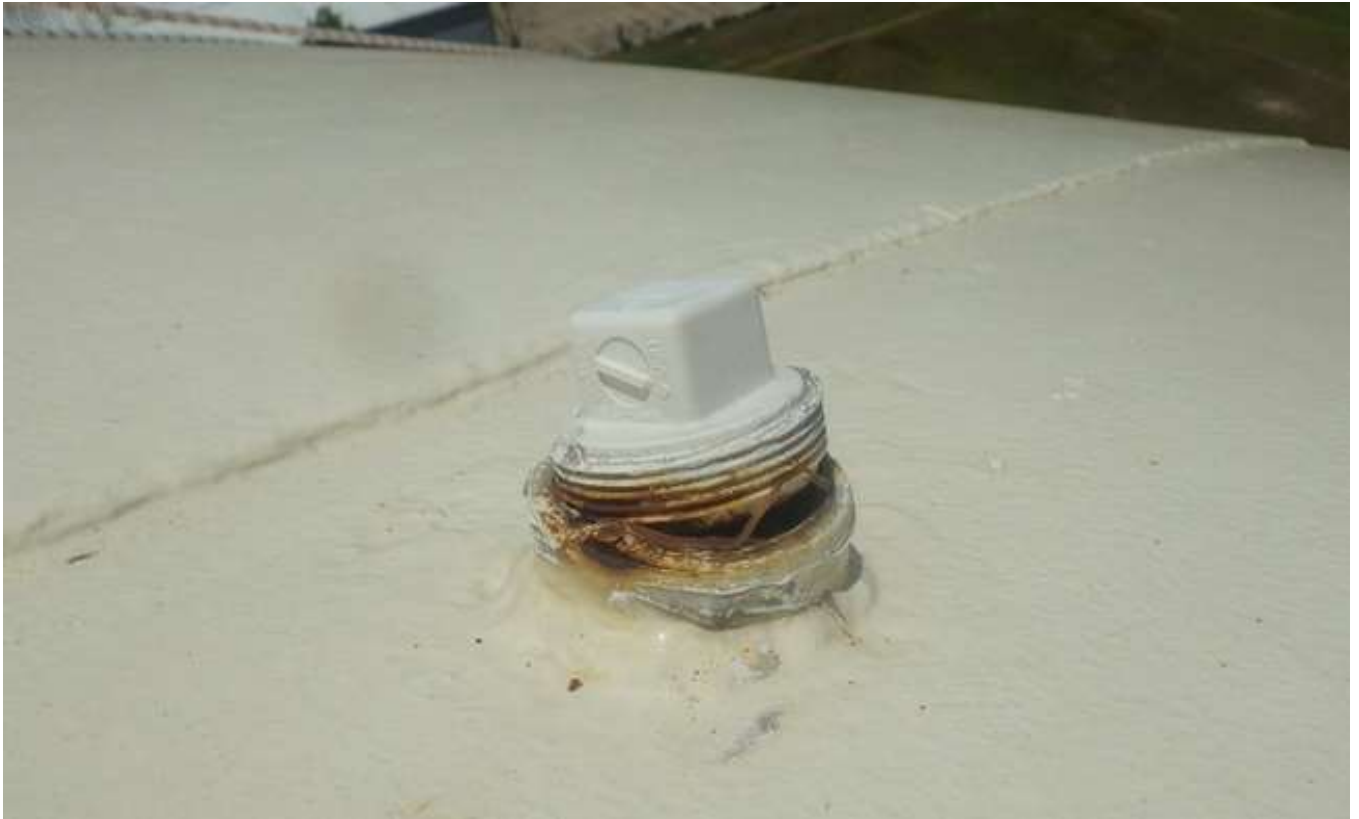
32. Broken plug of threaded and plugged coupling in the roof.

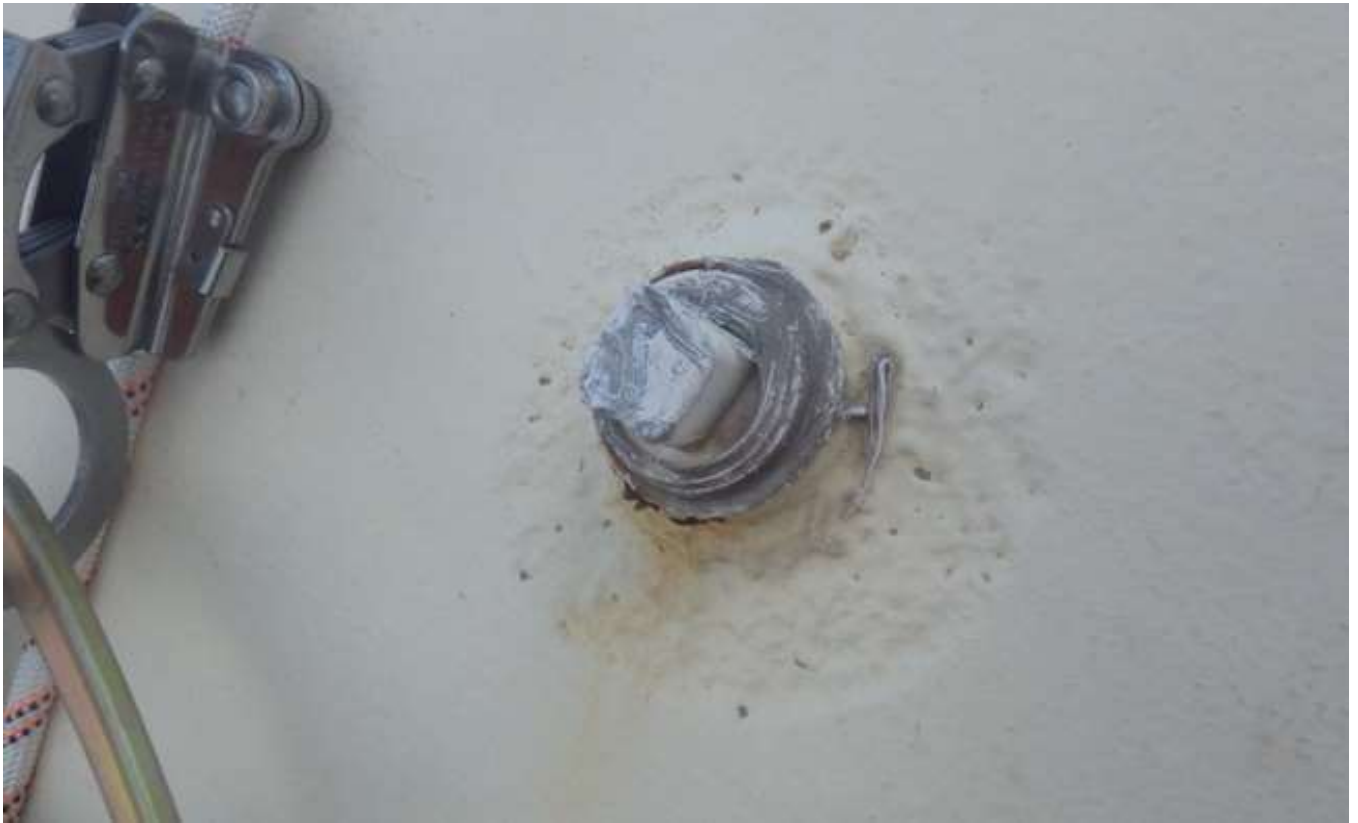
33. Pitting which had occurred prior to the last repainting around threaded and plugged coupling in the roof.

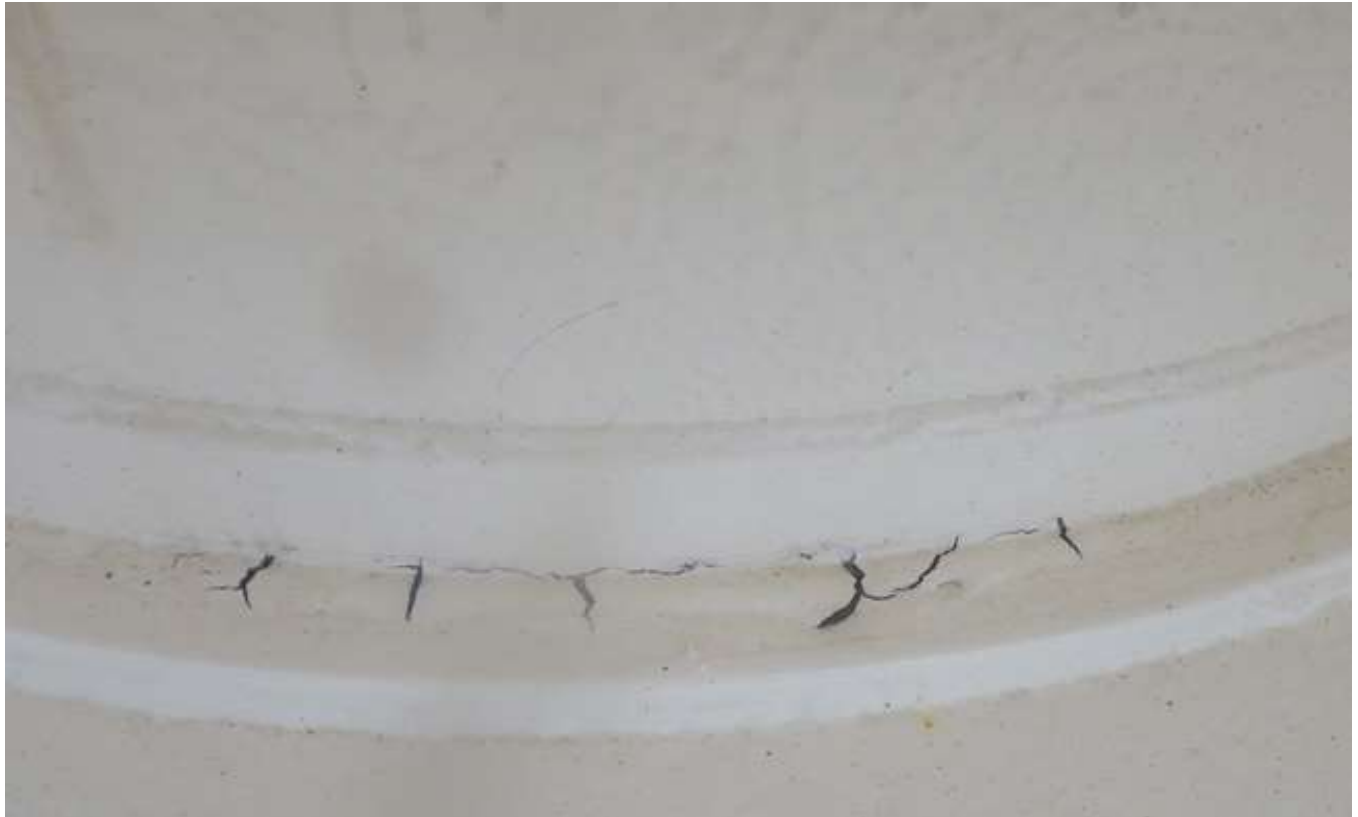
38. Coating failure around the access tube roof manhole curb.

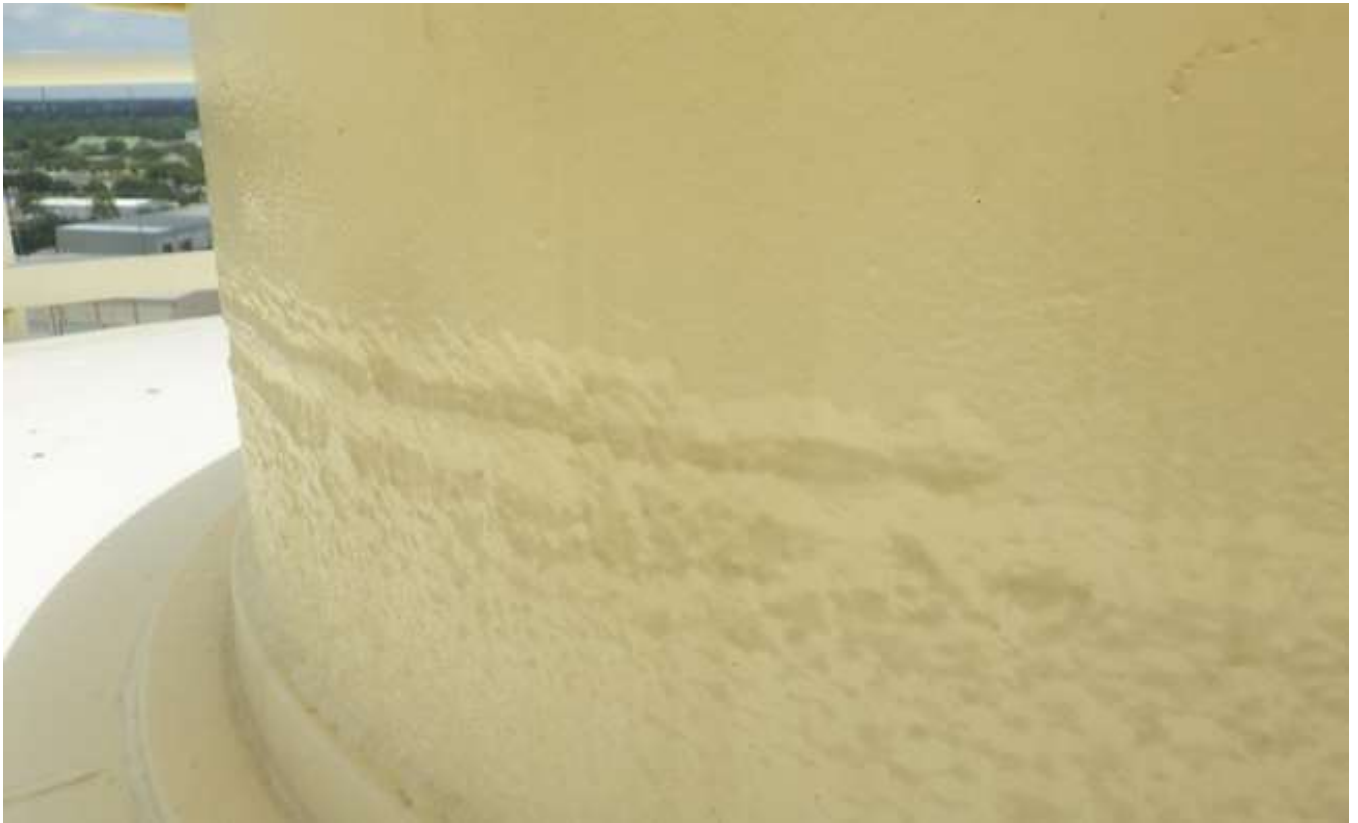
39. Pitting which had occurred prior to the last repainting on the access tube roof manhole curb.

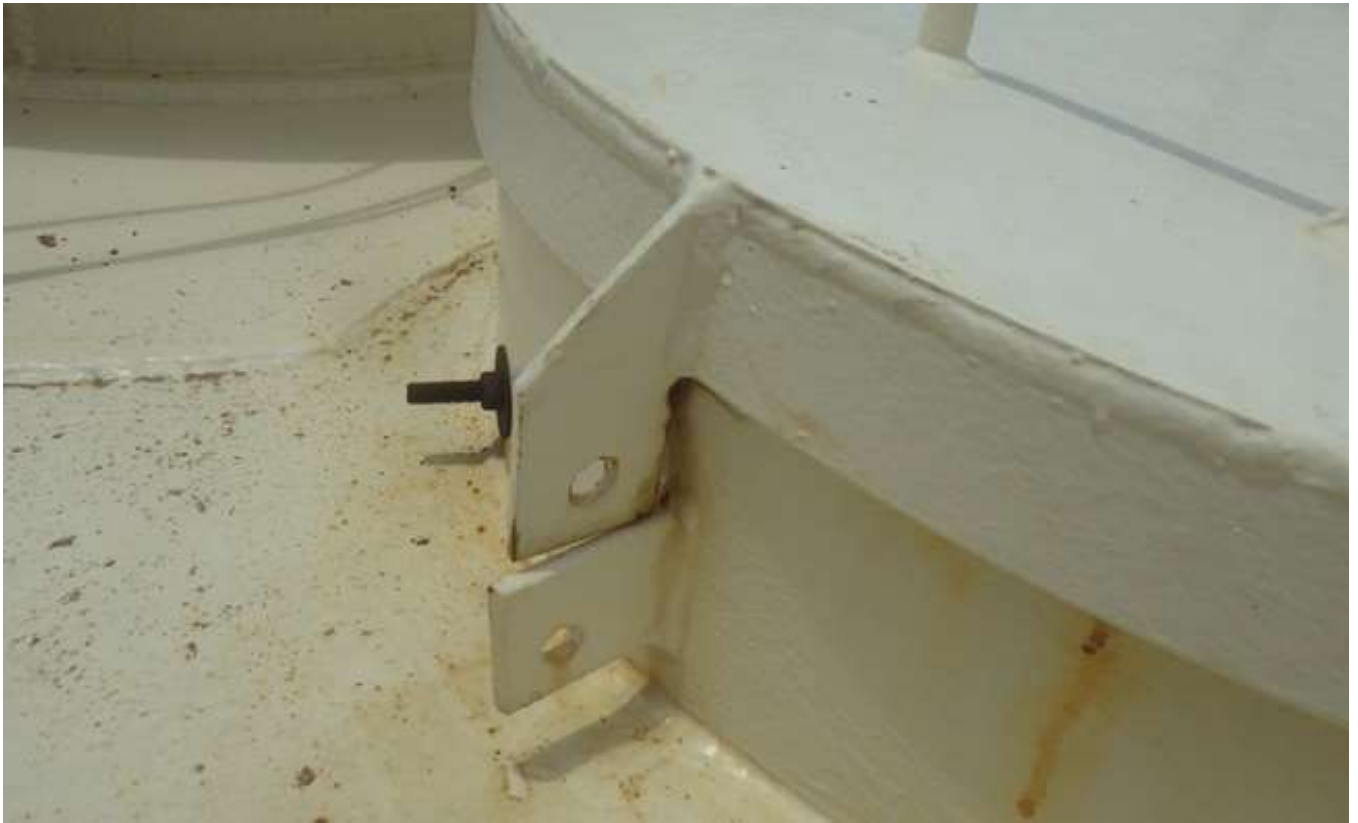
11. **Roof Manholes: There were safety-related, sanitary, AWWA, TCEQ, and operational deficiencies noted: (1) the container roof manhole cover did not fully close and its locking hasps were misaligned, and (2) the container roof manhole cover was not locked.** The roof was equipped with one access tube manhole and one container manhole. The manholes were

41. Misaligned container roof manhole locking hasps.

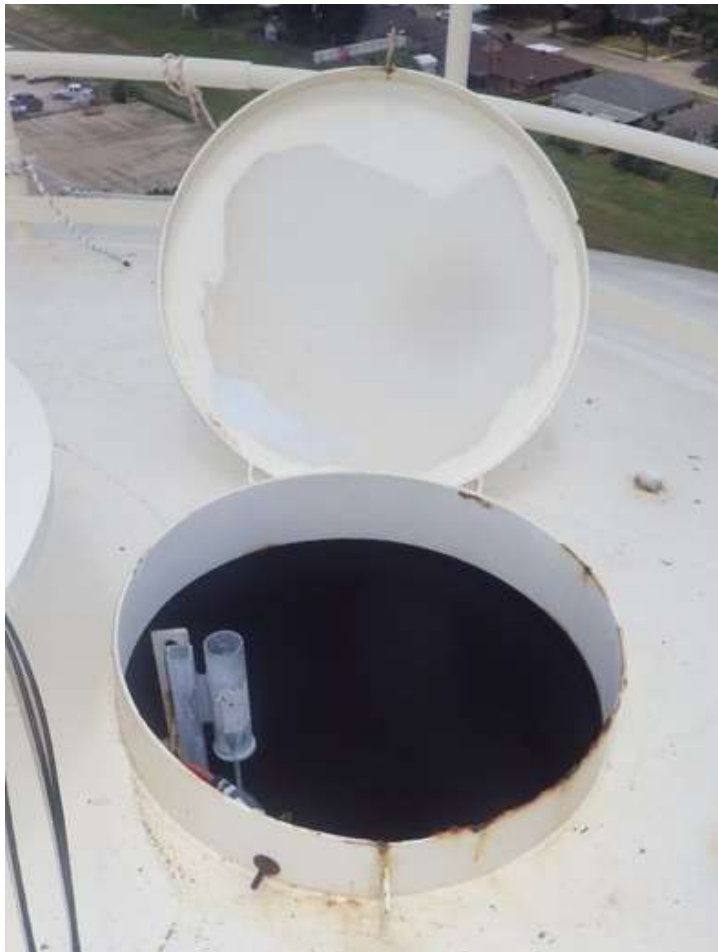
42. Corrosion on the container roof manhole curb and previously touched-up area on the cover interior.

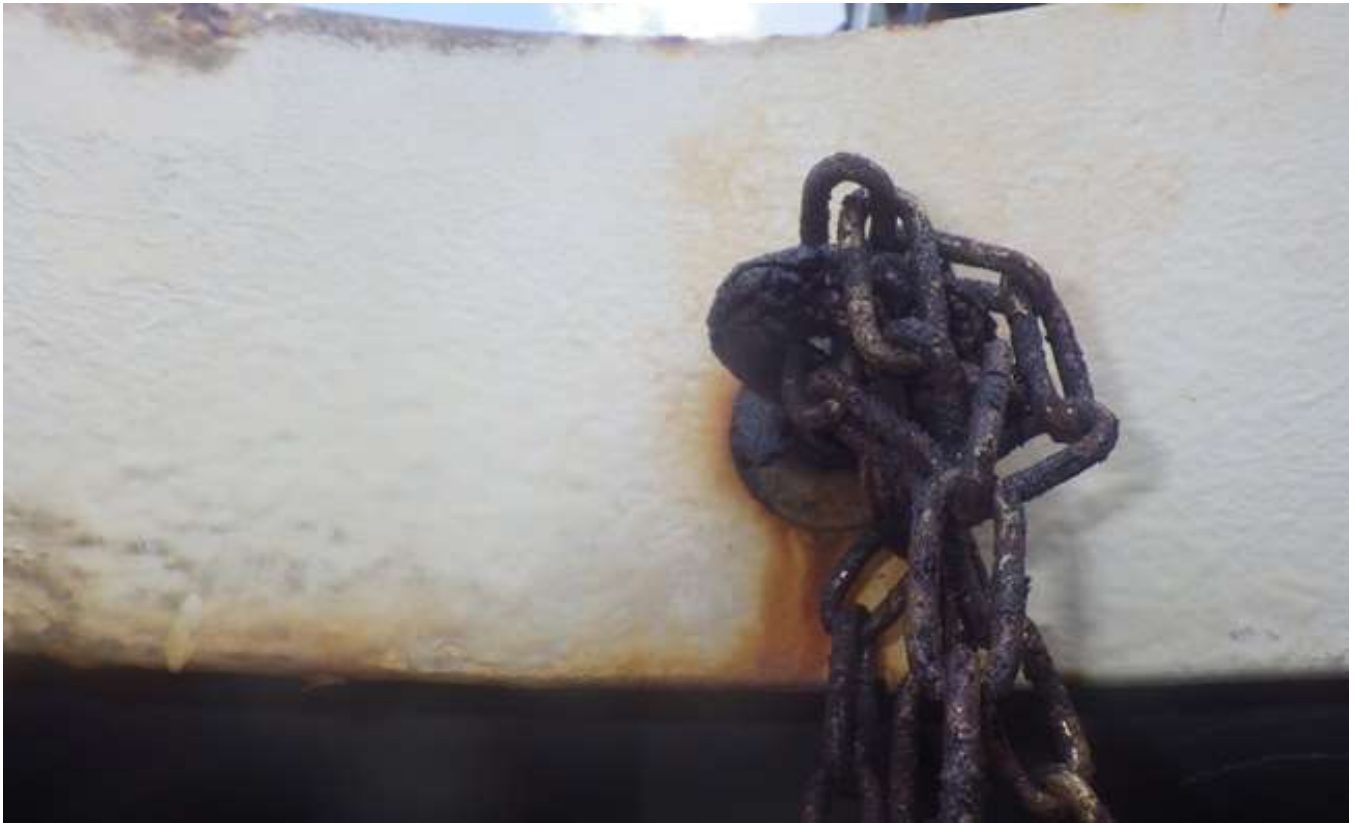
43. Corrosion and metal loss on chain penetrating the container roof manhole curb.

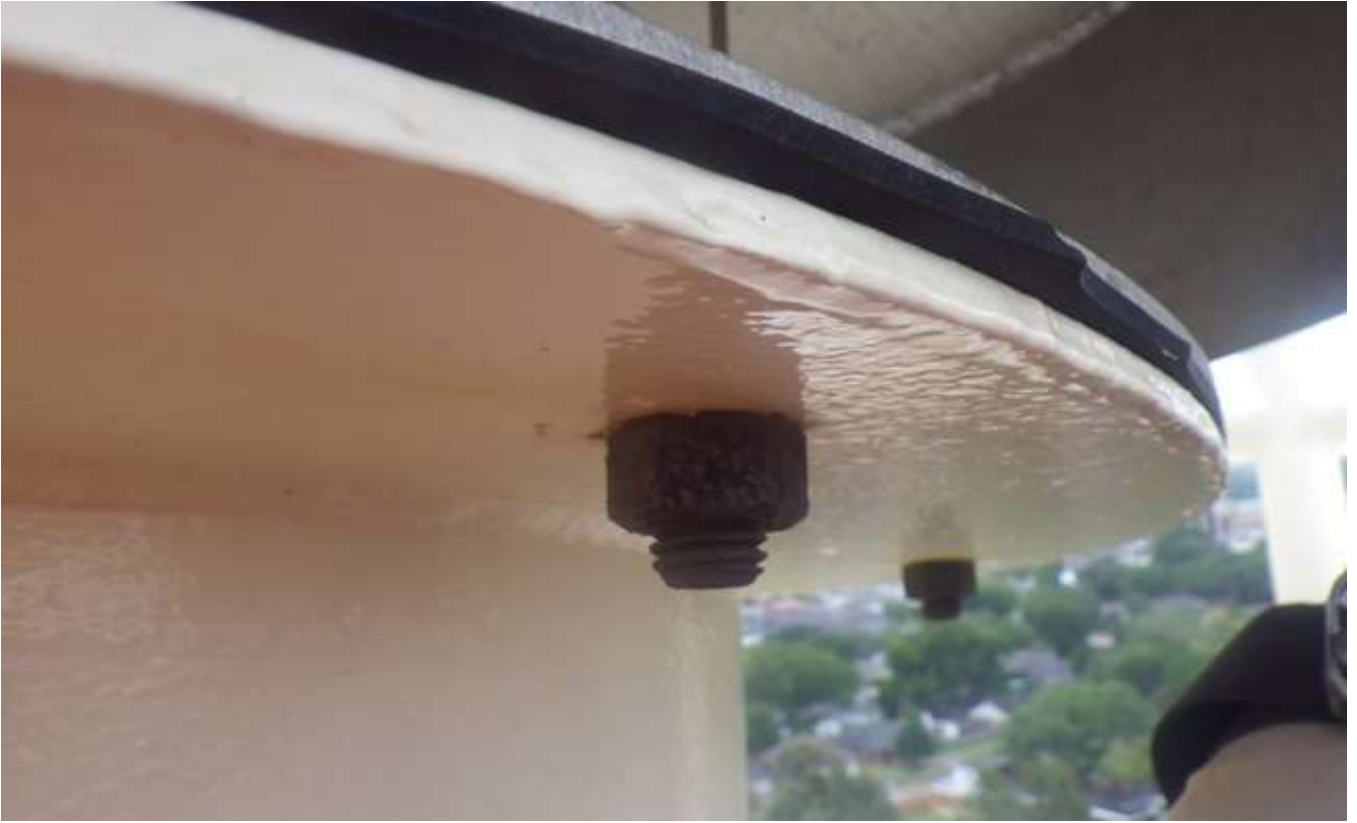
45. Gasket and corroded bolts and nuts on the roof vent flange.
