EVALUATION OF THE 250,000 GALLON WELDED STEEL SINGLE-PEDESTAL SPHEROID

**“AVON STREET TANK”
DEER PARK, TEXAS**

THE CITY OF DEER PARK

July 25, 2023

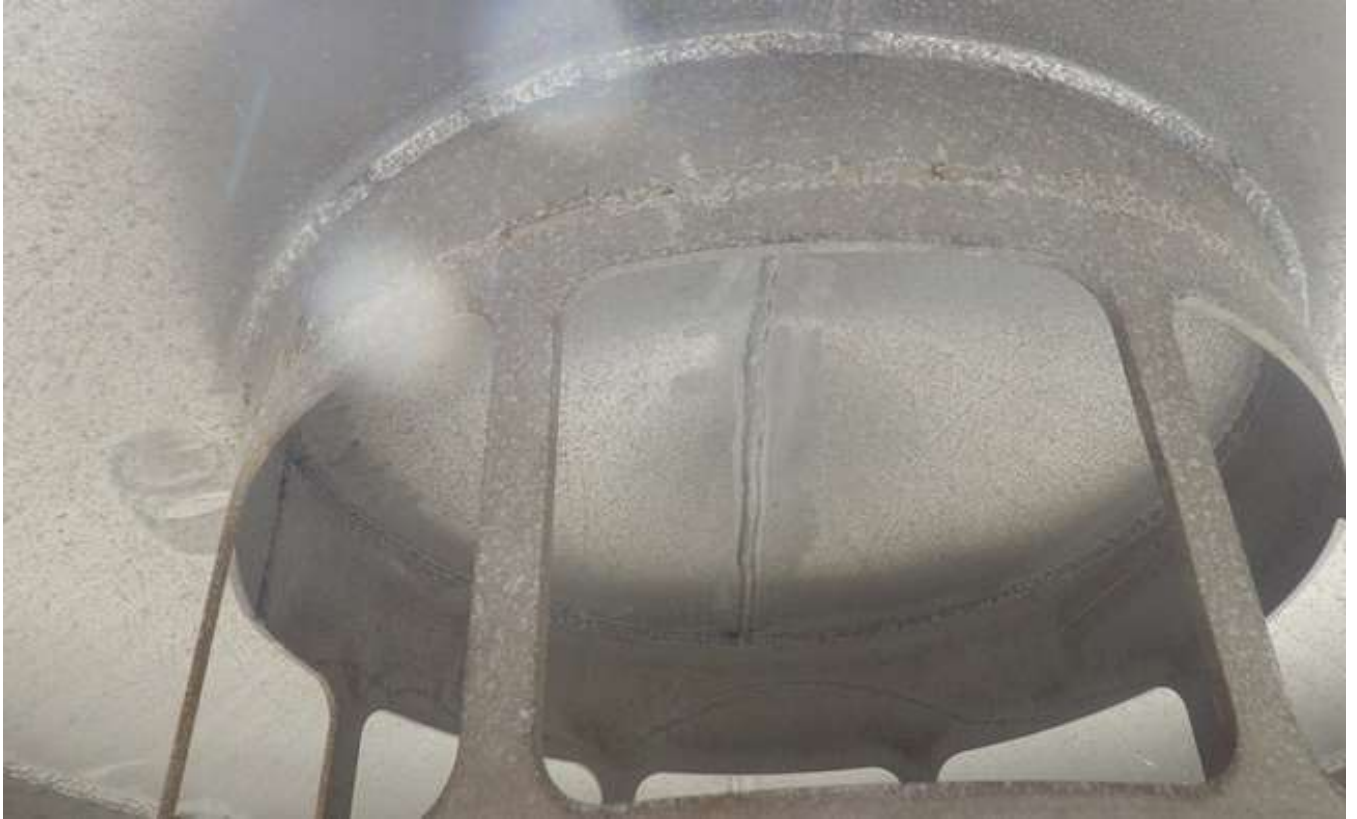
12. **Roof Vent:** There were sanitary, AWWA, TCEQ, and operational deficiencies noted: **(1) the roof vent was not of a clog-resistant design, and (2) the roof vent was not screened which would allow the ingress of birds and insects into the tank.** The roof was equipped with a vent attached to a flanged opening. The roof vent flange was equipped with a gasket which appeared to be in adequate condition. Corrosion and metal loss were observed on the bolts and nuts at the flange. The roof vent was not screened which would allow the ingress of birds and insects into the tank. (See photos 44-46)

46. Roof vent missing screening.

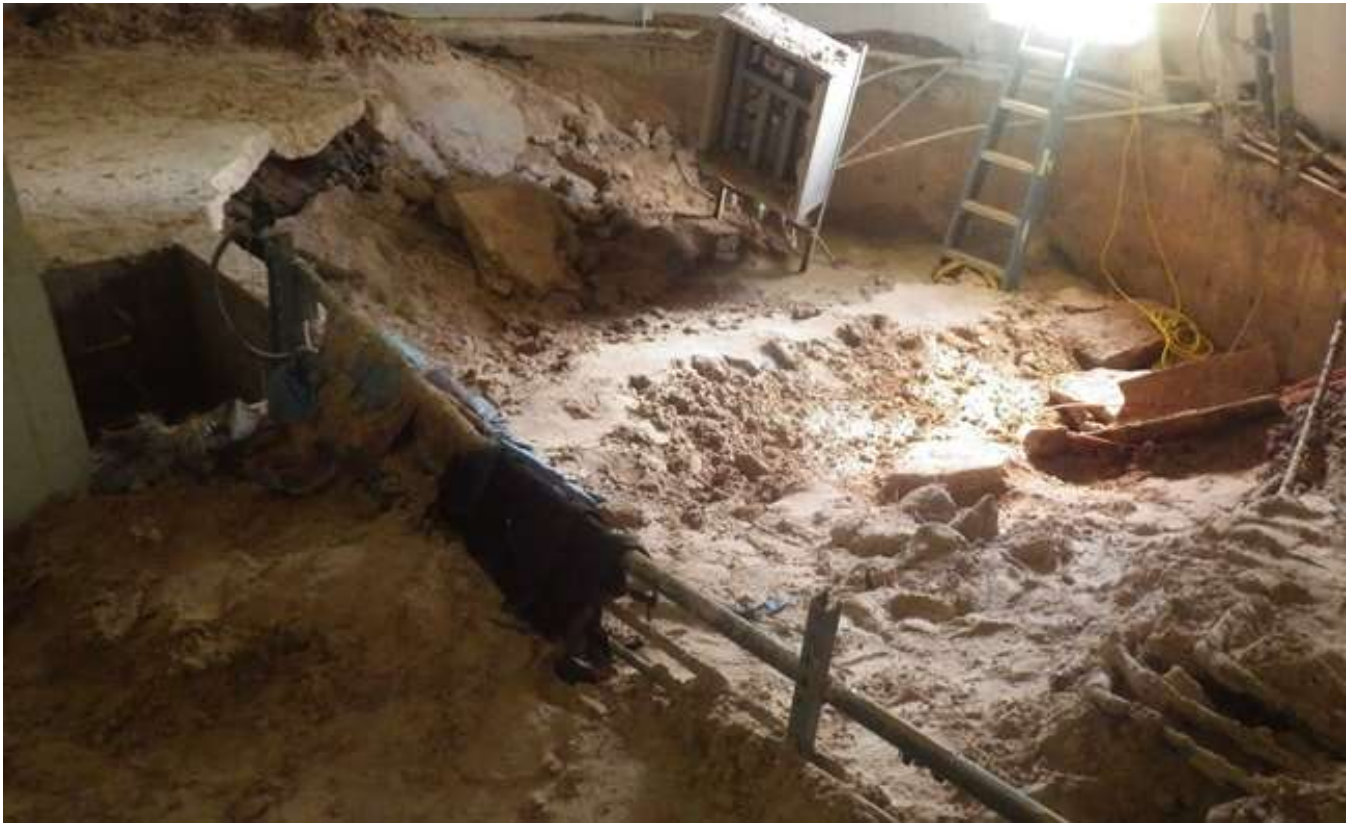
2. **Base Cone Condition:** There was an operational deficiency noted: the base cone concrete floor was severely damaged and the underlying fill disturbed. There were safety-related deficiencies noted: (1) an uncovered cabinet and several broken conduits and cables exposed wiring at the damaged concrete floor of the base cone, and (2) the sand, debris, and conduits on the damaged concrete floor crated a trip hazard. The coating on the interior of the base cone appeared to be in good overall condition with no significant coating failure or corrosion observed. The interior dry base cone coating had fair adhesion to the steel. The base plate projection appeared to be in adequate condition at the time of the field evaluation. The base cone floor was constructed of concrete and approximately half of the floor was severely damaged. The underlying fill was disturbed. An uncovered cabinet and broken conduits and cables exposed wiring at the damaged

47. Conduits and cabinets exposing wiring at the severely damaged base cone floor.

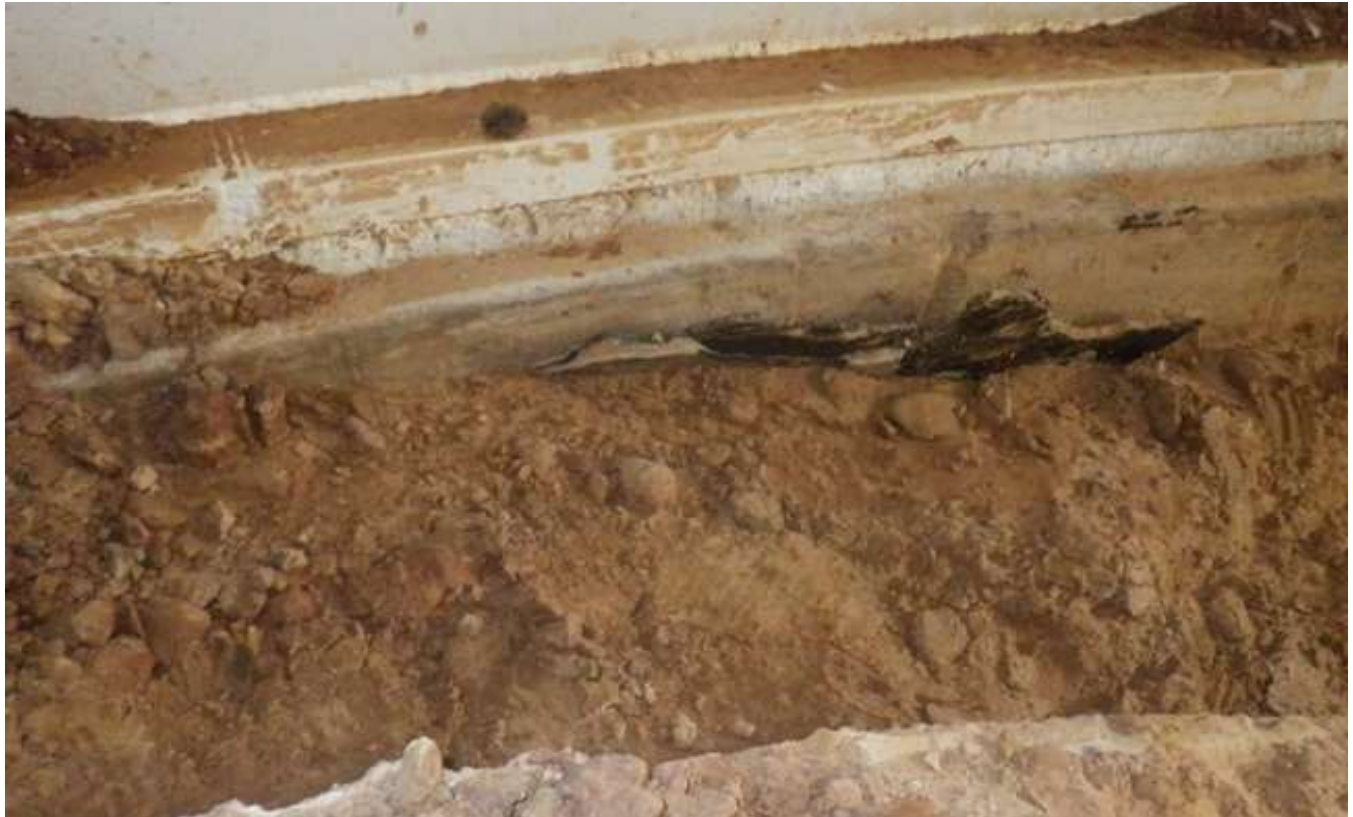
48. Severely damaged base cone floor.

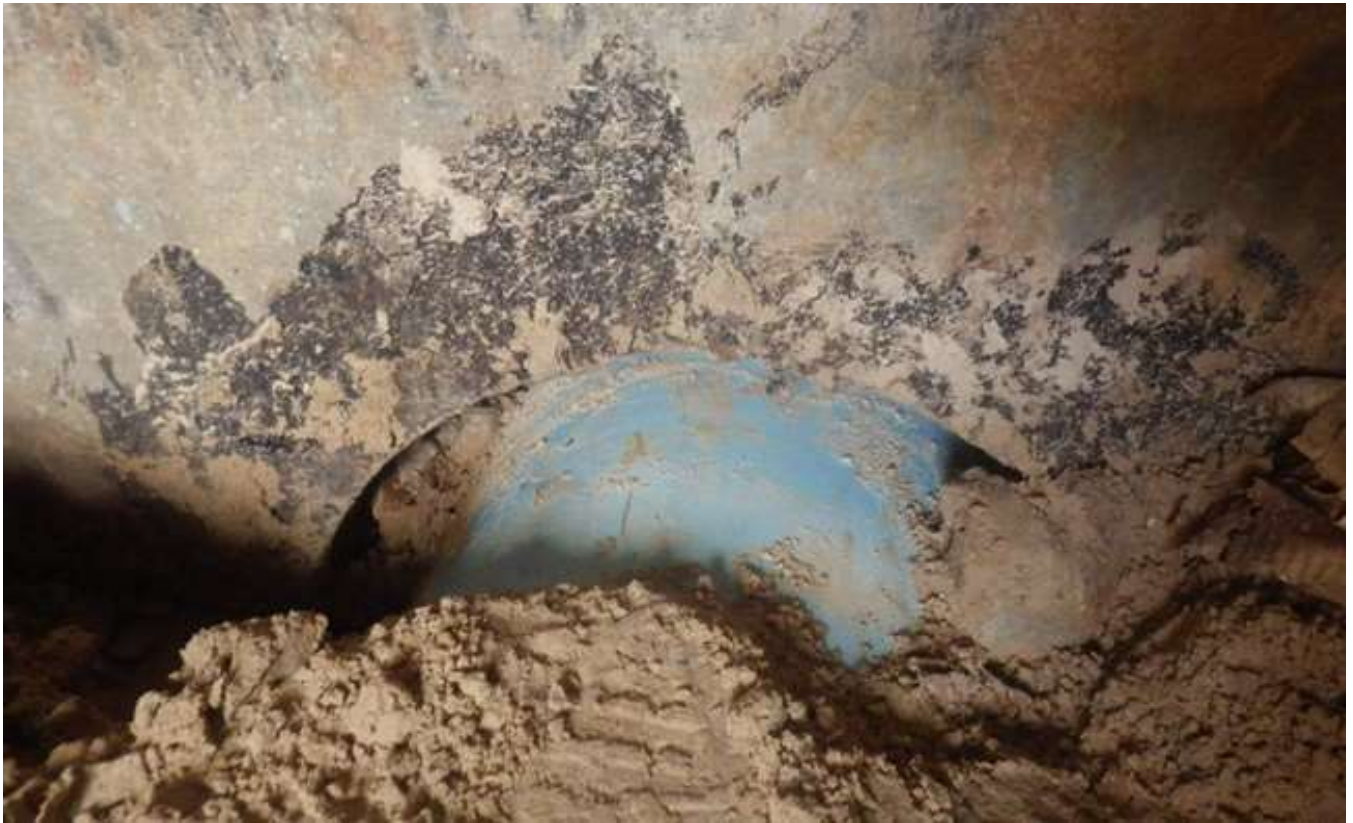
49. Exposed piping at the severely damaged base cone floor.

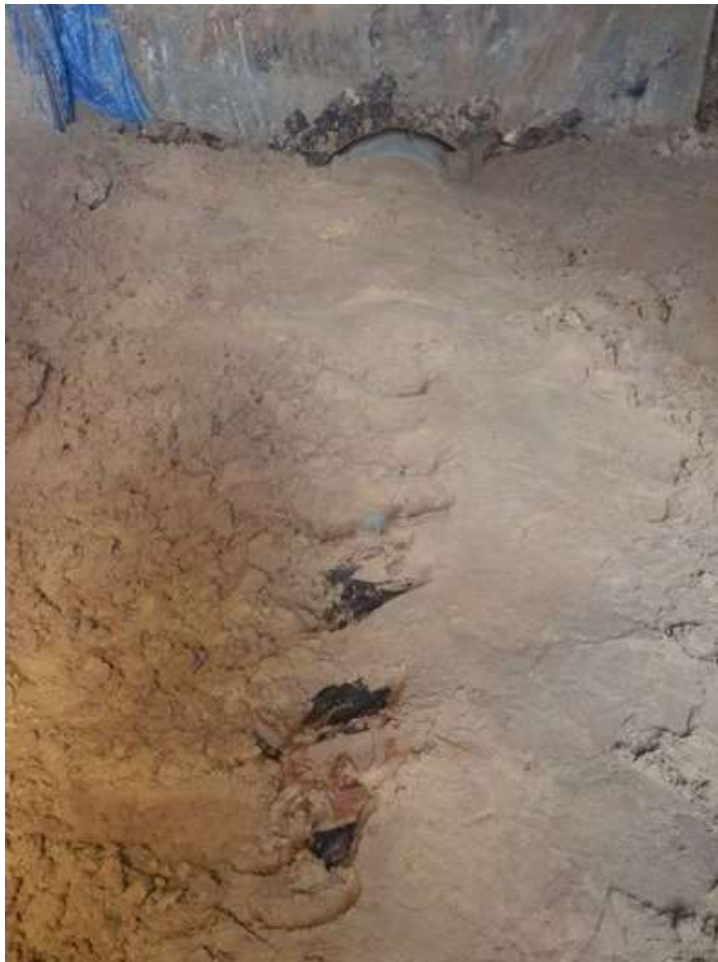
50. Exposed piping below the severely damaged base cone floor.

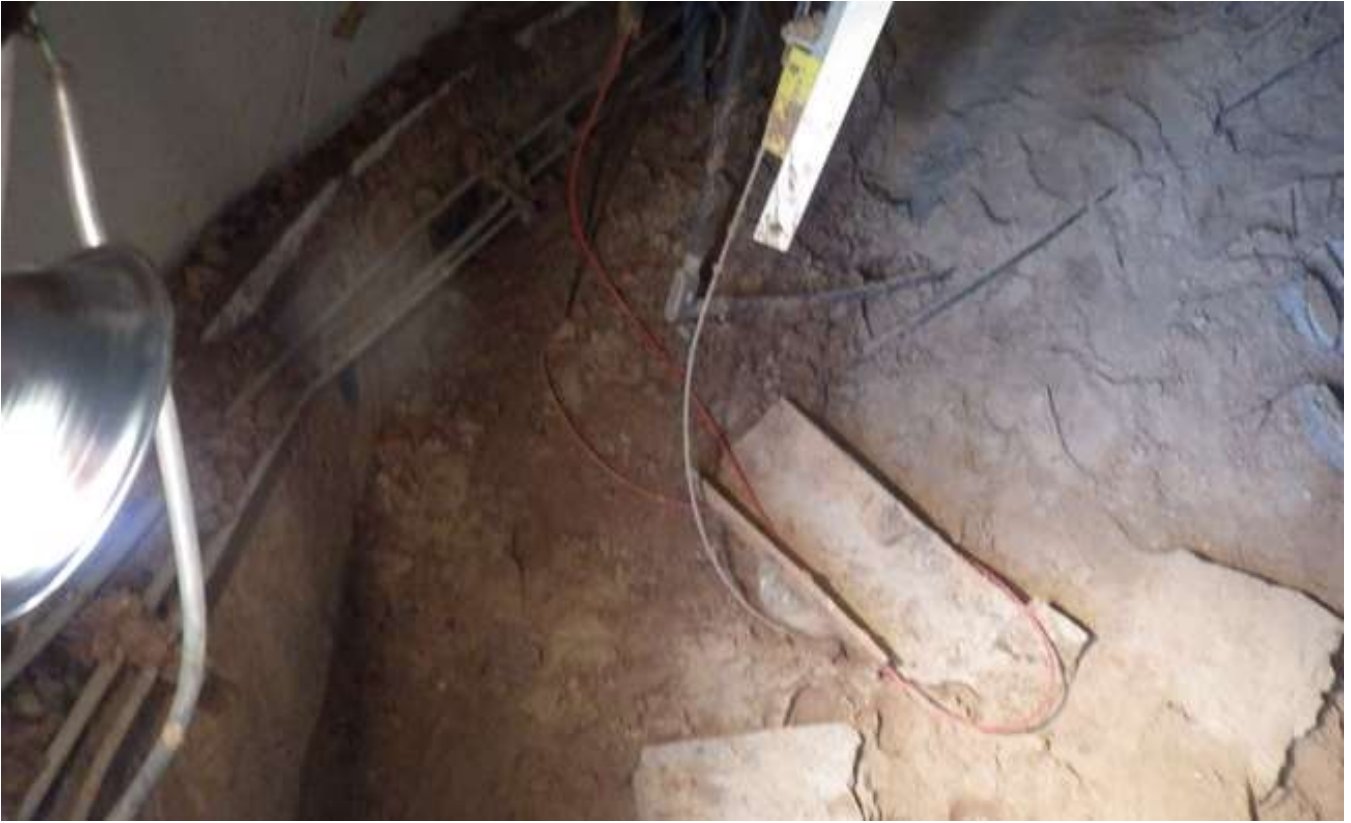
51. Debris and exposed conduits at severely damaged base cone floor.

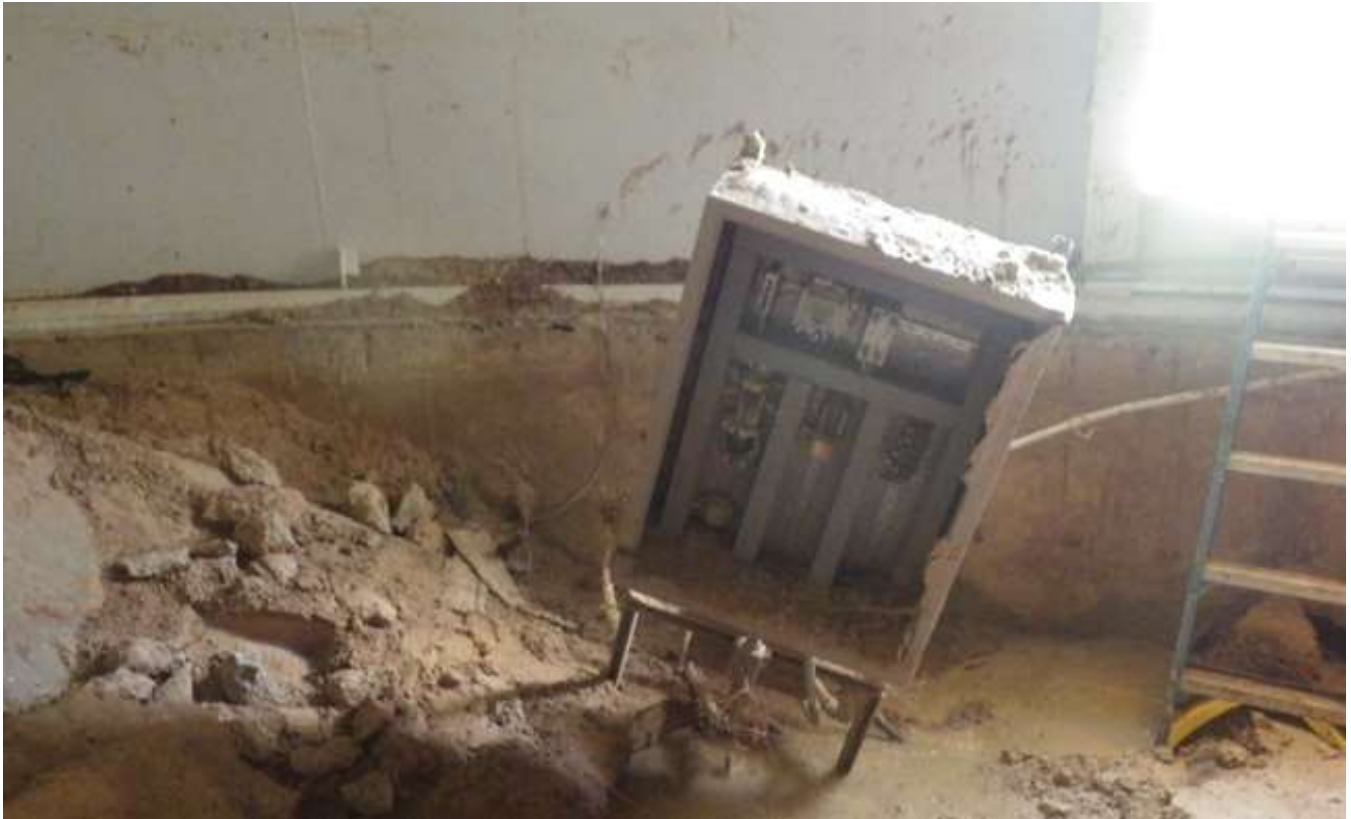
52. Uncovered electrical cabinet exposing wiring above severely damaged base cone floor.

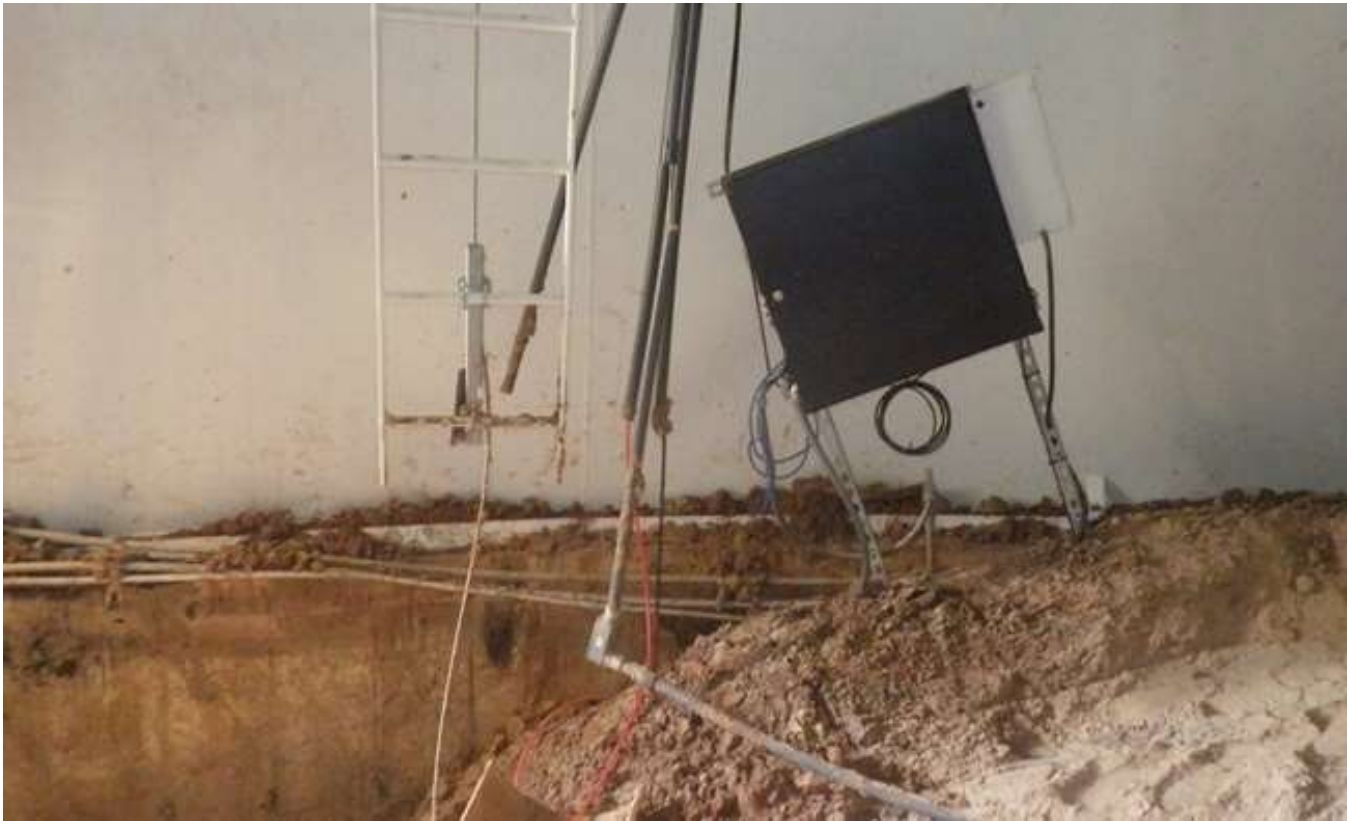
53. Electrical cabinet and broken conduits exposing wiring above severely damaged base cone floor.

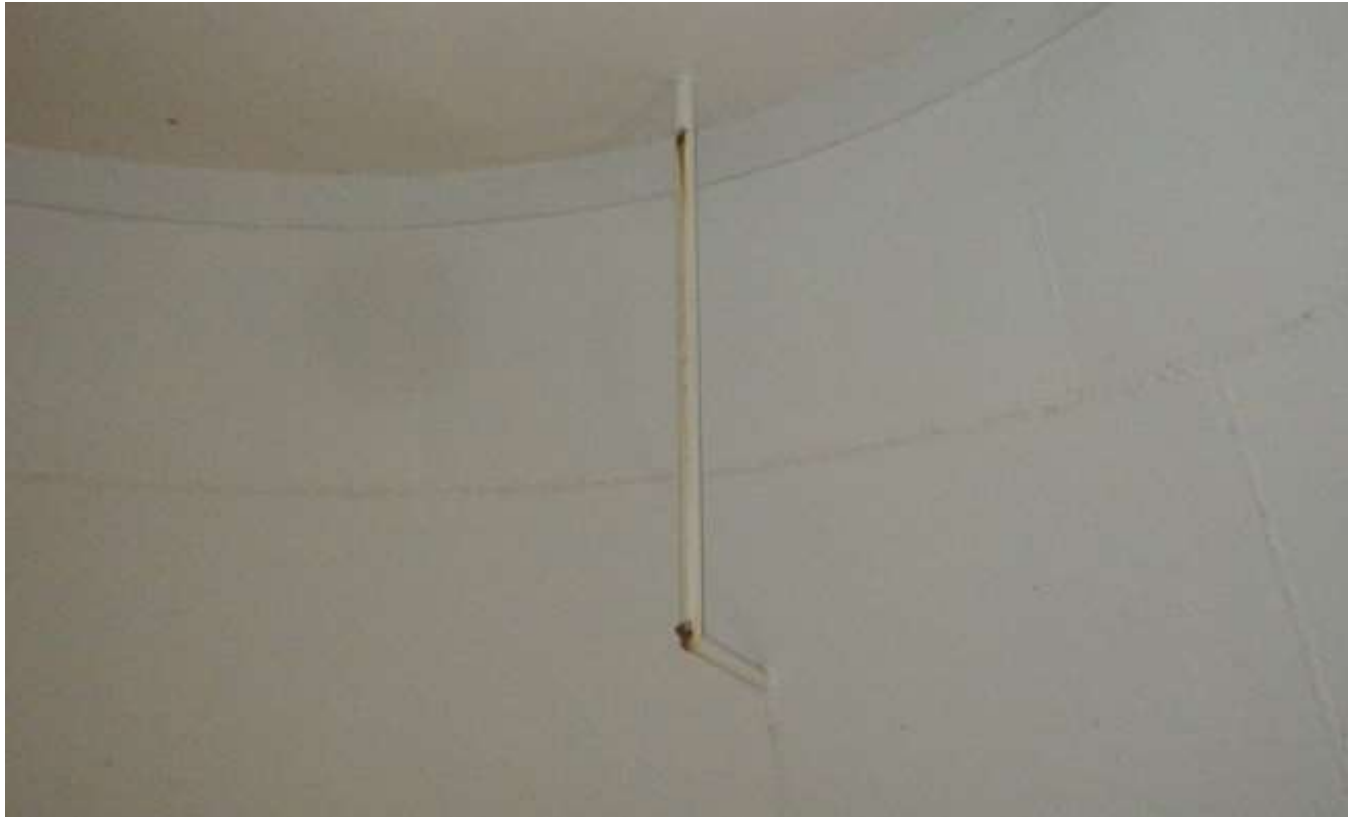
64. Spots of corrosion on the condensate ceiling drain pipe.

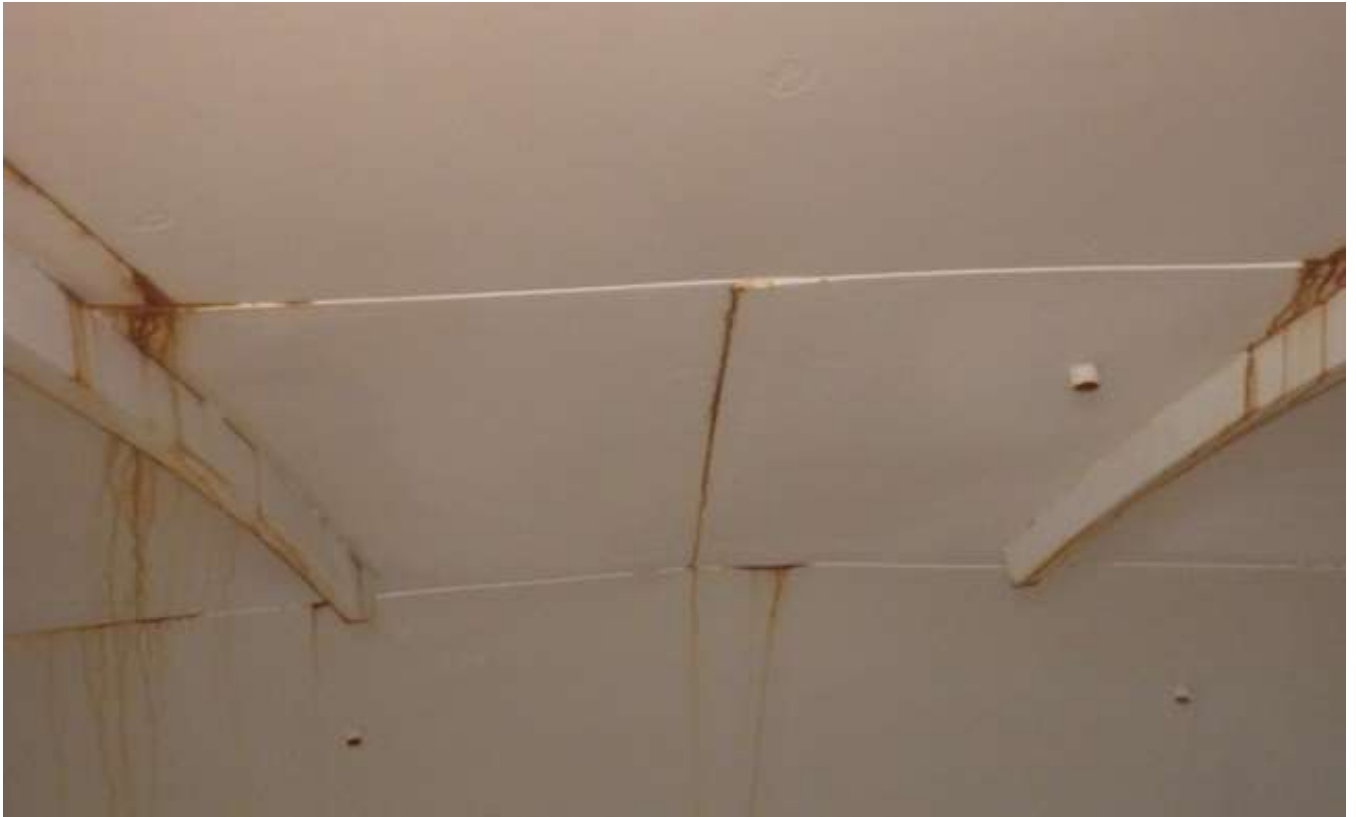
84. Corrosion and rust staining on areas of the roof interior and stiffeners.

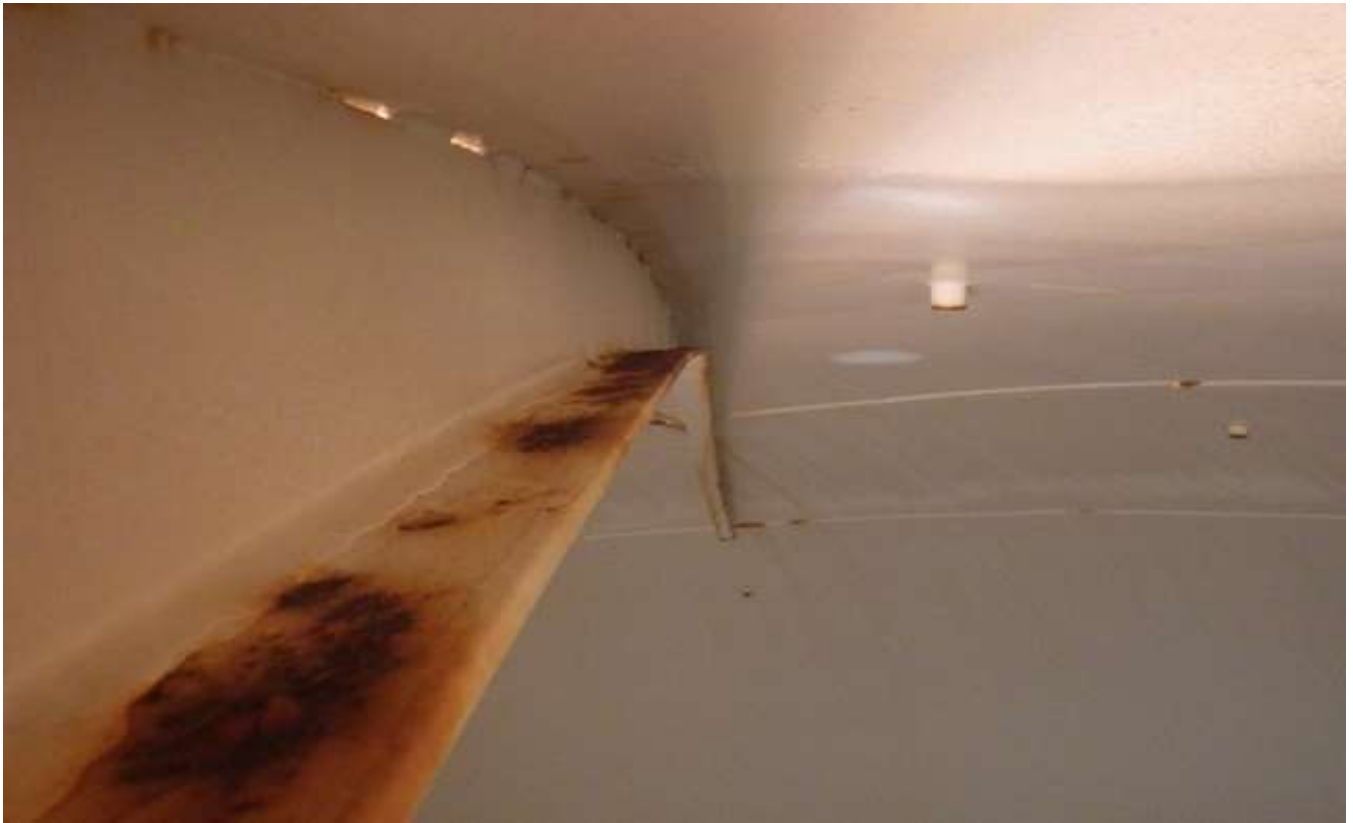
85. Corrosion on interior roof stiffener.

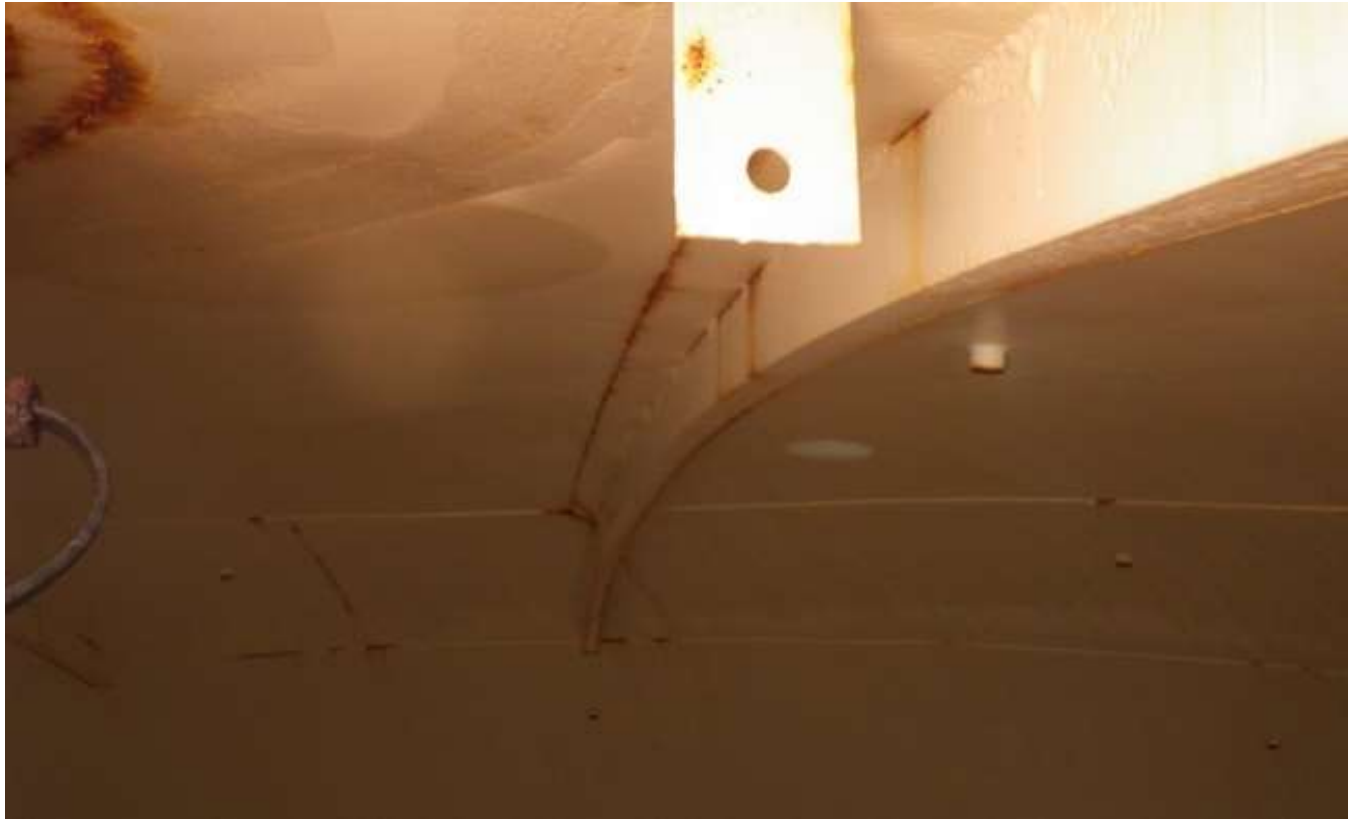
86. Corrosion and rusts staining on areas of the roof interior and stiffener. Note lug on the roof.

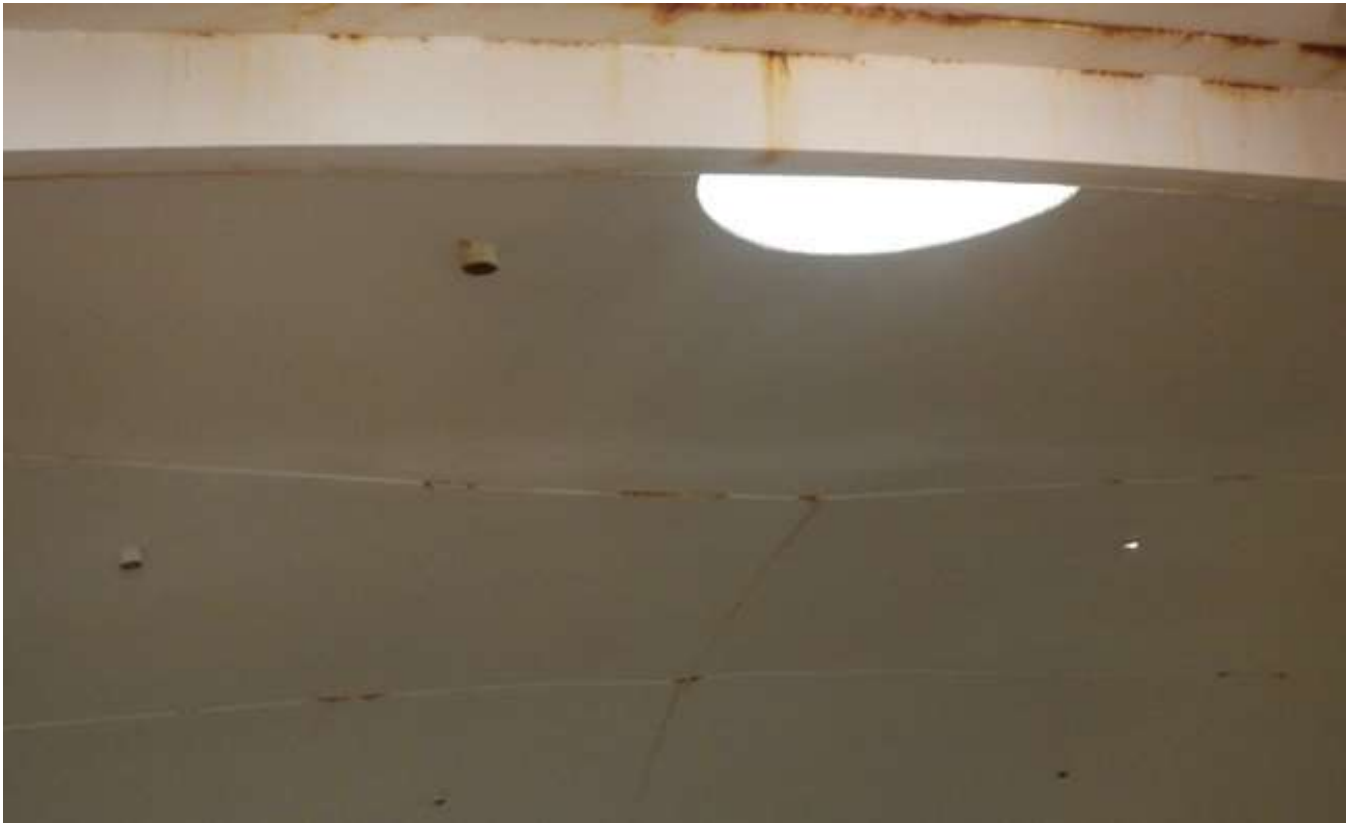
87. Corrosion and rust staining on areas of the roof interior and stiffener.

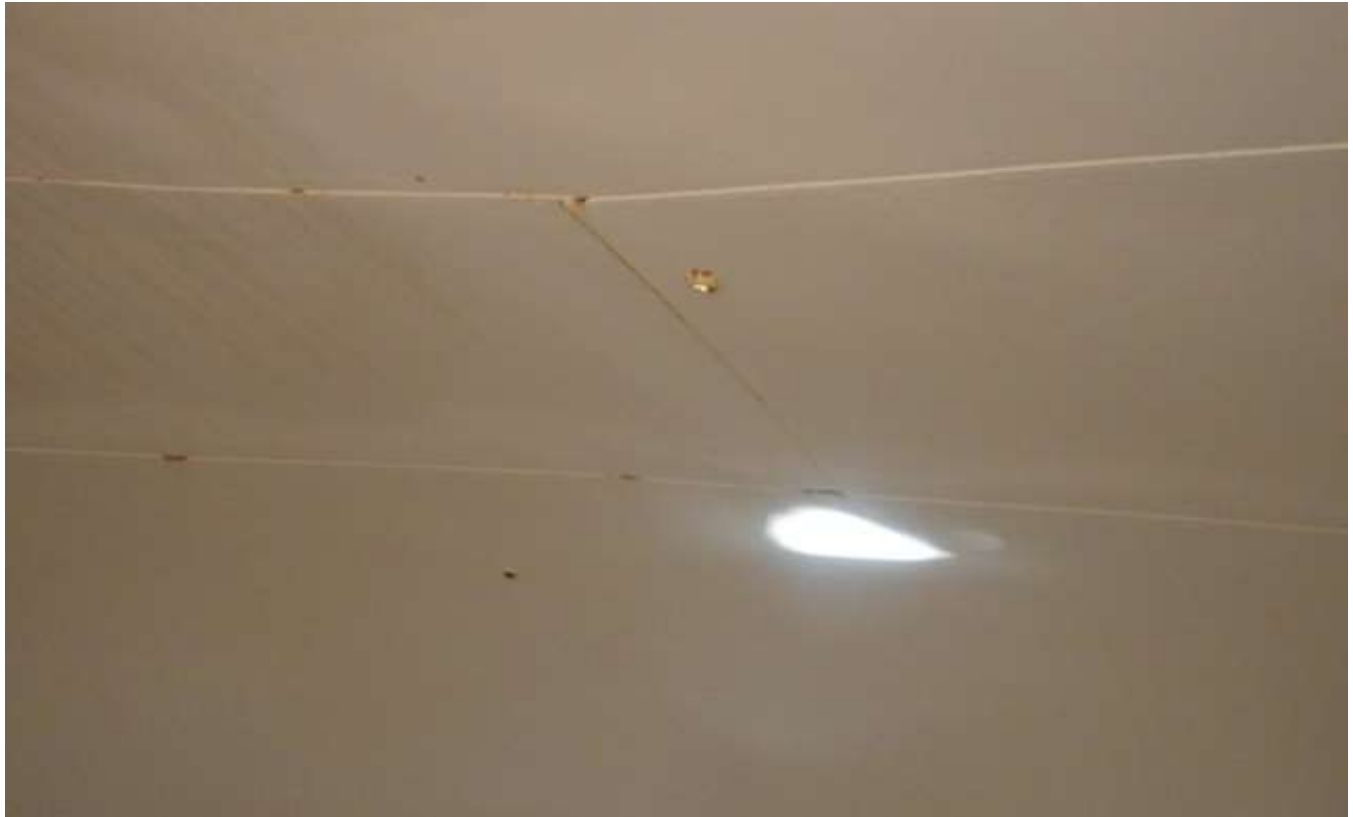
88. Minor corrosion and rust staining on areas of the roof interior.

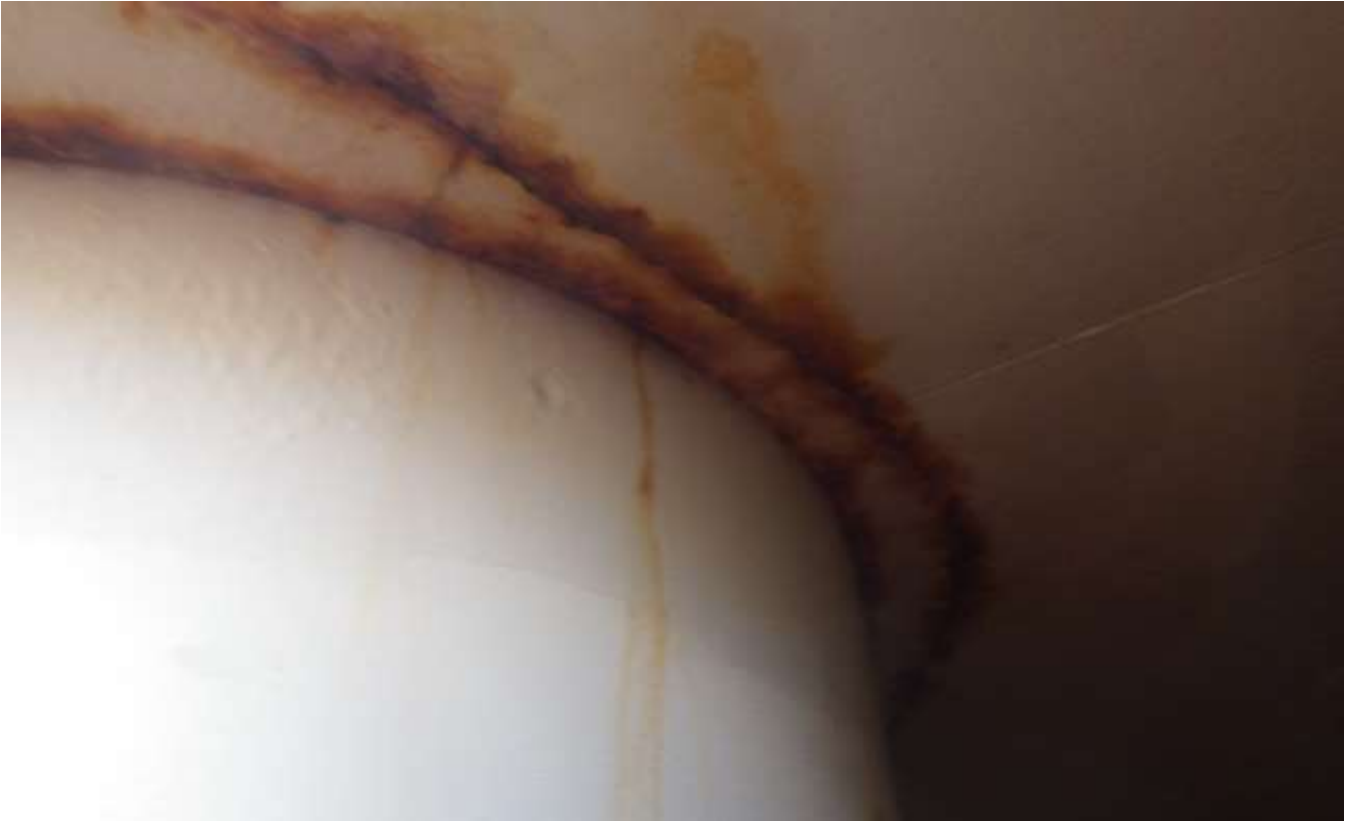
91. Corrosion and rust staining on the roof interior around the access tube.

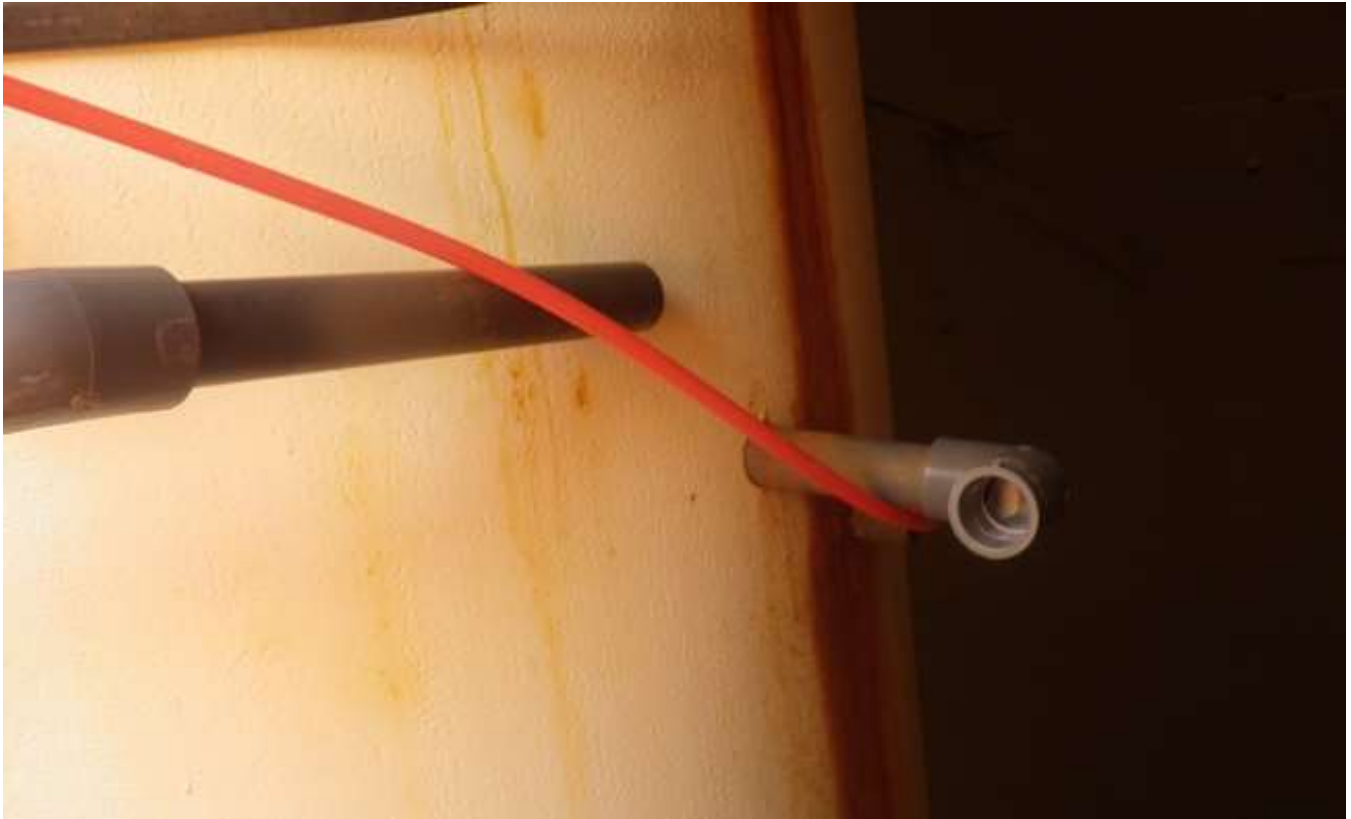
92. Pipe projecting from the access tube. Note detached pipe.

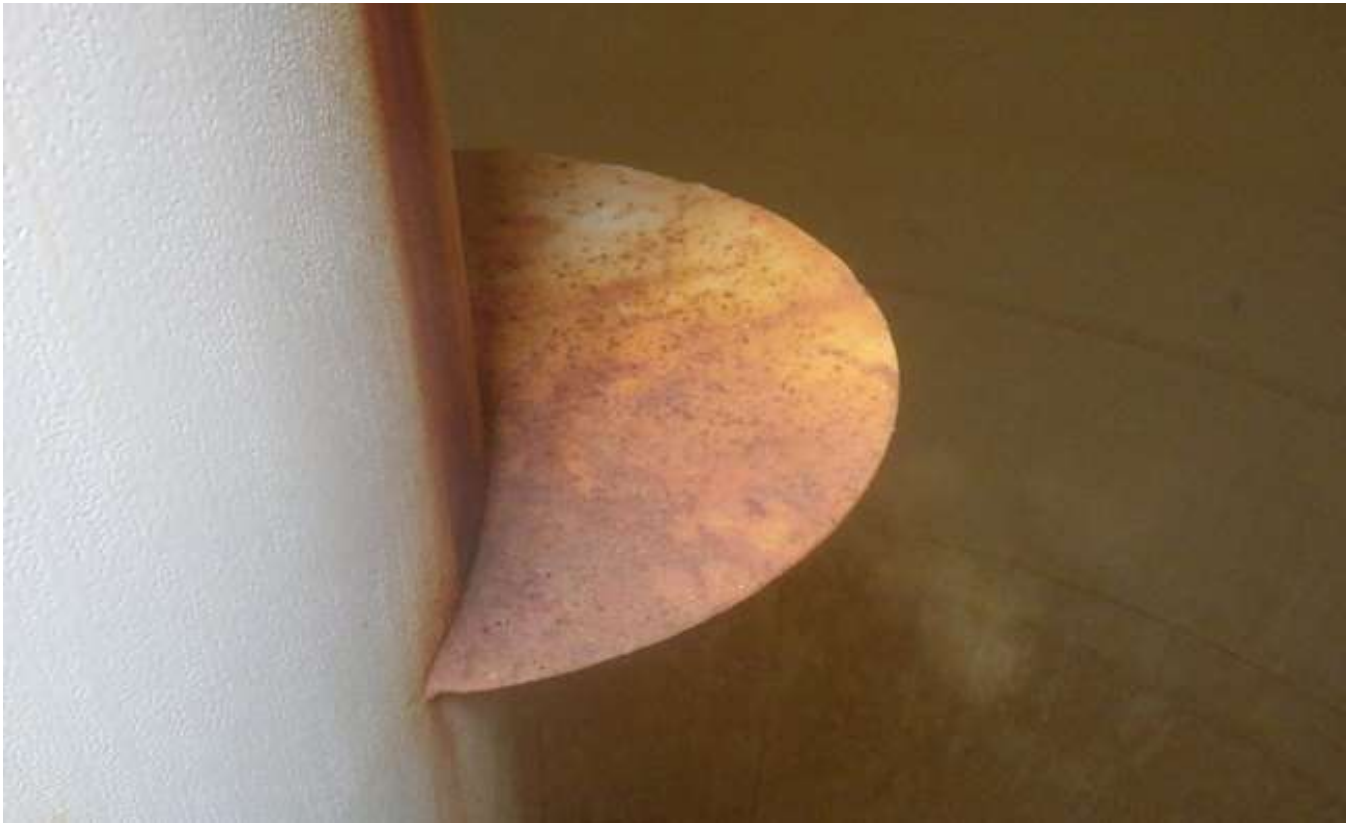
93. Corrosion on overflow inlet anti-vortex plate.

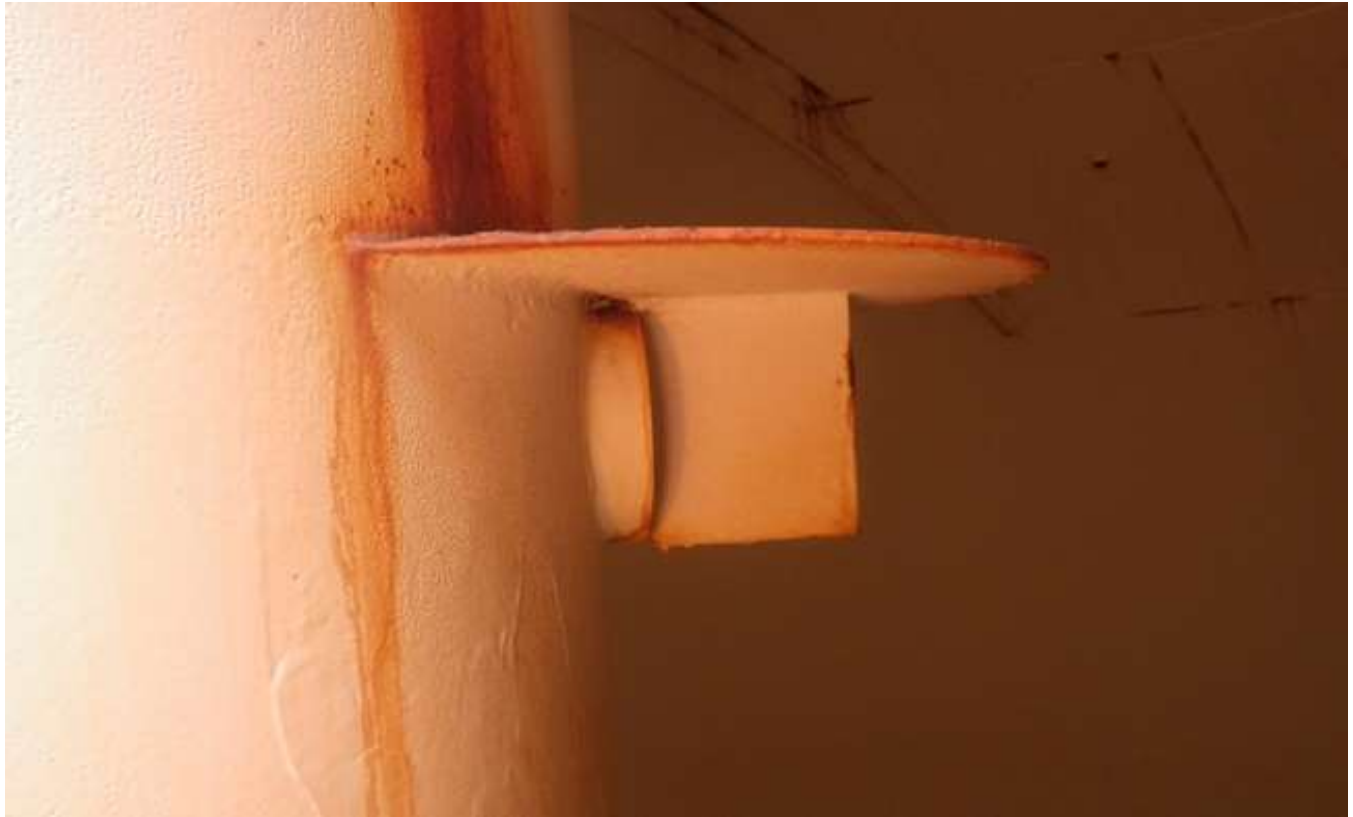
94. Corrosion on overflow inlet anti-vortex plate.

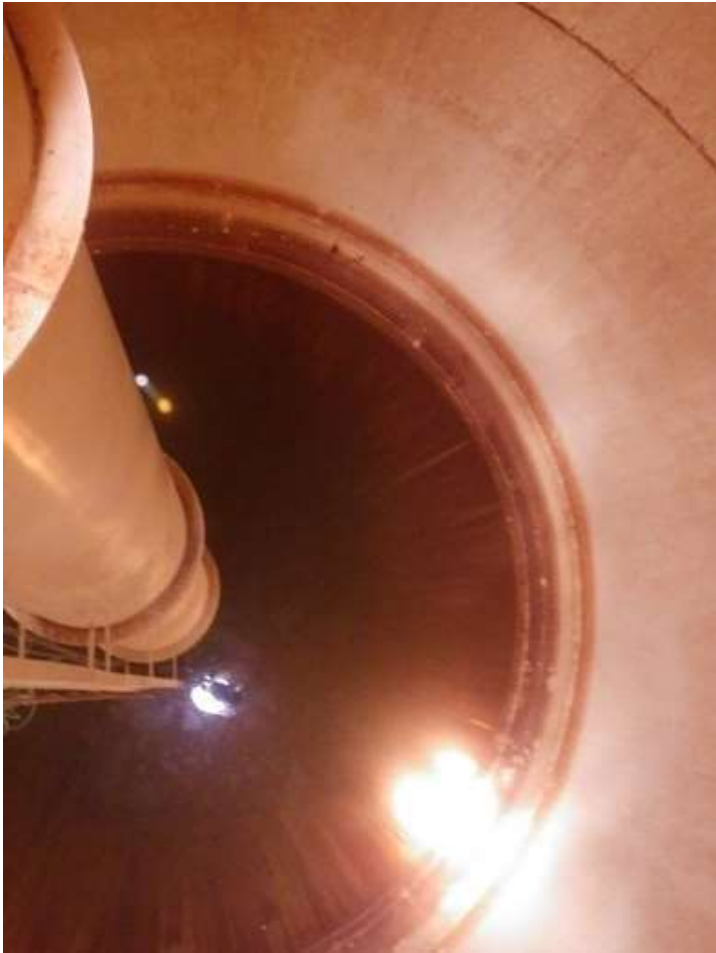
95. Interior wet access tube and bowl. Note water and silt on the bowl.

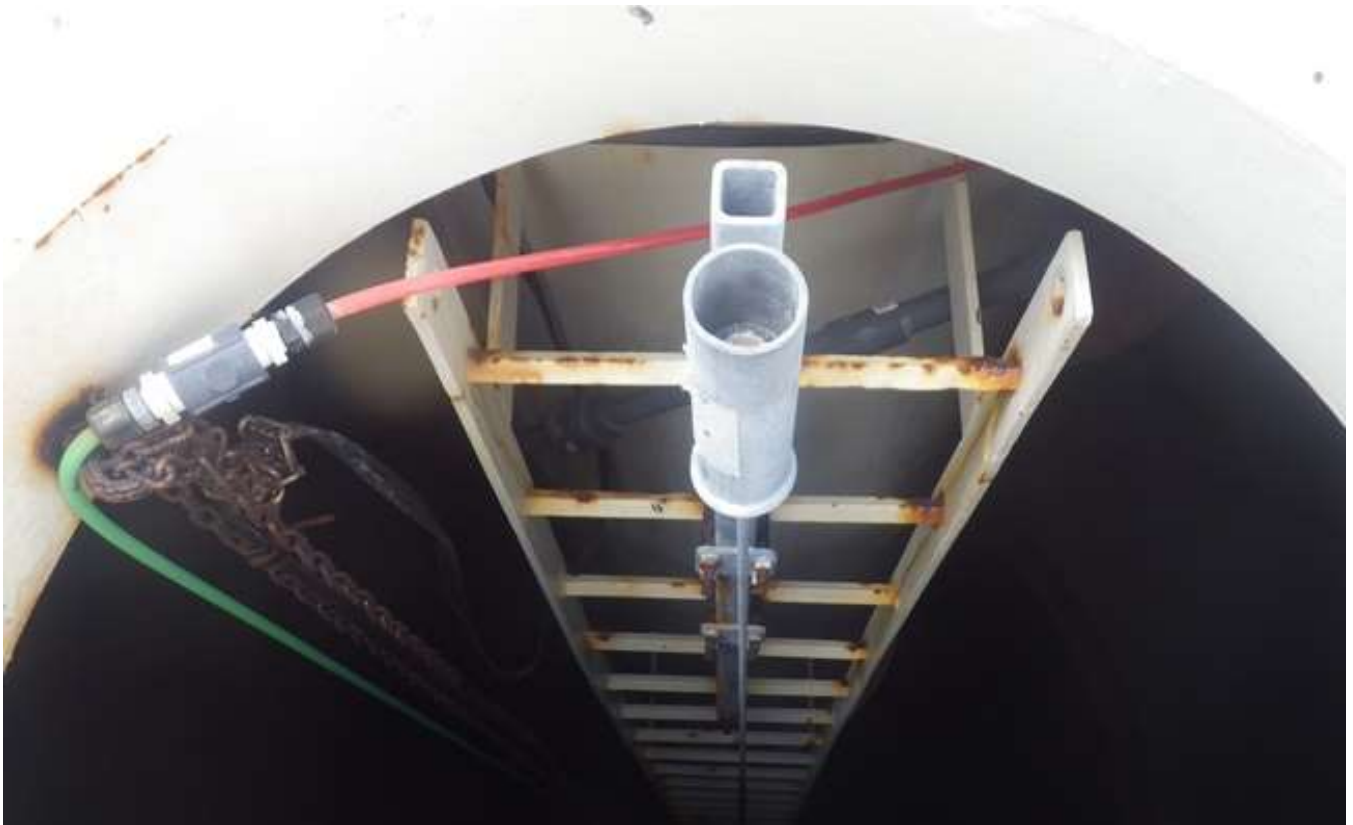
97. Interior wet container ladder rungs, safe-climbing device, and chains. Note corrosion on areas of the ladder rungs and on the chains.

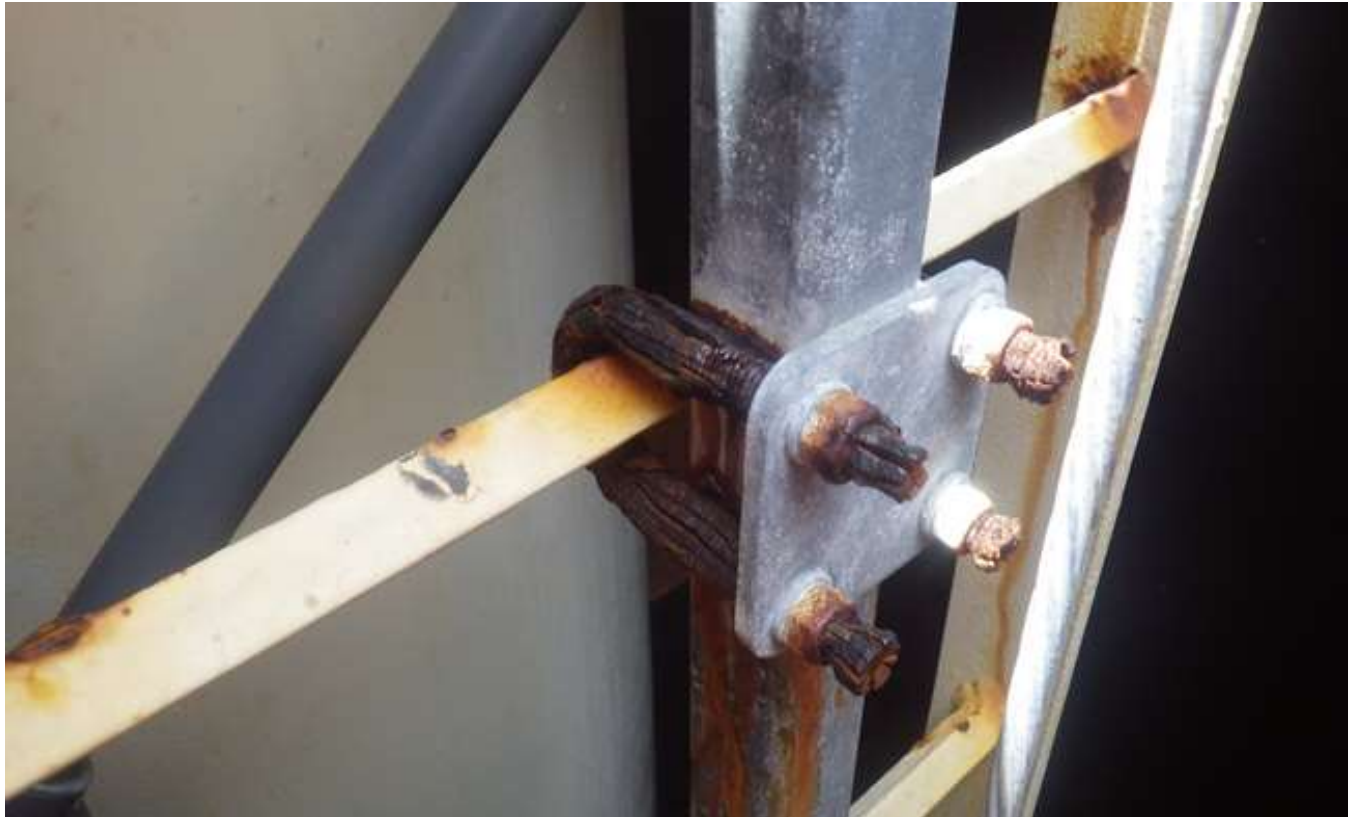
98. Corrosion and metal loss on the interior wet container ladder safe-climbing device bracket.
