EVALUATION OF THE 250,000 GALLON WELDED STEEL SINGLE-PEDESTAL SPHEROID

**“AVON STREET TANK”
DEER PARK, TEXAS**

THE CITY OF DEER PARK

July 25, 2023

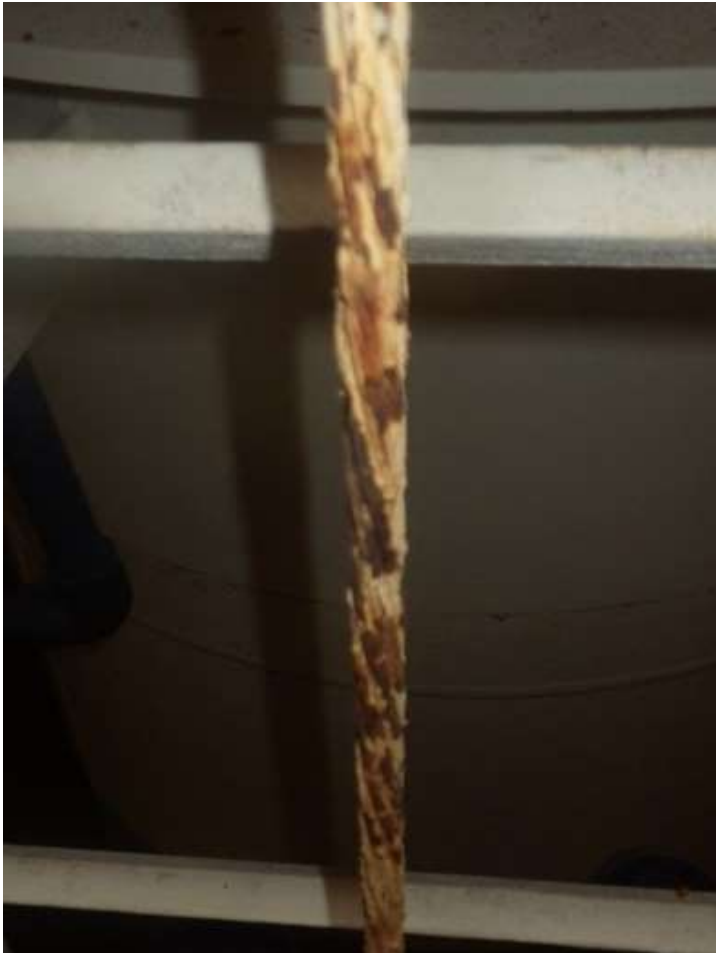
99. Corrosion on the interior wet container ladder safe-climbing device.

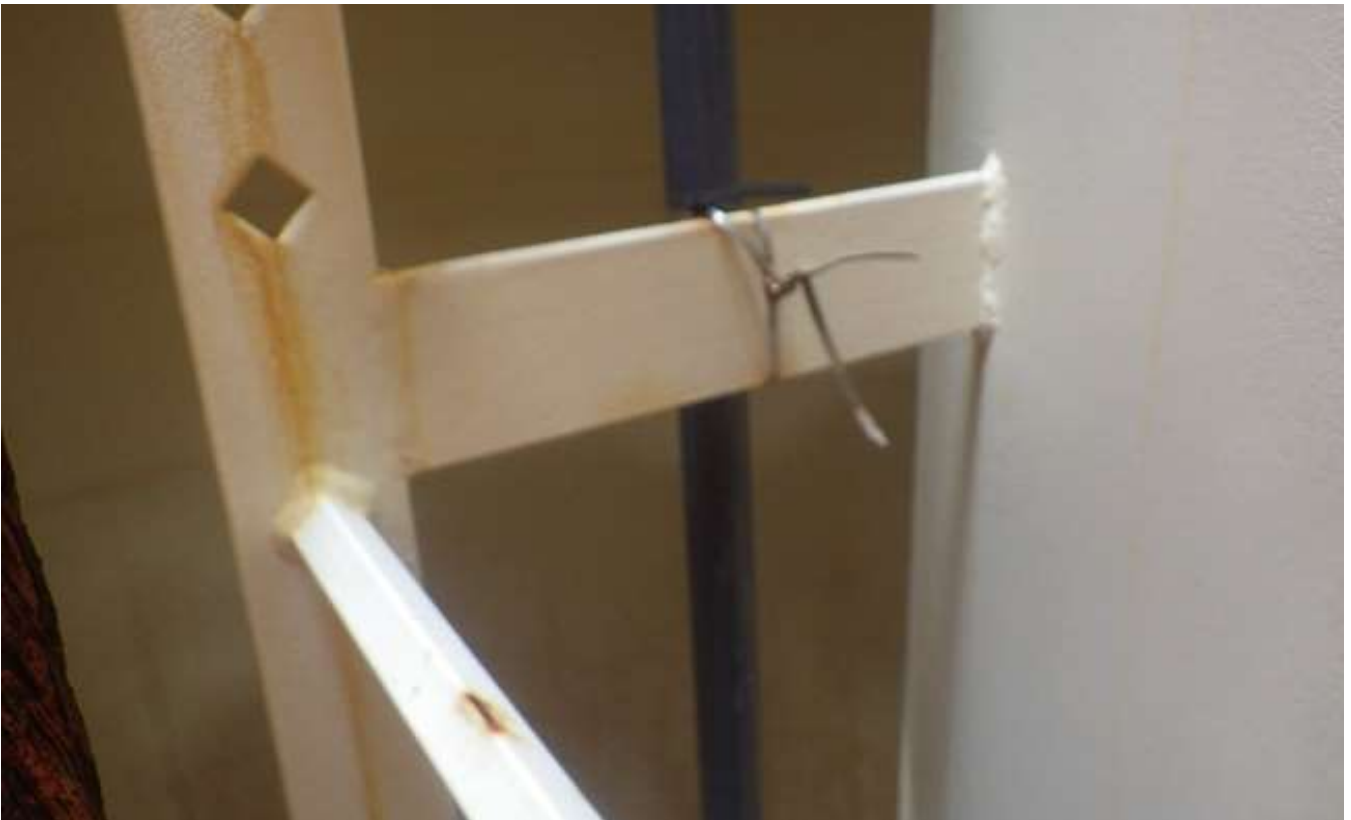
100. Conduit attached to the interior wet container ladder bracket.

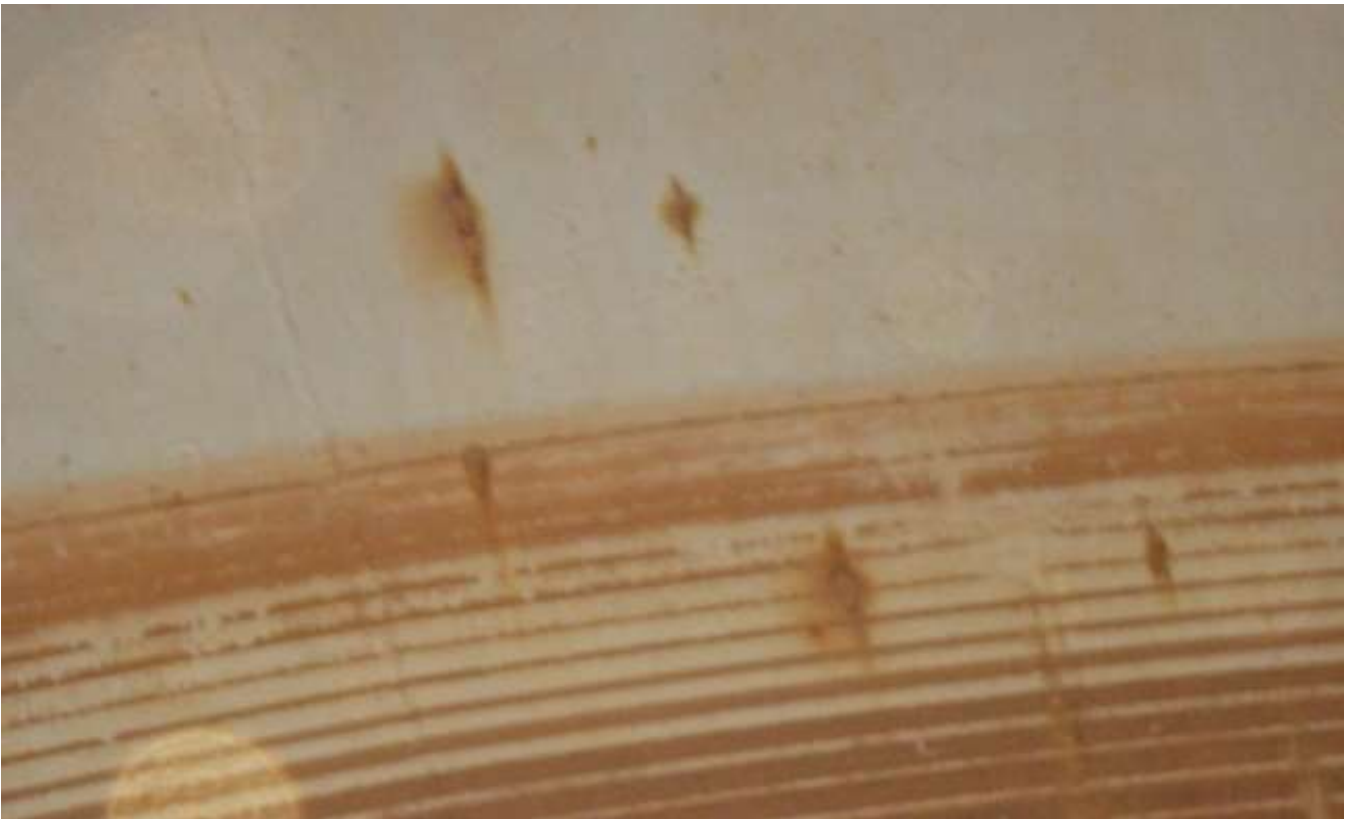
104. Spots of corrosion, rust tubercles, and rust staining on the interior wet bowl.

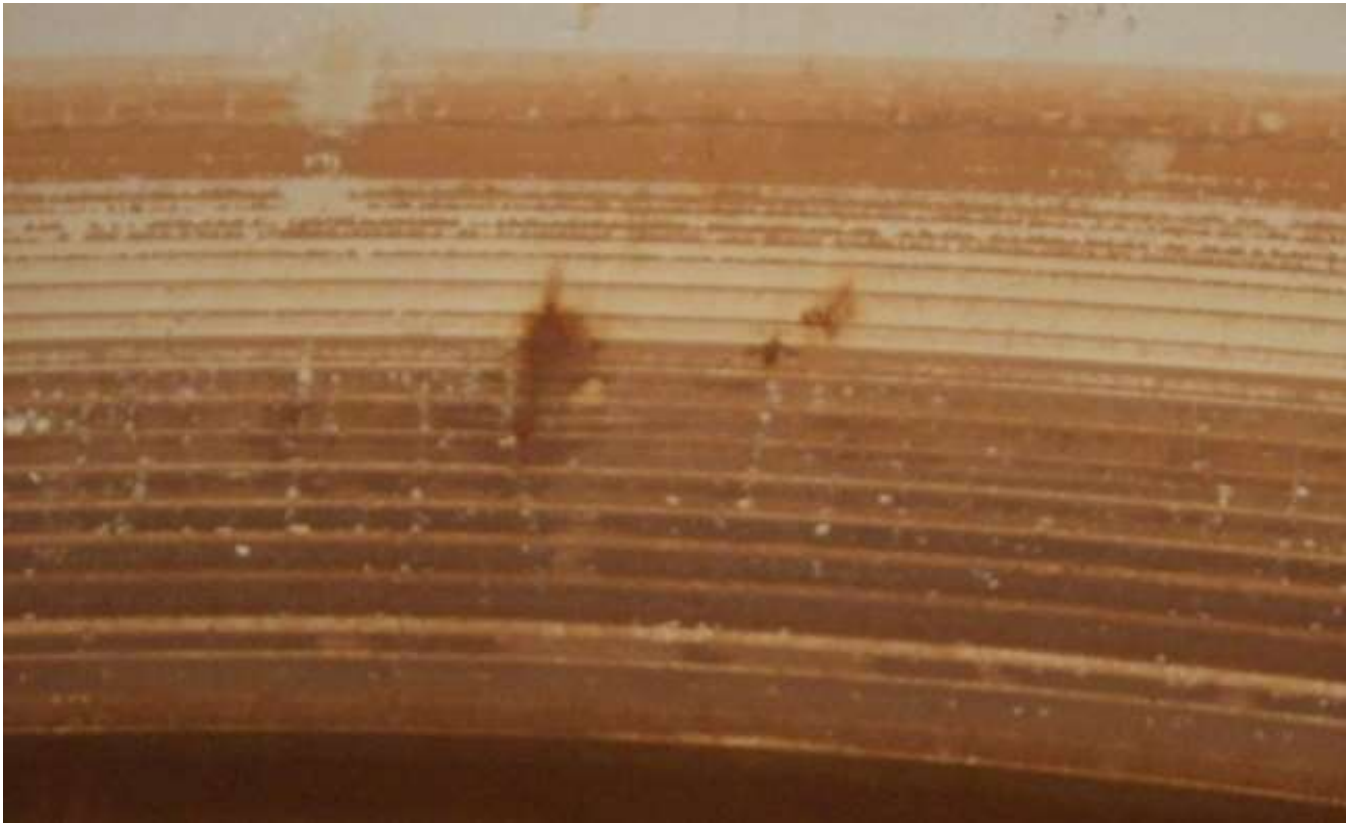
105. Spots of corrosion, rust tubercles, and rust staining on the interior wet bowl.

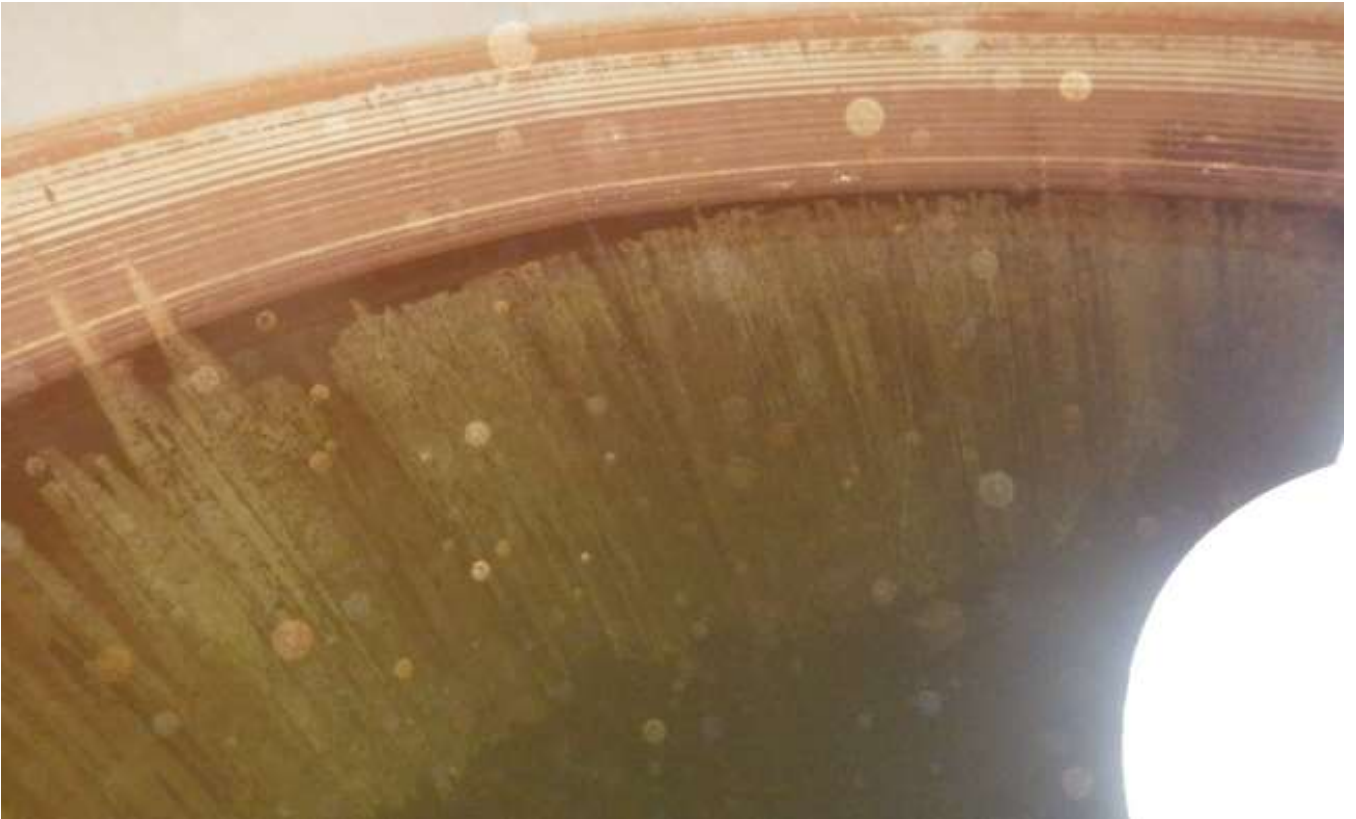
106. Water and silt on the bowl.
