# **City of Deer Park Municipal Court and Theater Building**

1302 Center St.

**Tremco Incorporated**

September 11, 2015

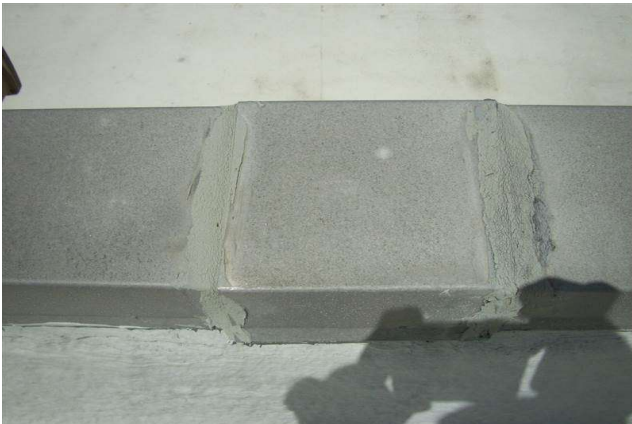
Open wall joints.

Work Performed	
TremCare	Sealed open wall joints.

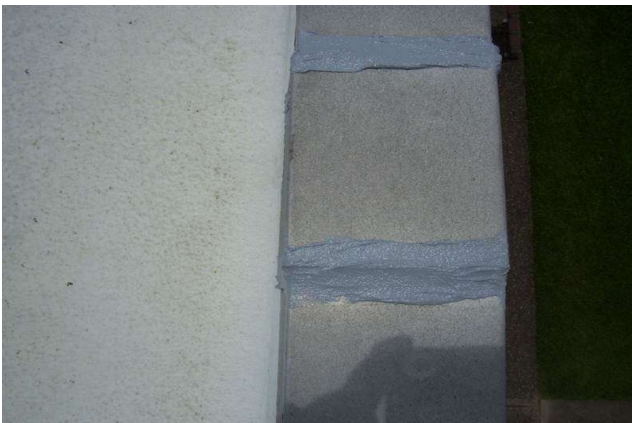
Sealed wall joints.

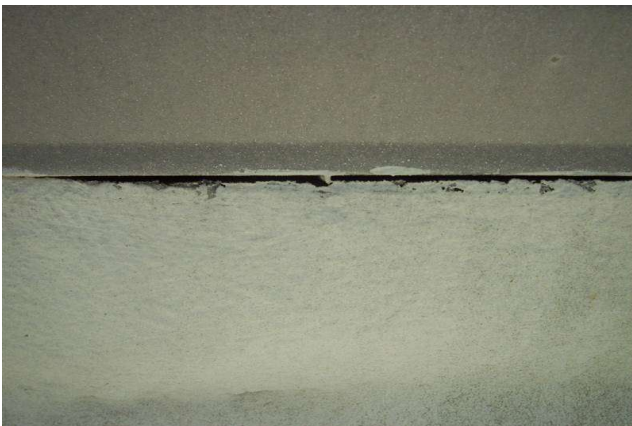
Open wall joint.

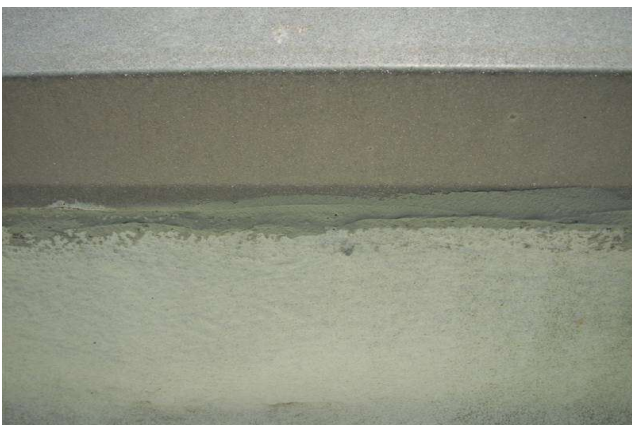
Sealed wall joint.
