Replacement of stone (205 sf total)  
Type A - 90 sf  
Type B - 115 sf

PROJECT:  
DEER PARK GATEWAY

SHEET TITLE  
LAYOUT PLAN

L2.1

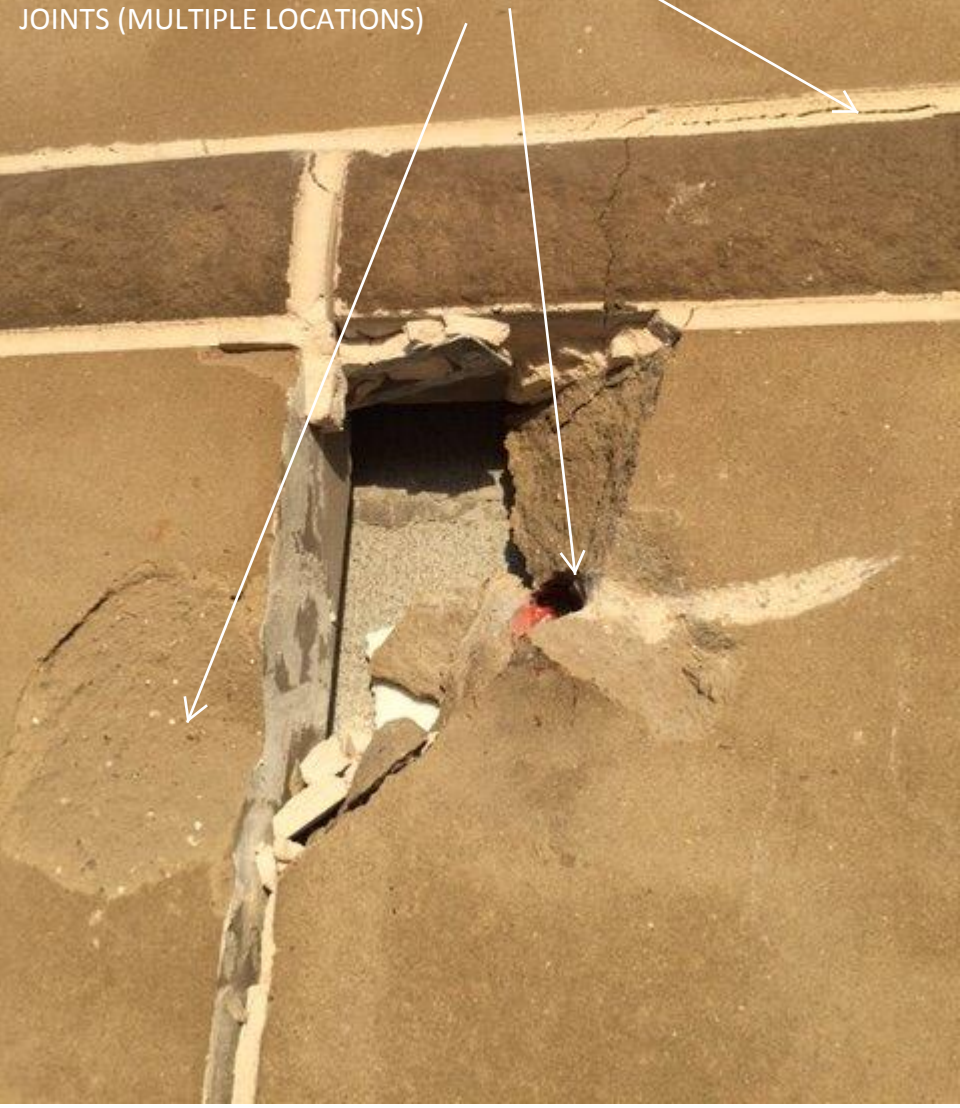
STAR MOUNTING ANCHORS RIPPED  
FROM WALL CAUSING DAMAGE TO  
SURROUNDING STONE AND GROUT  
JOINTS (MULTIPLE LOCATIONS)

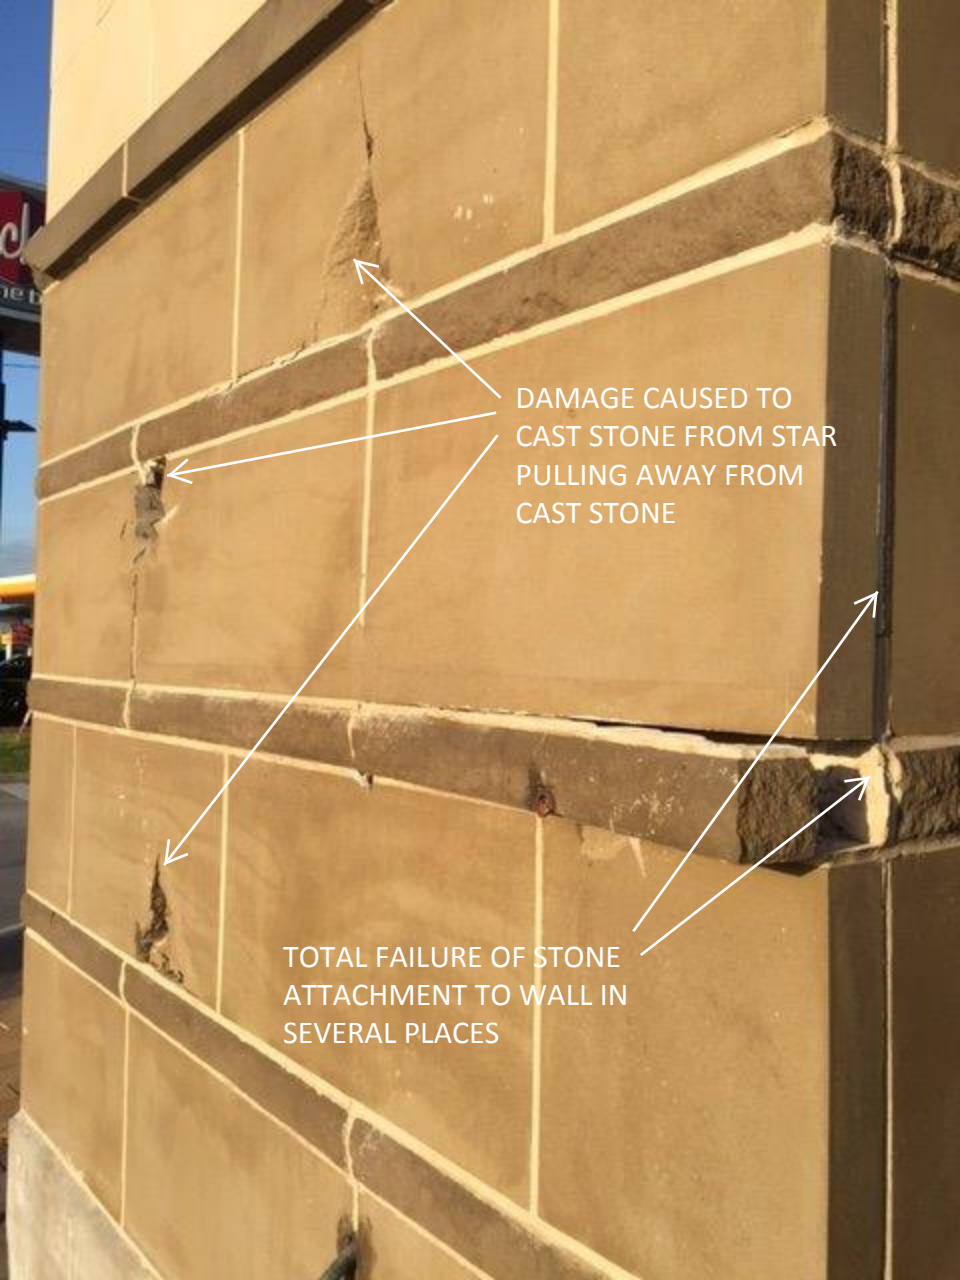
DAMAGE CAUSED TO  
CAST STONE FROM STAR  
PULLING AWAY FROM  
CAST STONE

TOTAL FAILURE OF STONE  
ATTACHMENT TO WALL IN  
SEVERAL PLACES

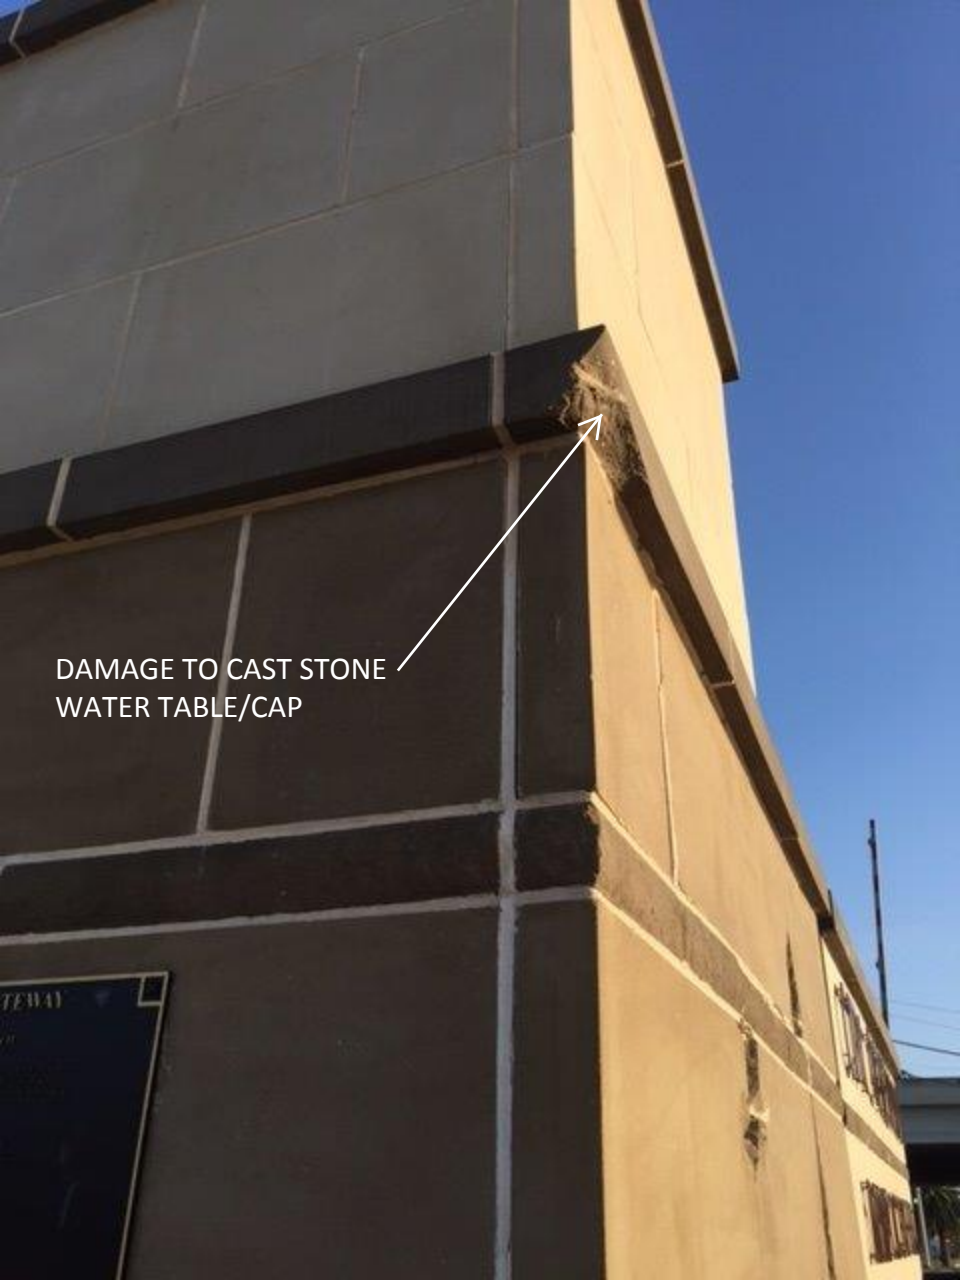
DAMAGE TO CAST STONE  
WATER TABLE/CAP

CAST STONE CAP  
HAS MOVED AND  
MORTAR HAS BEEN  
COMPROMISED

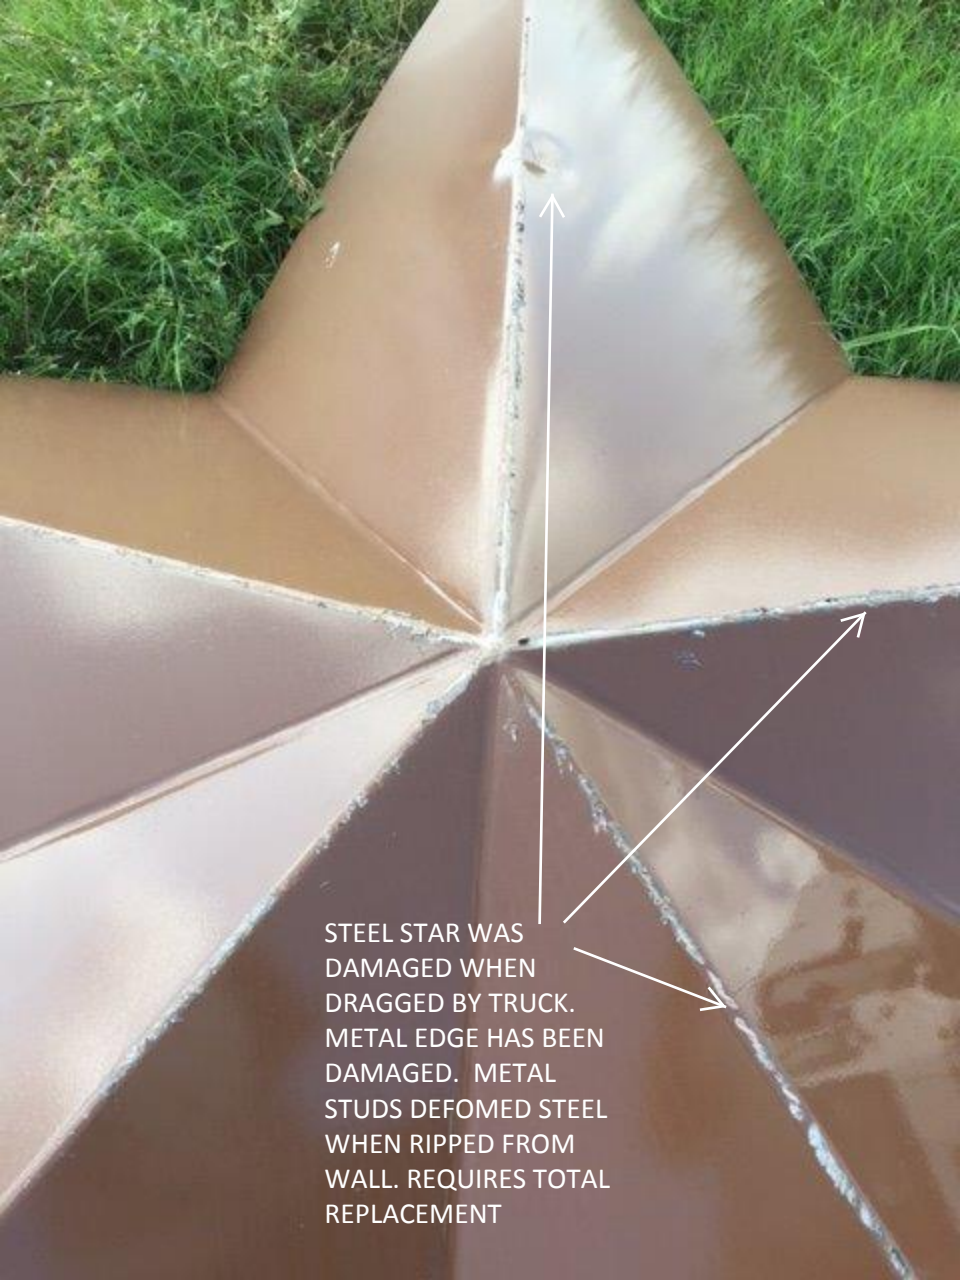
STEEL STAR WAS  
DAMAGED WHEN  
DRAGGED BY TRUCK.  
METAL EDGE HAS BEEN  
DAMAGED. METAL  
STUDS DEFORMED STEEL  
WHEN RIPPED FROM  
WALL. REQUIRES TOTAL  
REPLACEMENT
