Building Observations Survey ©2016

Deer Park Community Center Deer Park, Texas

**Building Survey for Deer Park Community Center,
610 East San Augustine Street, Deer Park, Texas**

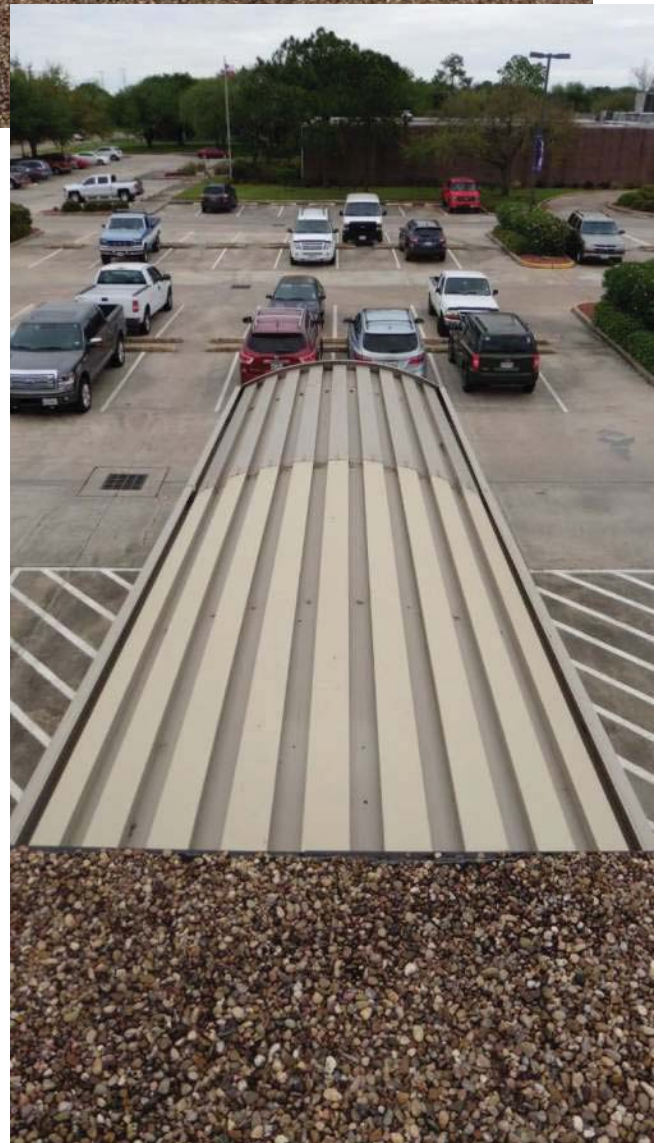
Addition canopy from above

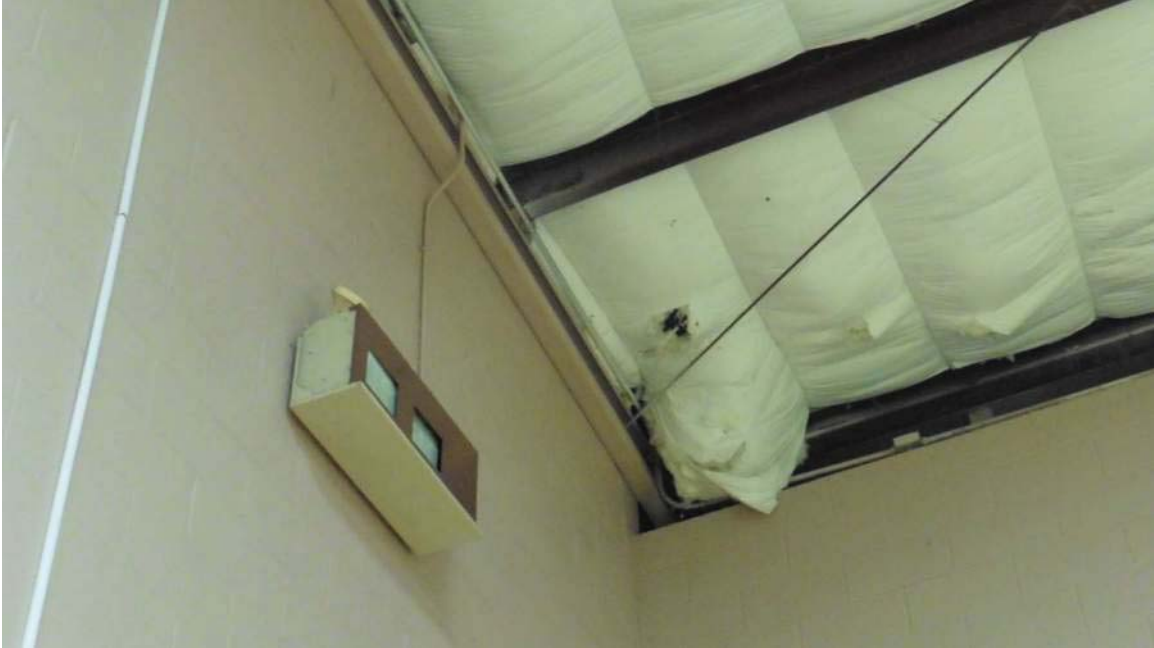
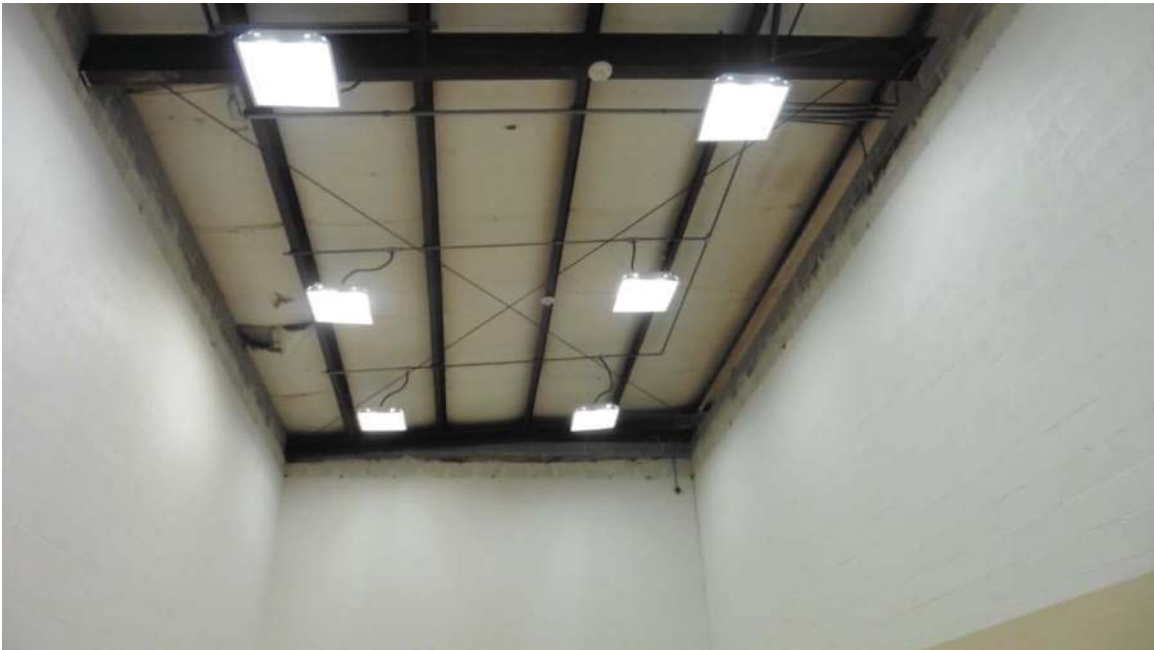
Examples of damaged “over-the-purlin” gym roof insulation

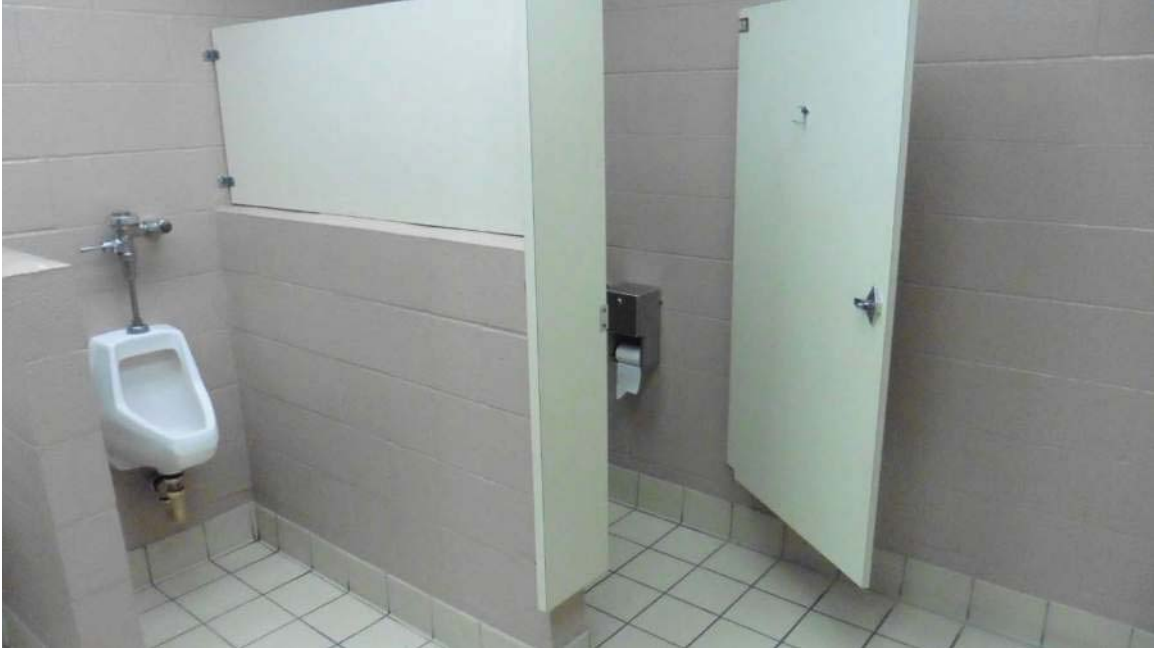
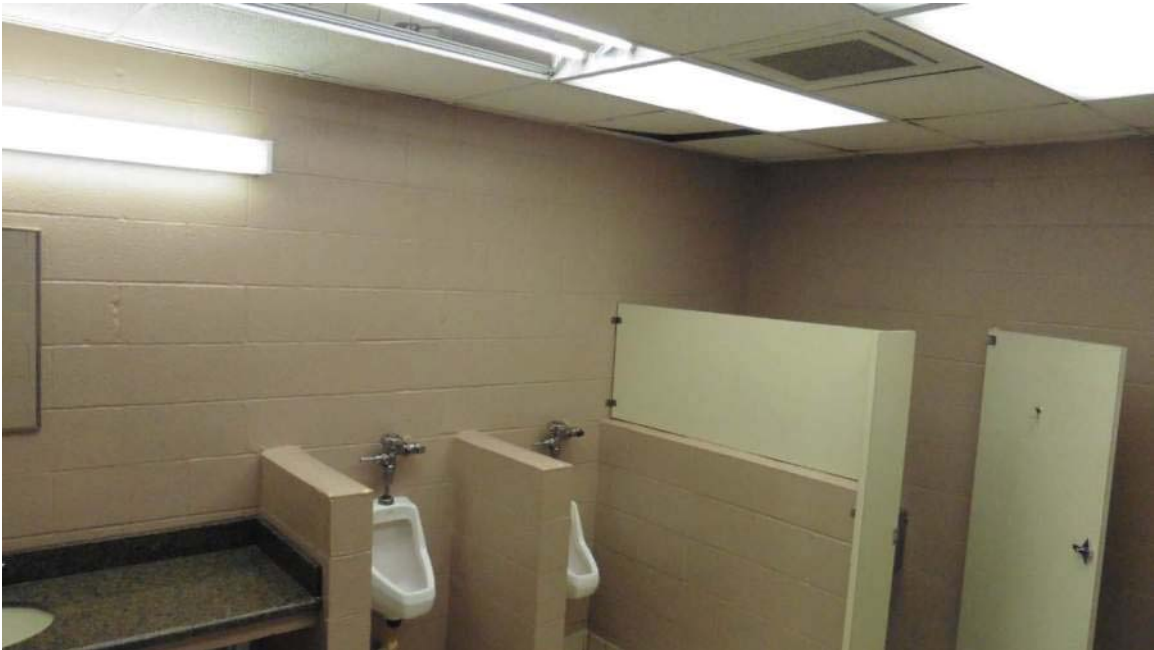
Condition of toilet rooms at gym

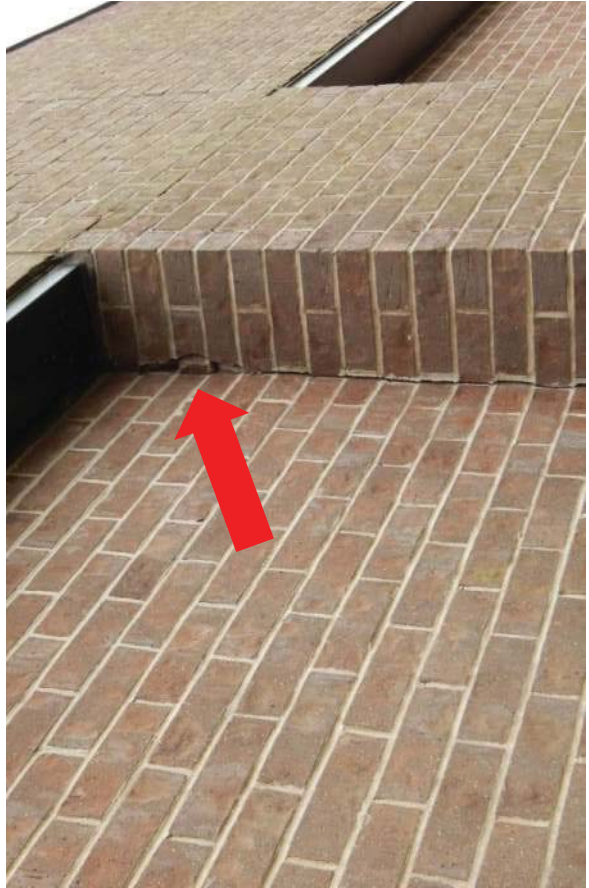
#11 Cracked brick at end of inset panel.

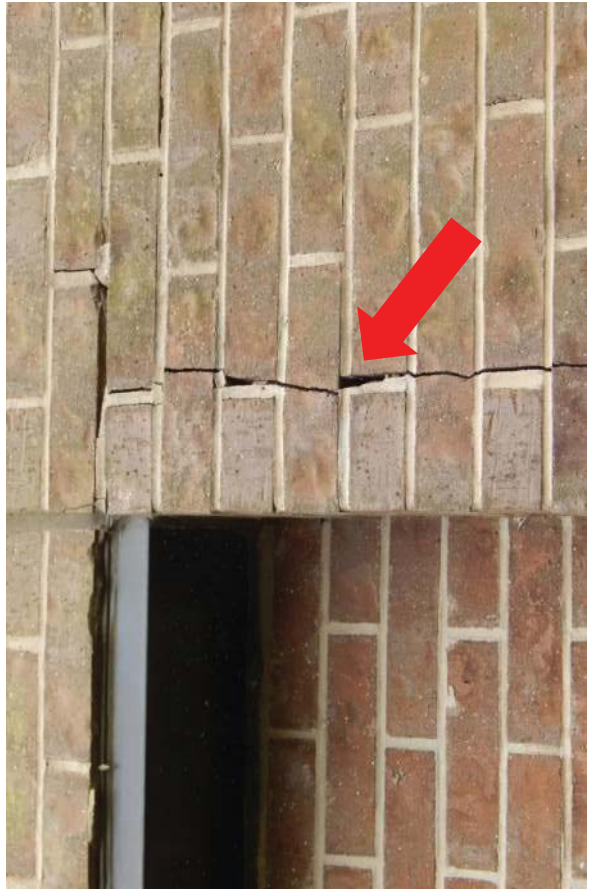
#12 Same location as photo #11 showing cracked brick in column. Lintel movement is causing this cracking.

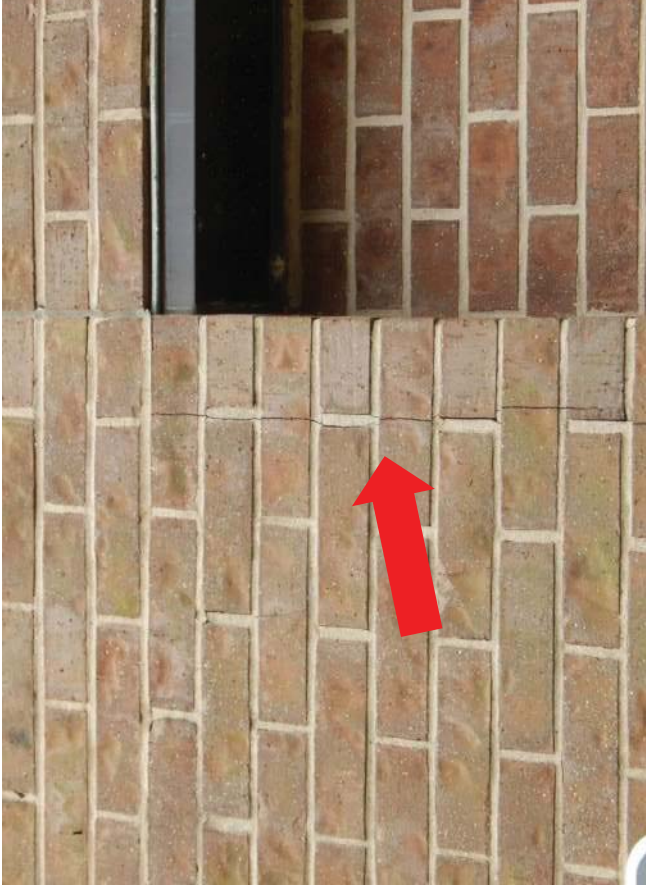
#14 Vertical crack where steel lintel over inset brick is
Moving and dragging the brick on the column

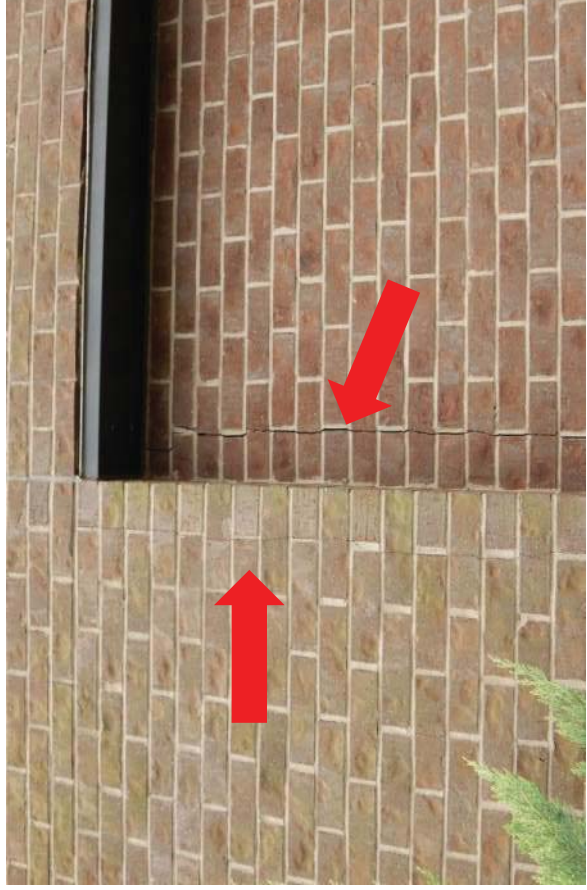
#15 Vertical crack in brick column and in brick inset panel.

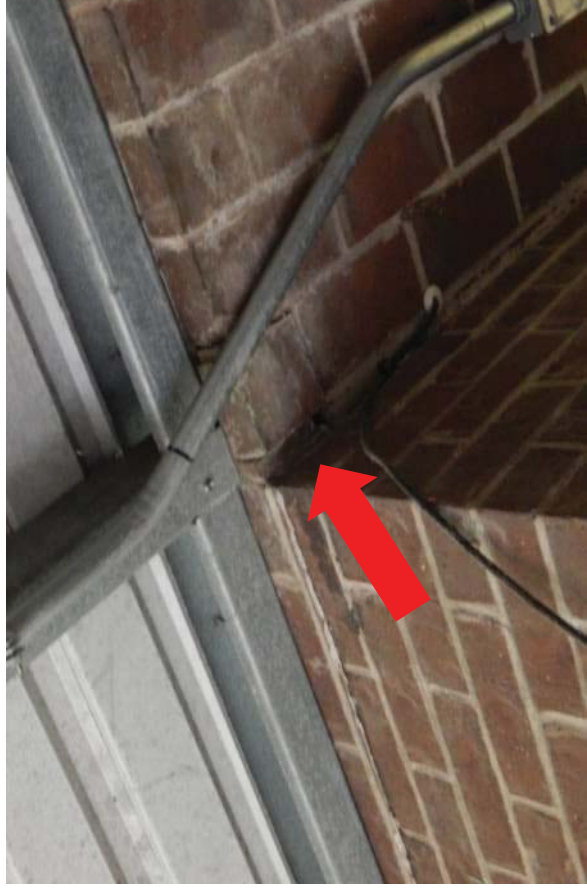
#16 Crack in brick of soffit brick same as photo #13

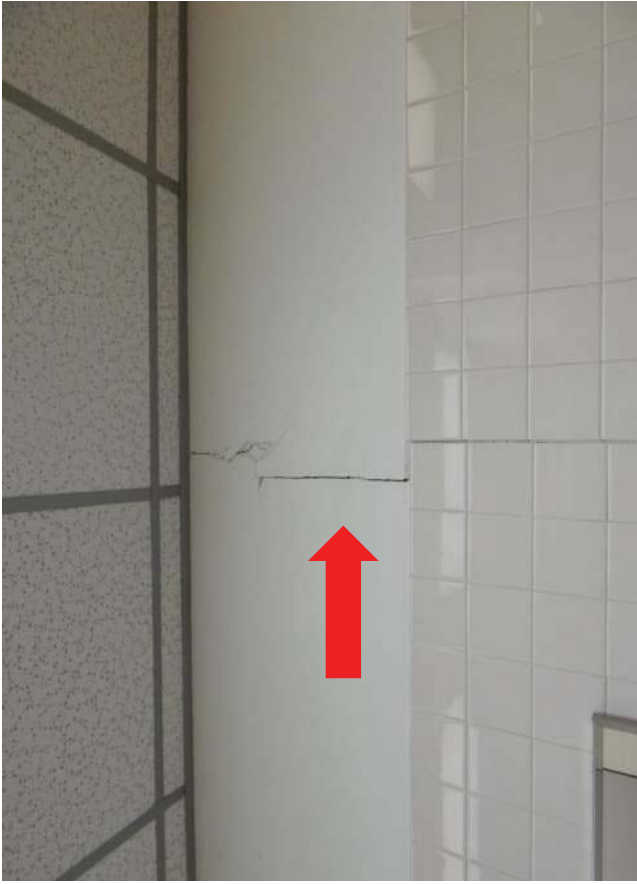
#35 Cracking in sheetrock wall and tile in bathroom

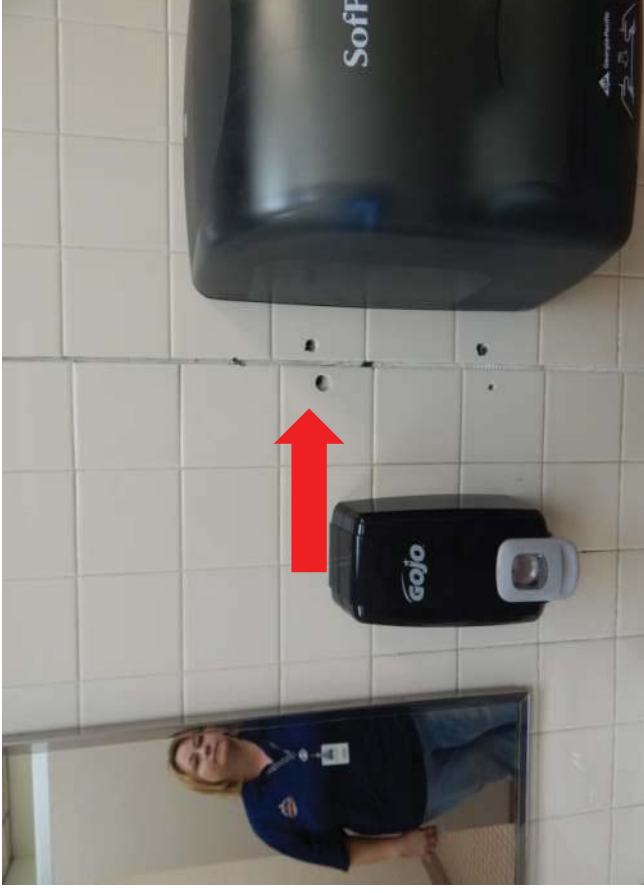
#36 Cracking and movement in tile joint. Mrs. Crenshaw said towel dispenser had to be moved.

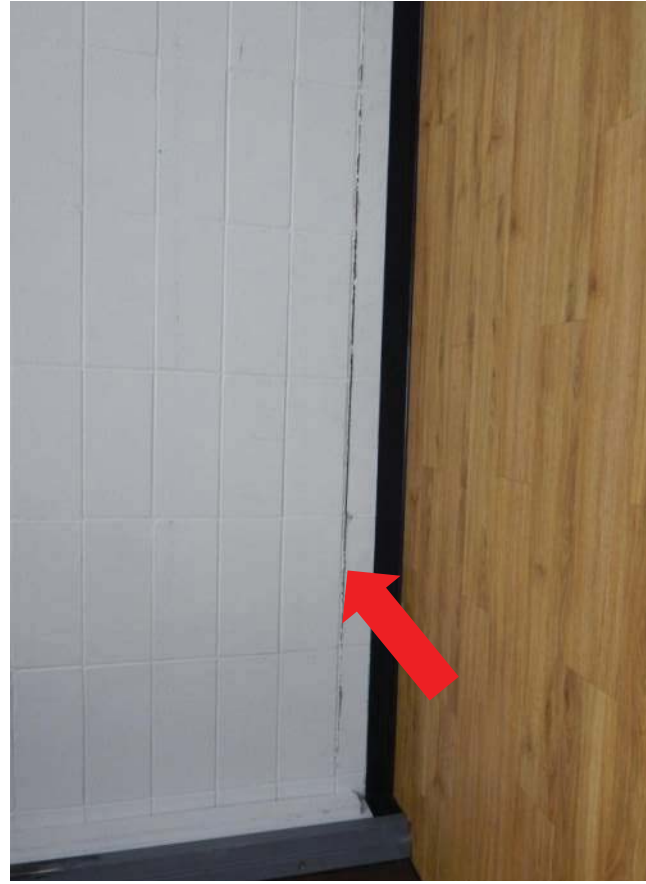
#46 Horizontal crack at base of CMU wall

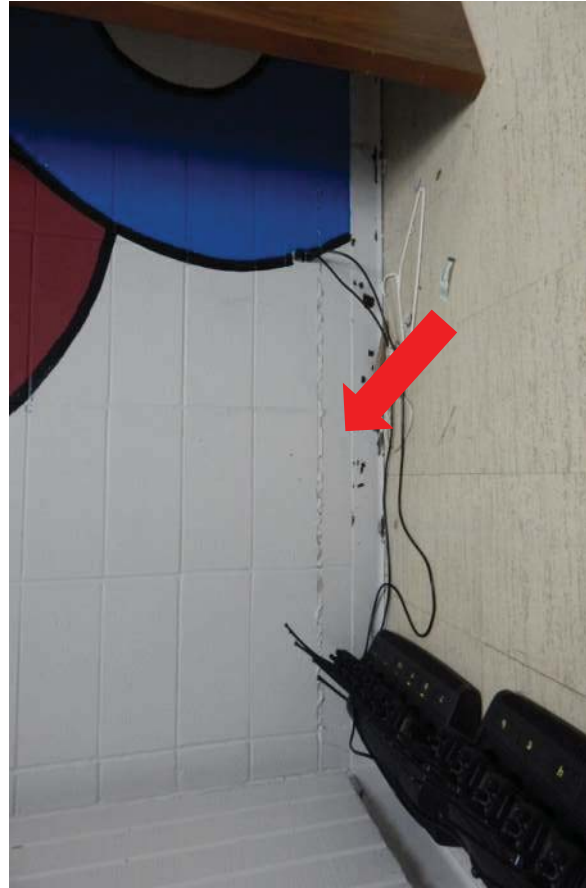
#48 Horizontal crack at base of CMU wall

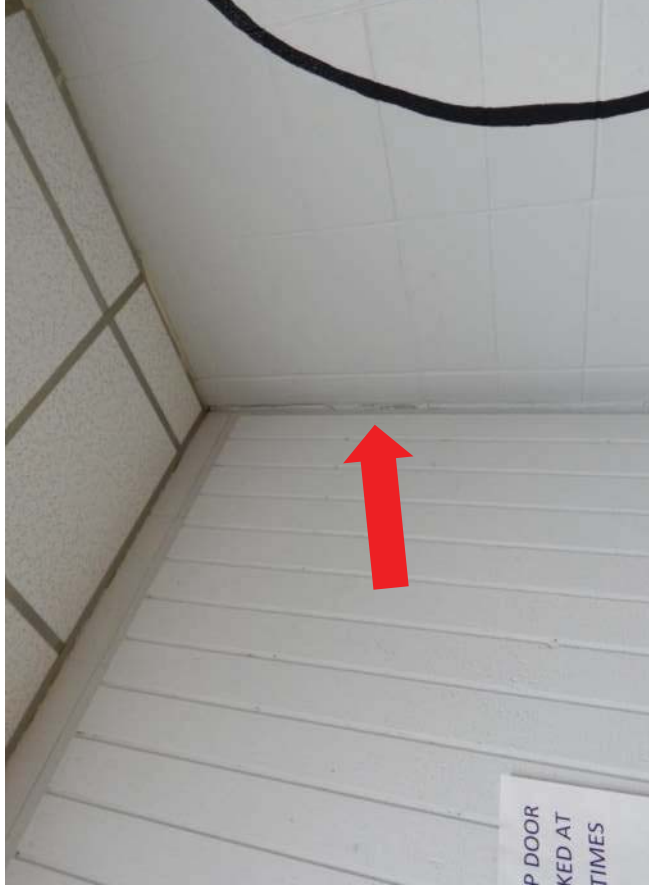
#47 Crack in corner of CMU wall

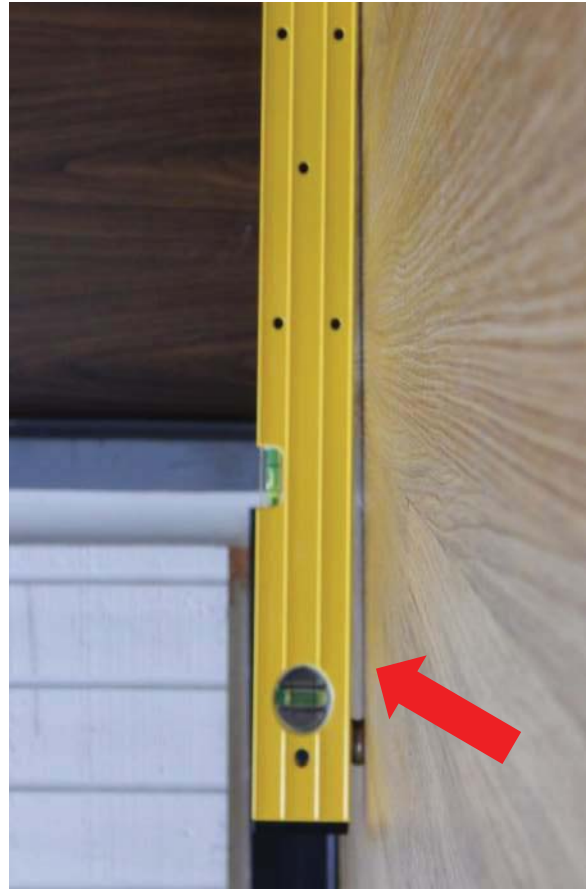
#49 Level on floor showing a slope of approximately 3/16 inch per foot

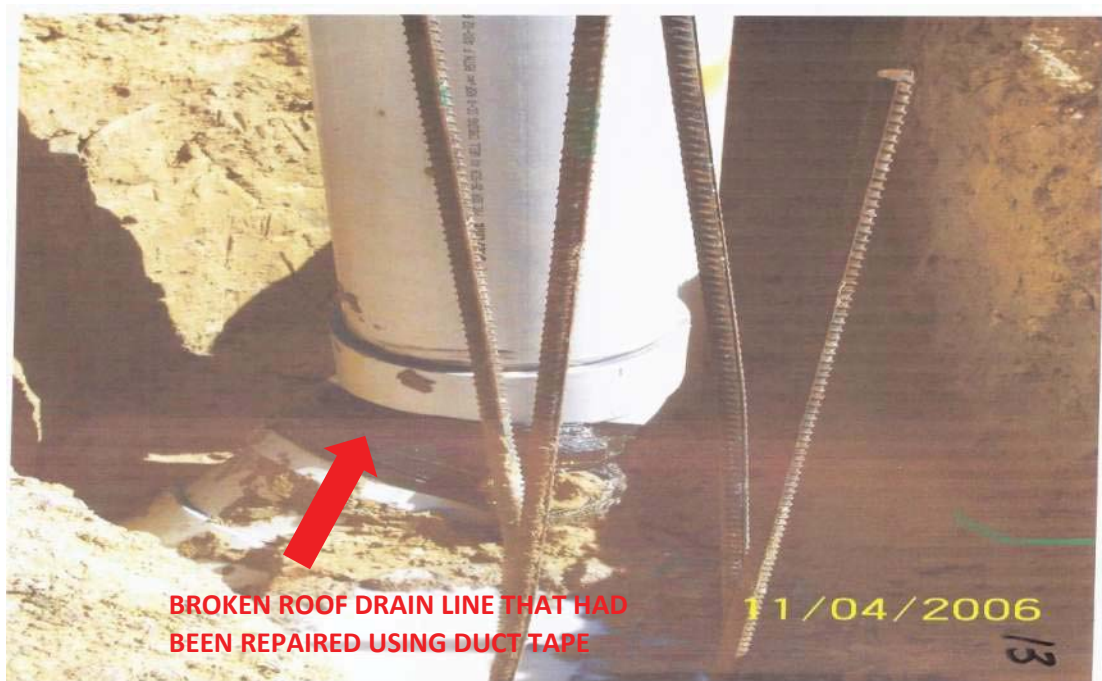
#6 Photo taken by contractor of Phase Two showing broken drain line that was repaired using duct tape

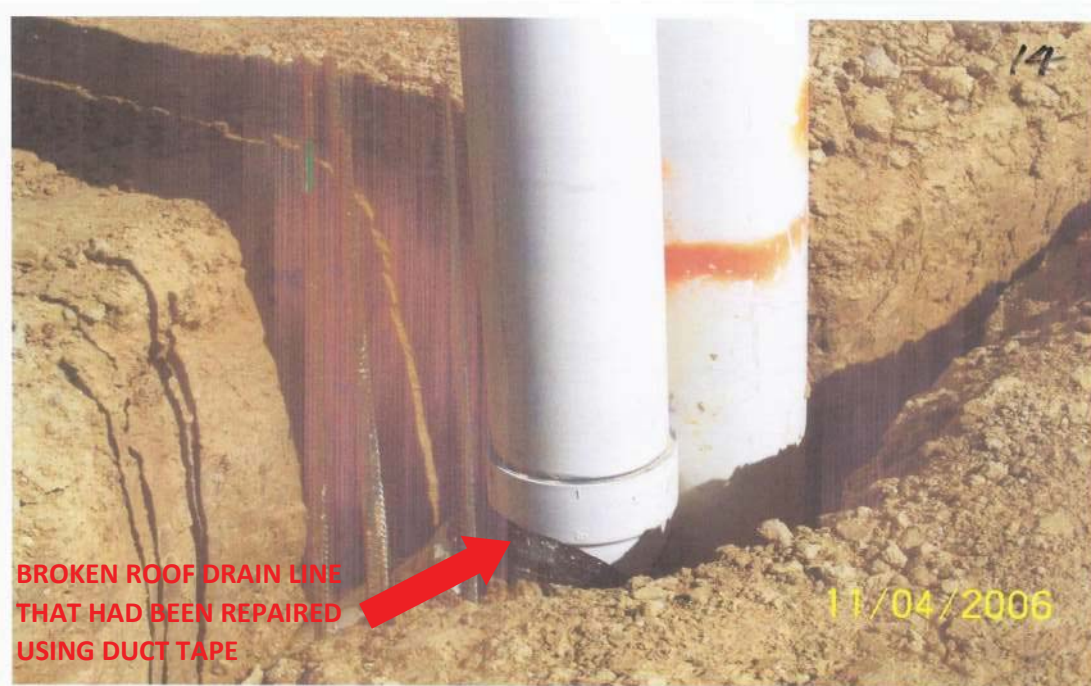
#7 Photo taken by contractor of Phase Two showing broken drain line that was repaired using duct tape and being covered with fill.

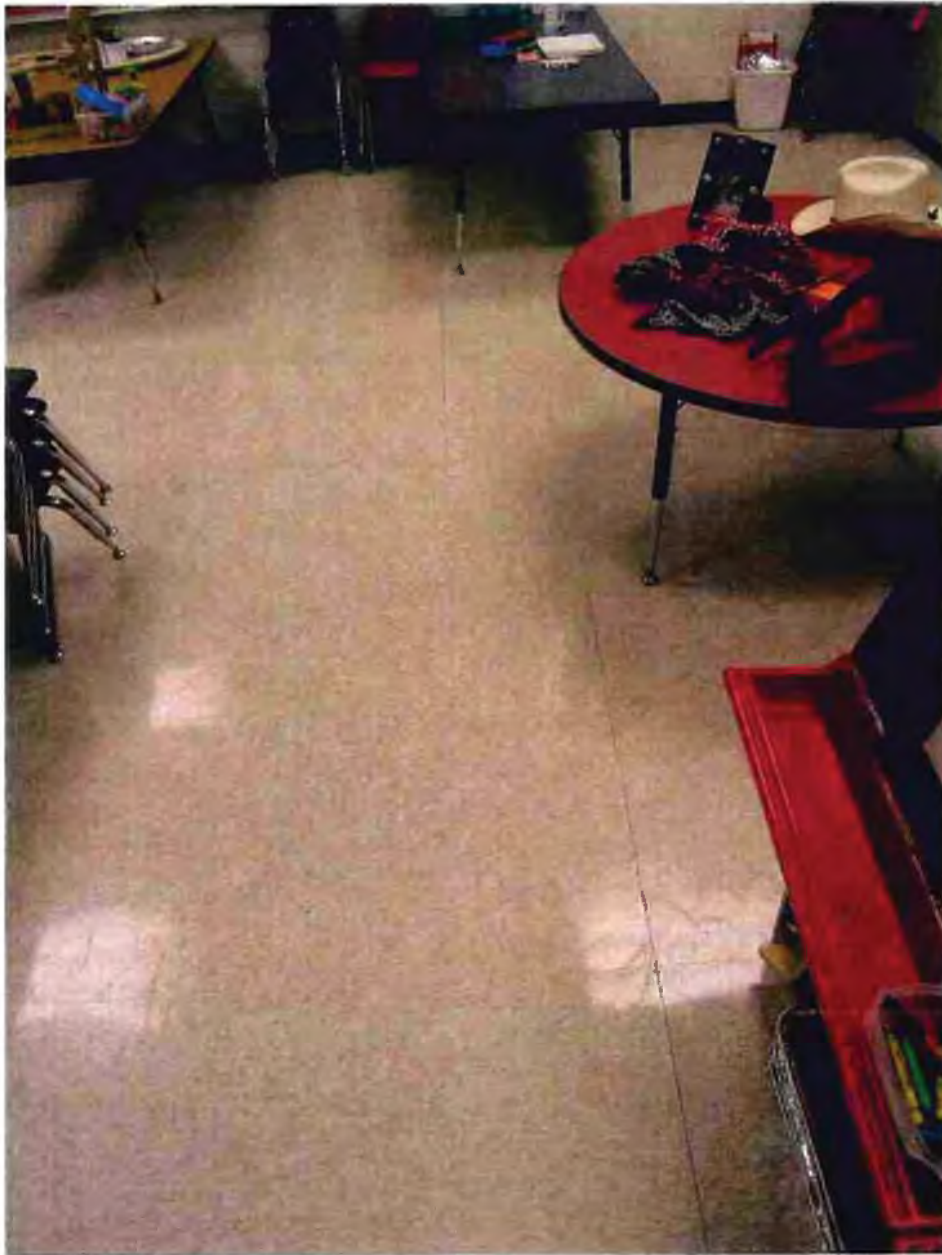
Photo 2. Separation of floor tiles in addition.

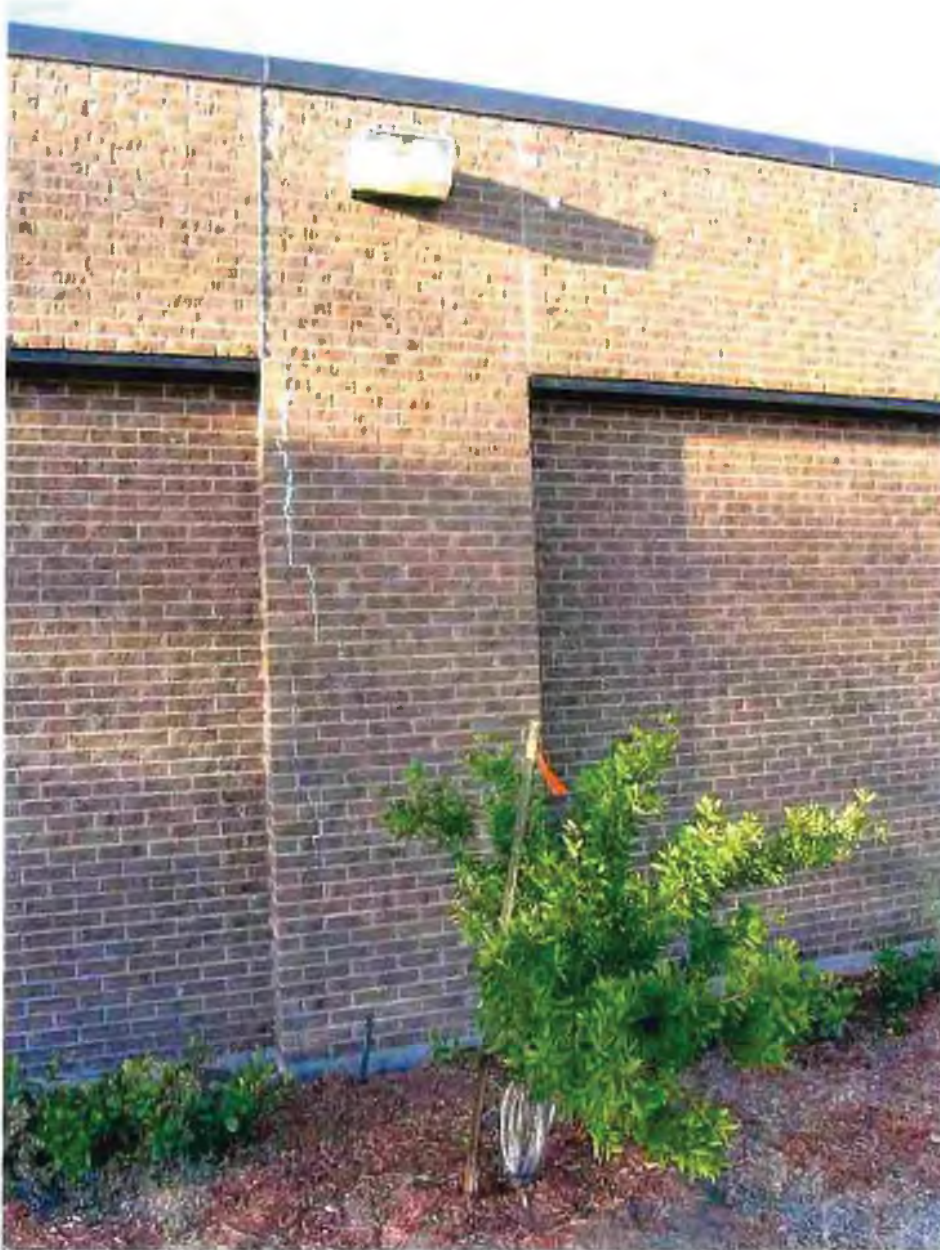
Photo 5. Exterior façade cracks (in original building) closing at top.
