PROJECT:
DEER PARK GATEWAY

CLIENT:
CITY OF DEER PARK
710 E. SAN AUGUSTINE
DEER PARK, TX 77536

SHEET TITLE
LAYOUT PLAN

| SHEET NAME: TOWER WALL & DETAILS | |

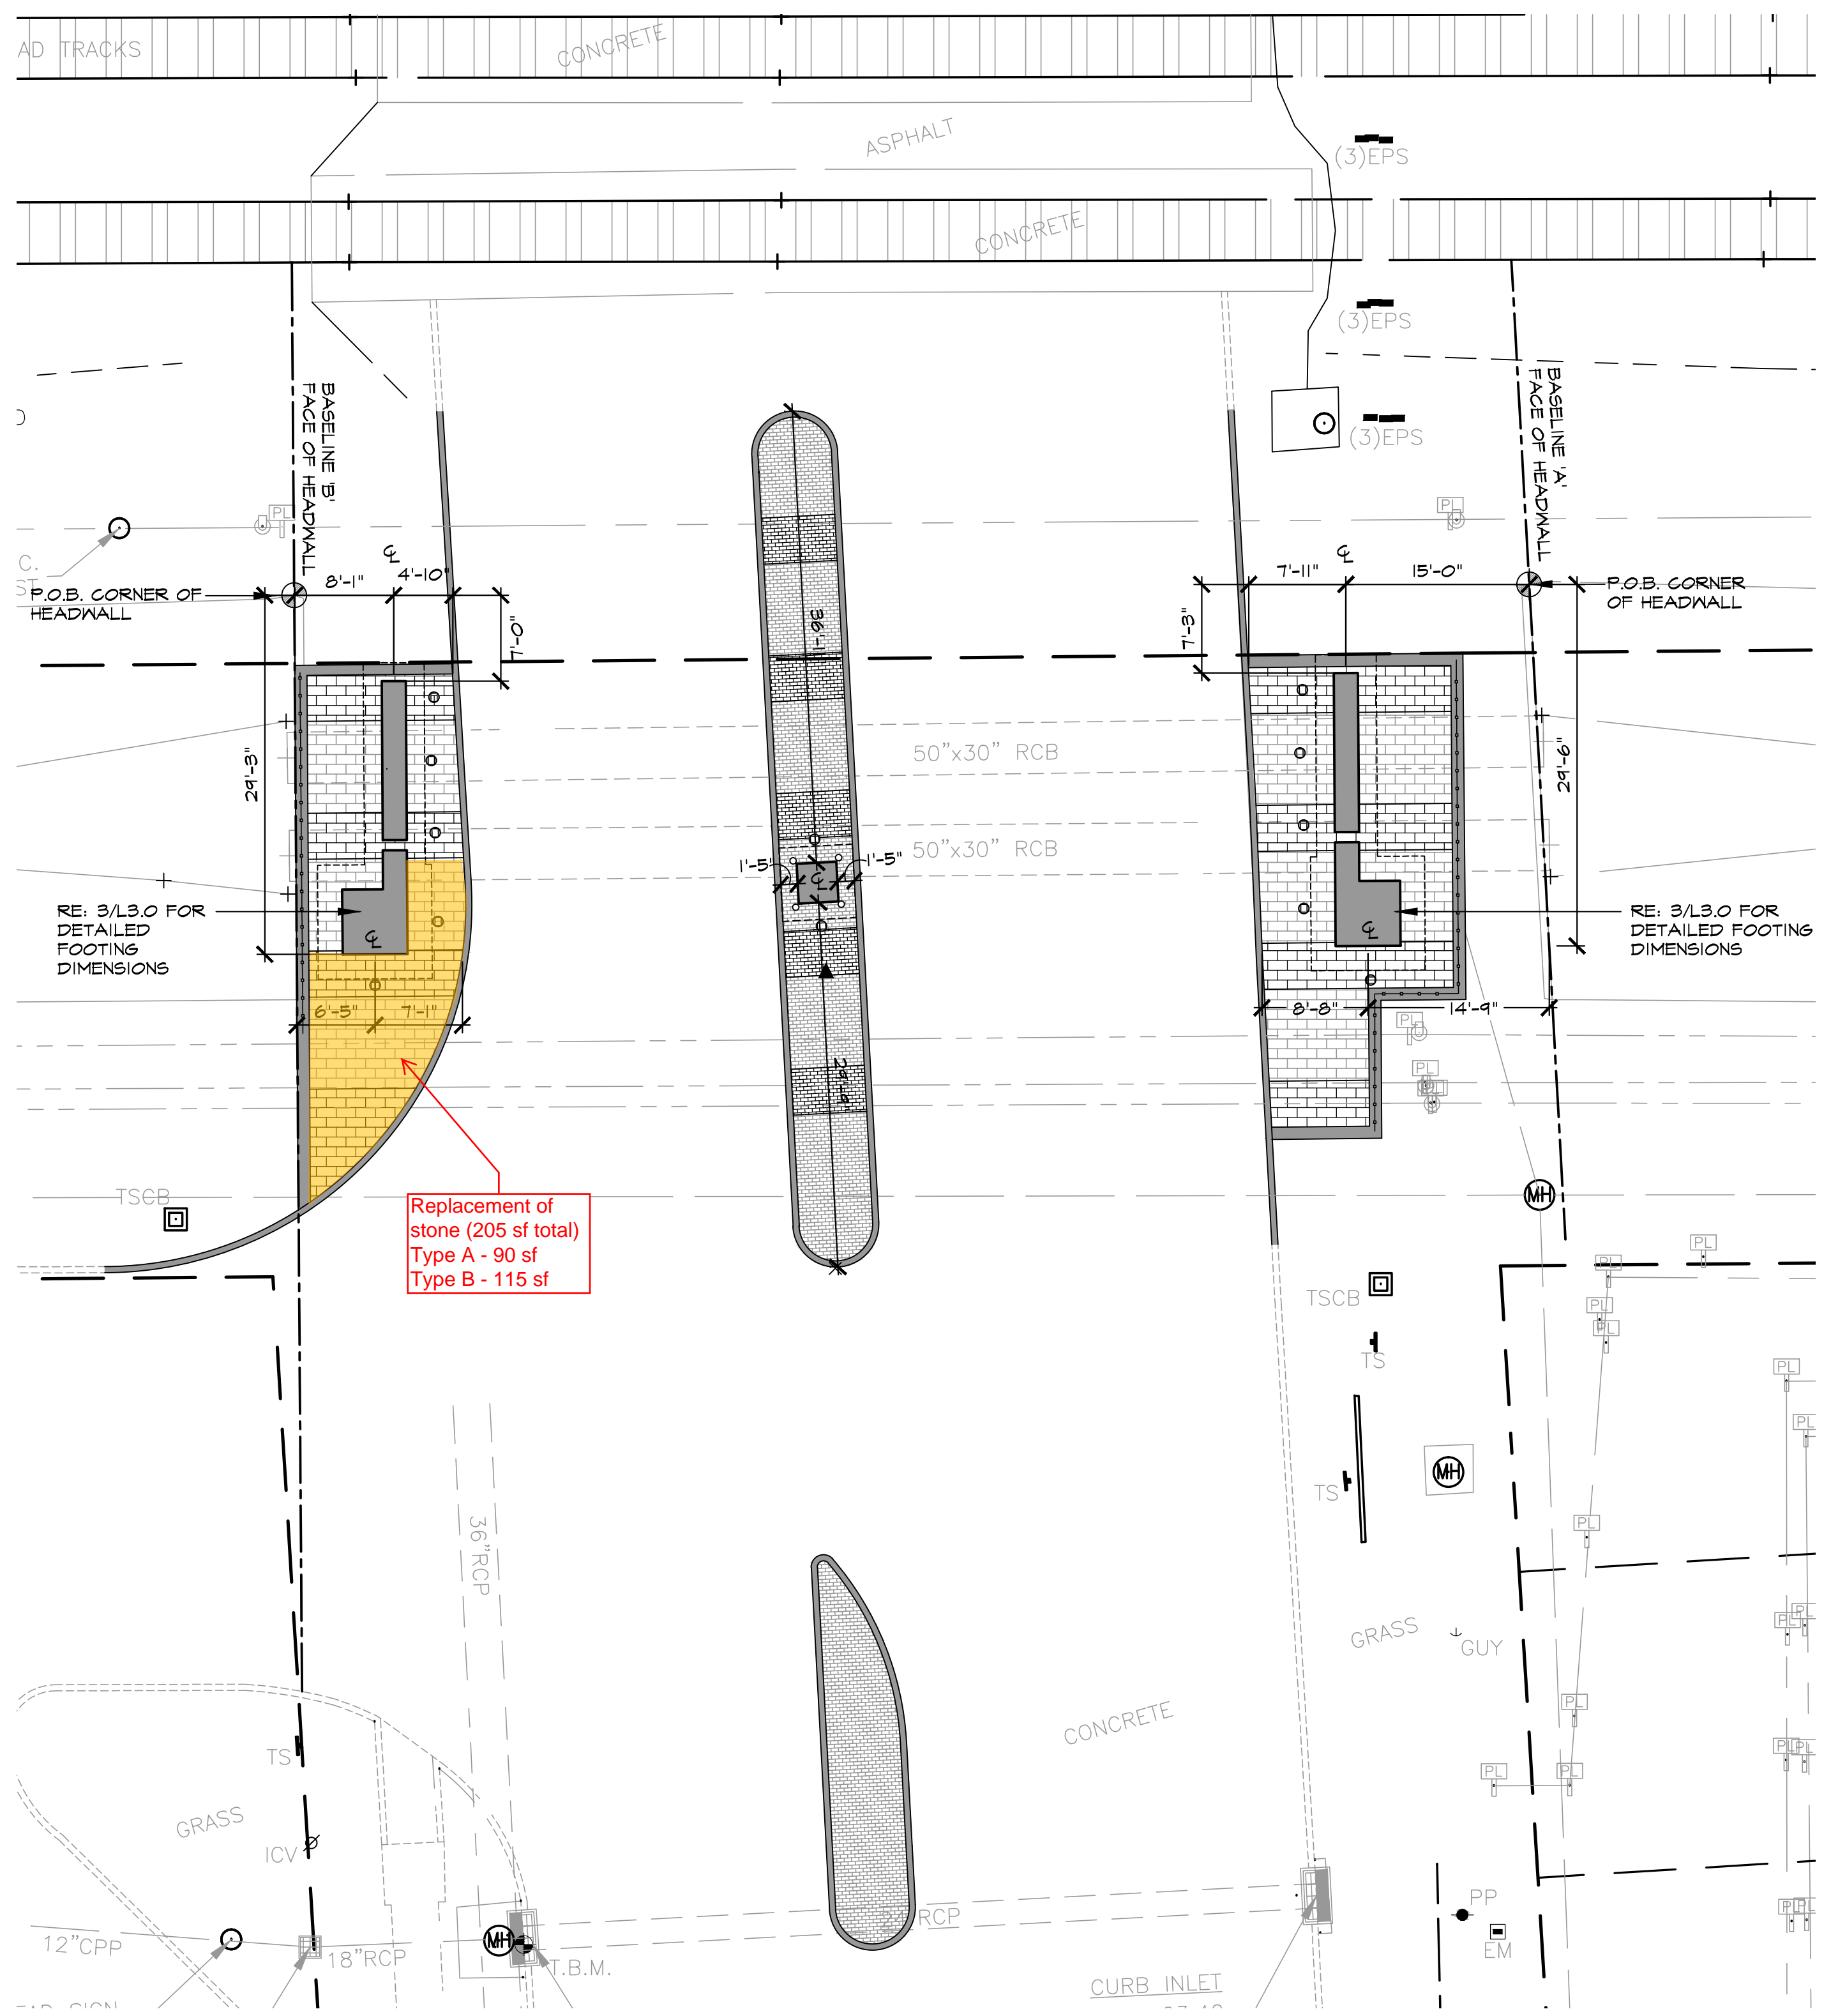
2 GATEWAY LAYOUT PLAN

STAR MOUNTING ANCHORS RIPPED FROM WALL CAUSING DAMAGE TO SURROUNDING STONE AND GROUT JOINTS (MULTIPLE LOCATIONS)

DAMAGE CAUSED TO
CAST STONE FROM STAR
PULLING AWAY FROM
CAST STONE

TOTAL FAILURE OF STONE
ATTACHMENT TO WALL IN
SEVERAL PLACES

DAMAGE TO CAST STONE
WATER TABLE/CAP

STEEL STAR WAS
DAMAGED WHEN
DRAGGED BY TRUCK.
METAL EDGE HAS BEEN
DAMAGED. METAL
STUDS DEFOMED STEEL
WHEN RIPPED FROM
WALL. REQUIRES TOTAL
REPLACEMENT

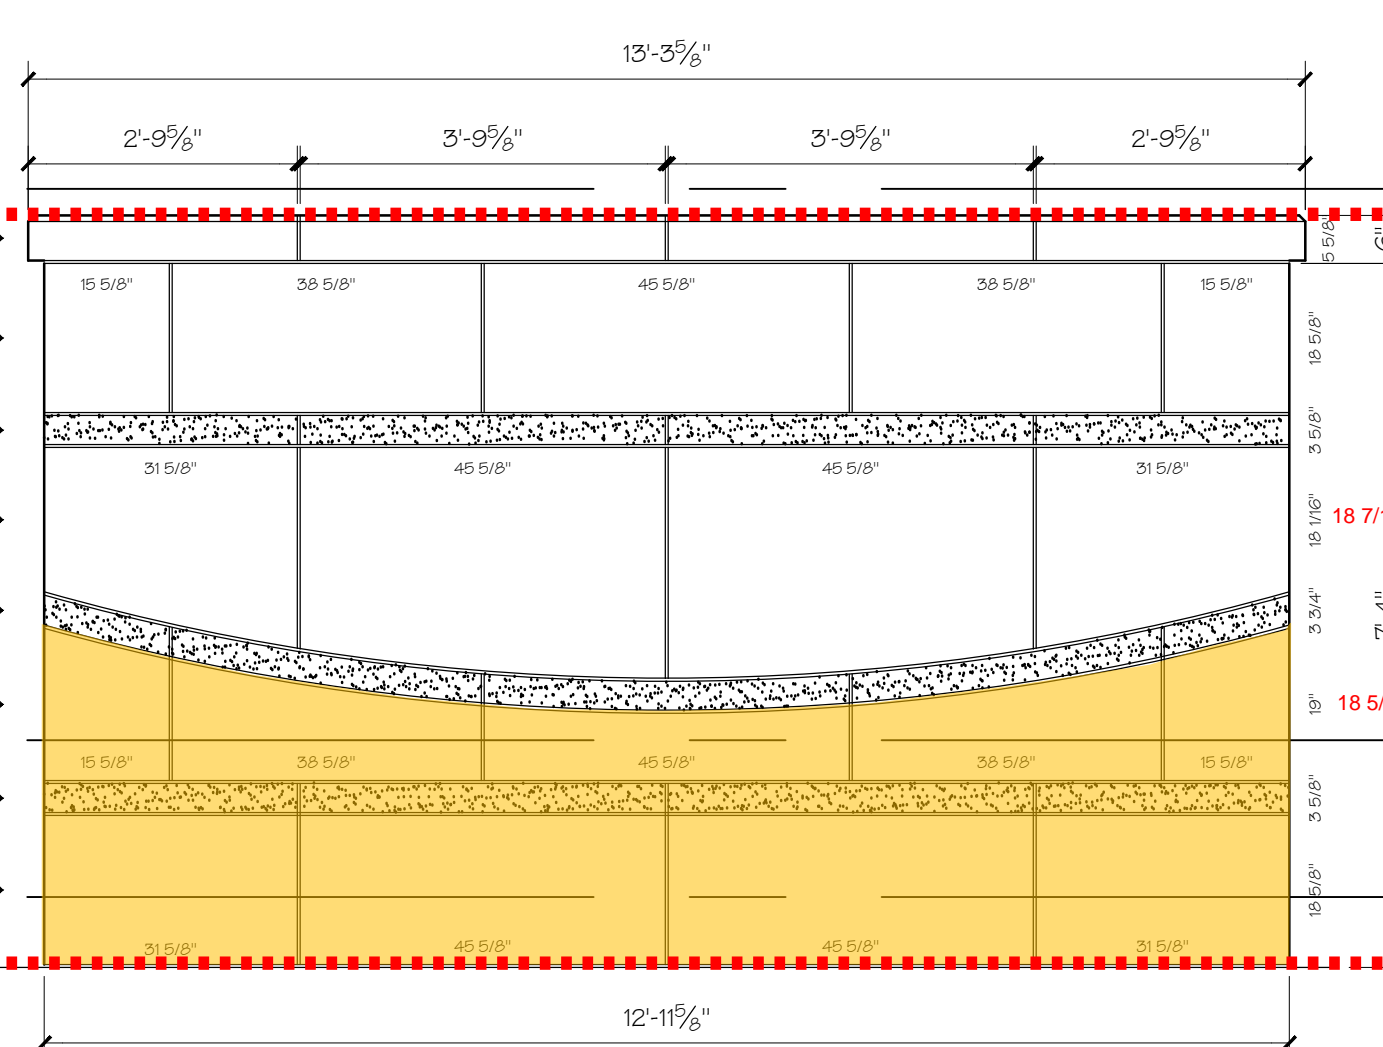
4 ELEVATION @ WALL
1/2" = 1'-0"

SURFACE SCRAPE ON CAST
STONE - RECOMMEND
REPLACING ENTIRE COLOR OF
THIS STONE ON THIS
ELEVATION TO SO THAT
COLOR REMAINS EVEN.
