# Building Observations Survey ©2016

## Deer Park Community Center Deer Park, Texas

**Building Survey for Deer Park Community Center,  
610 East San Augustine Street, Deer Park, Texas**

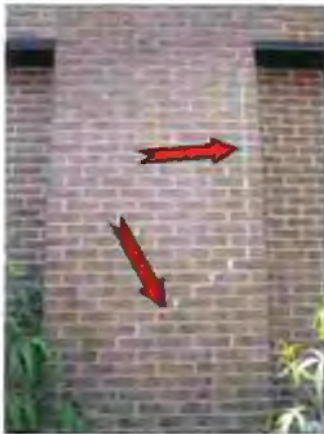
**Photo #9** Masonry-mortar-joint crack

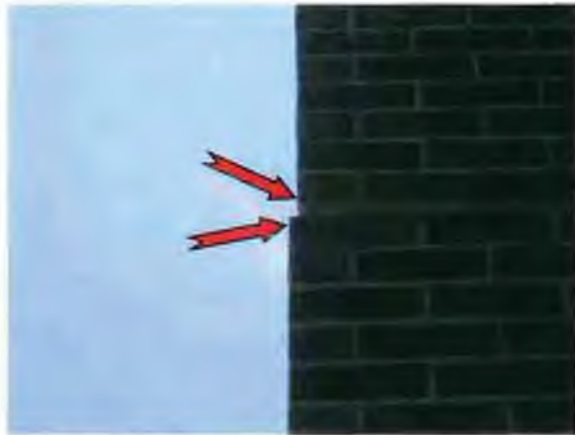
**Photo #13** Lateral movement in brick veneer

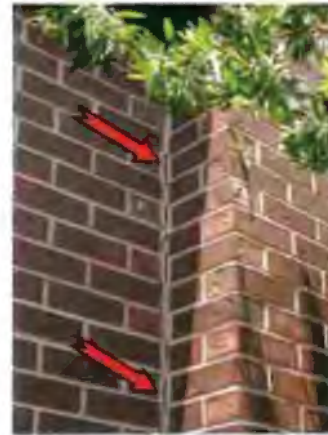
**Photo #14** Separation at expansion joint

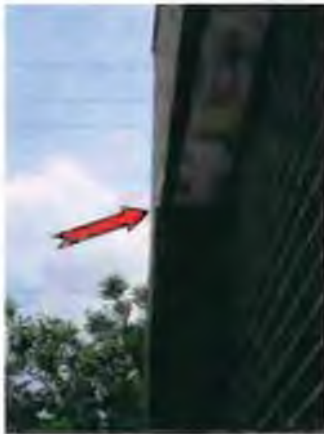
**Photo #15** Lateral movement in brick veneer

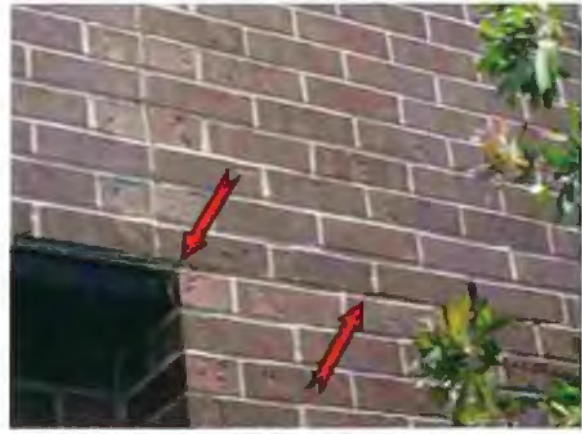
**Photo #16** Separation at expansion joint

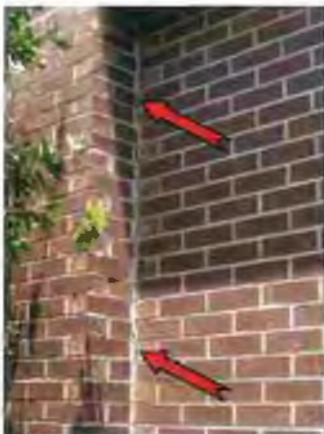
**Photo #17** Separation at expansion joint

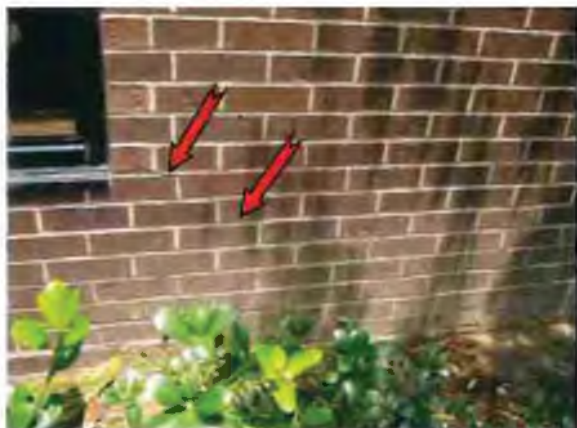
**Photo #19** Masonry-mortar-joint crack

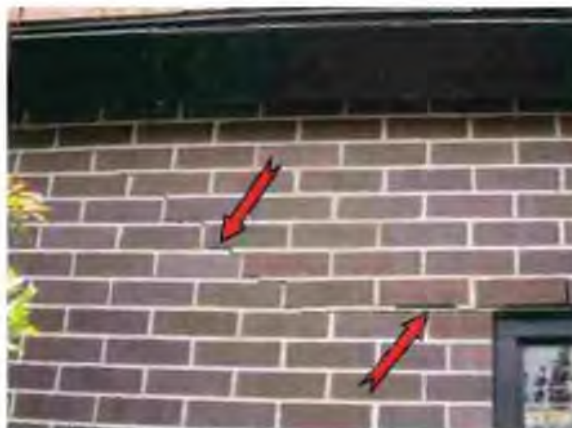
**Photo #20** Masonry-mortar-joint crack

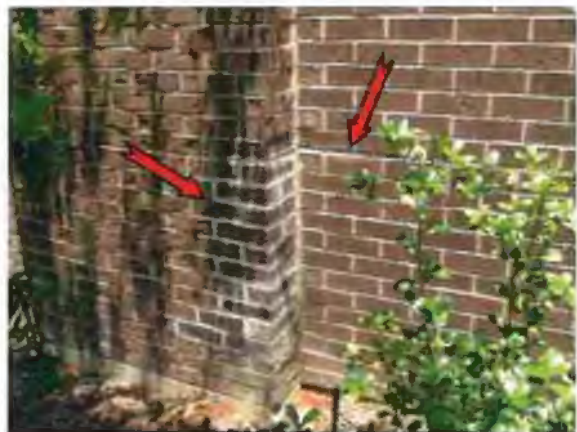
**Photo #21** Masonry-mortar-joint crack

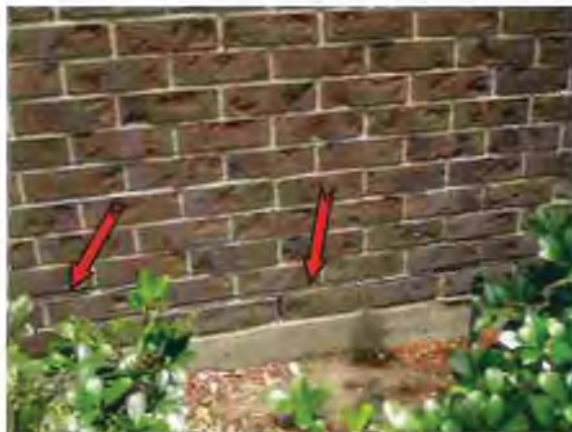
**Photo #22** Masonry-mortar-joint crack

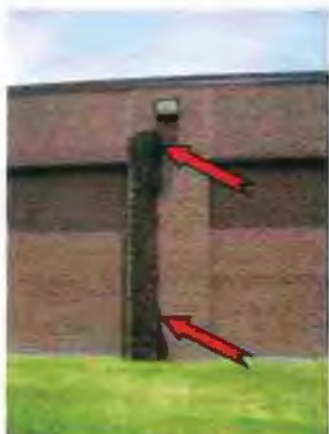
**Photo #23** Staining on exterior brick veneer

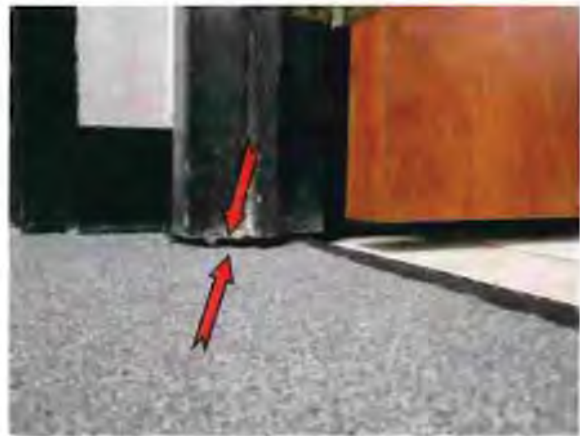
**Photo #26** Separation between door frame and floor

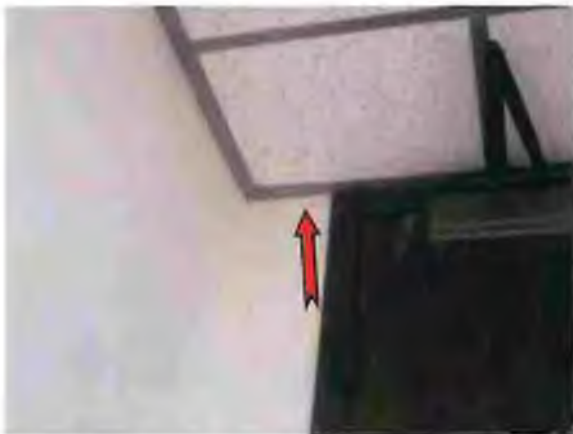
**Photo #46** Crack in gypsum wallboard wall

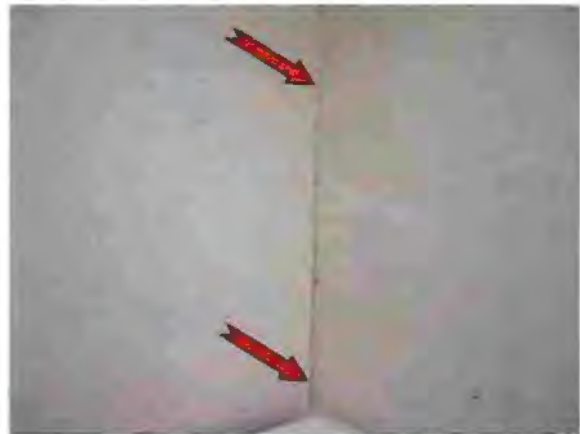
**Photo #55** Crack in gypsum wallboard wall

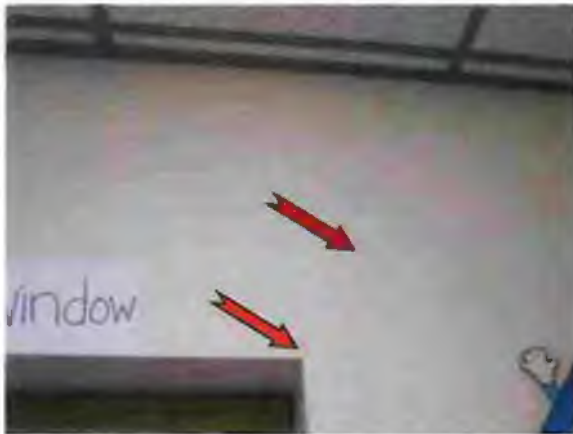
**Photo #56** Crack in gypsum wallboard wall

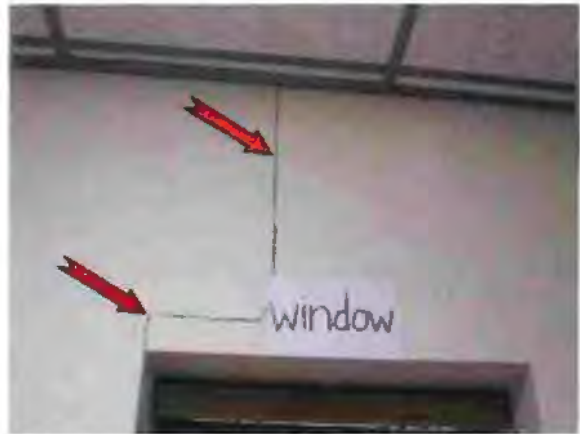
**Photo #57** Crack in gypsum wallboard wall

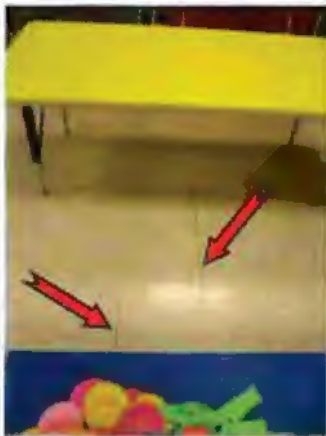
**Photo #60** Separations in vinyl tile floor

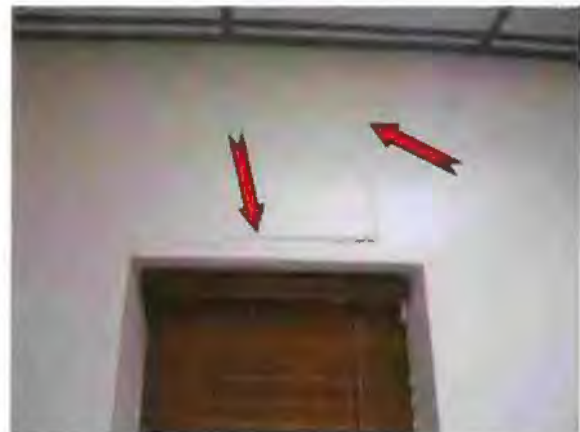
**Photo #65** Crack in gypsum wallboard wall

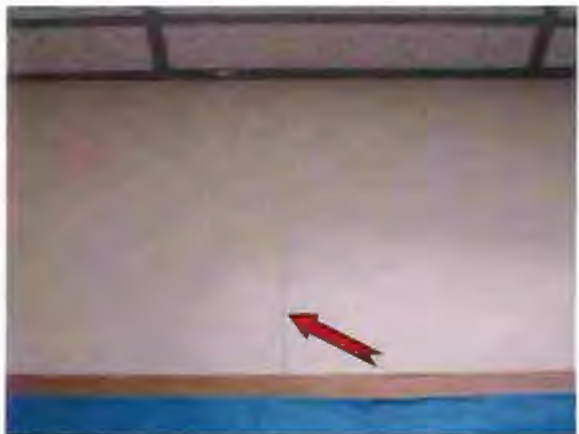
**Photo #71** Crack in gypsum wallboard wall
