EVALUATION OF THE 250,000 GALLON WELDED STEEL SINGLE-PEDESTAL SPHEROID

**“AVON STREET TANK”
DEER PARK, TEXAS**

THE CITY OF DEER PARK

July 25, 2023

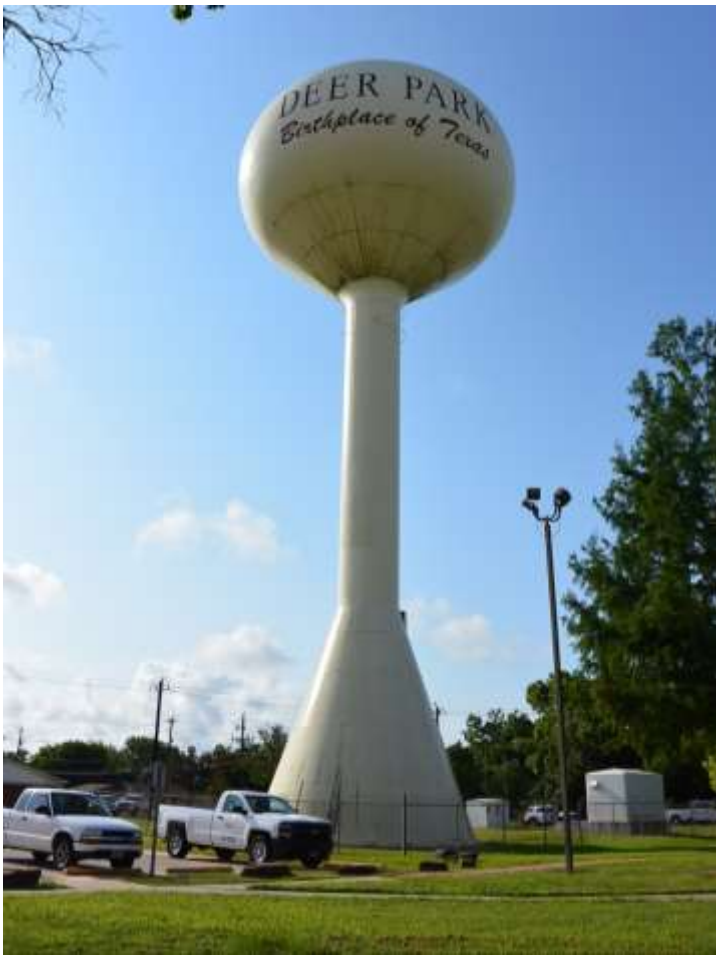
1. Tank and site.

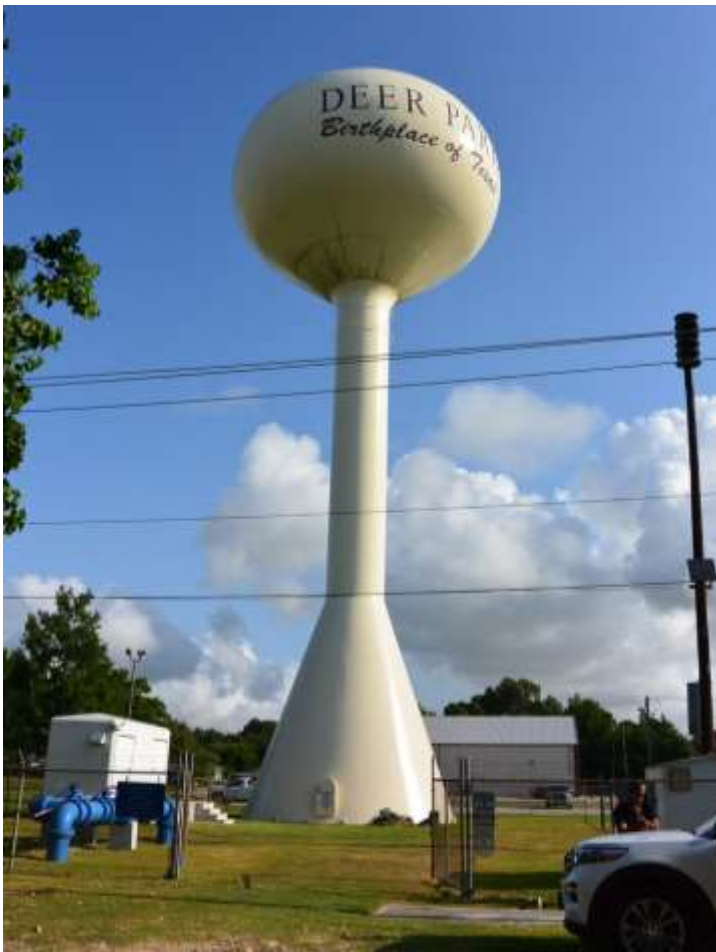
2. Tank and site.

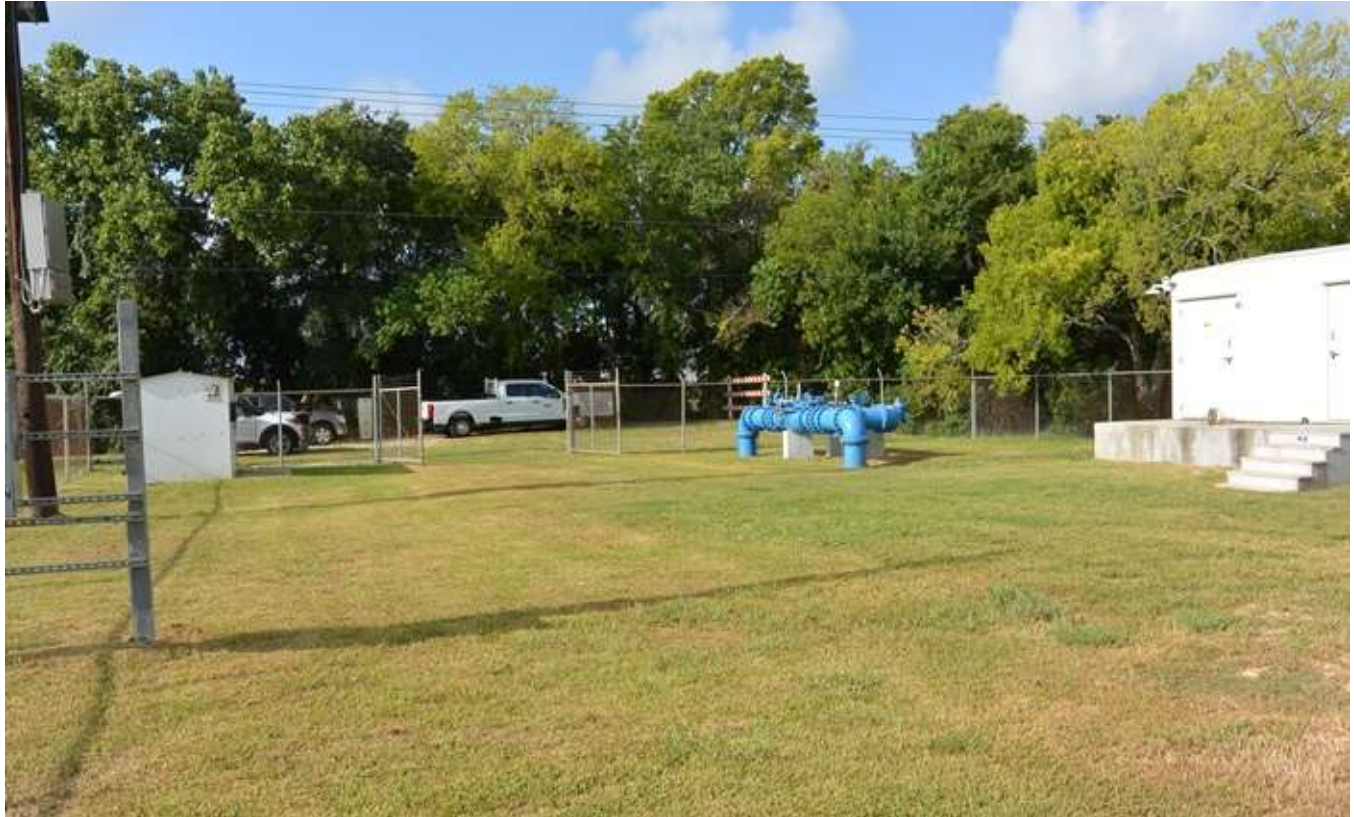
6. Piping and building on site.

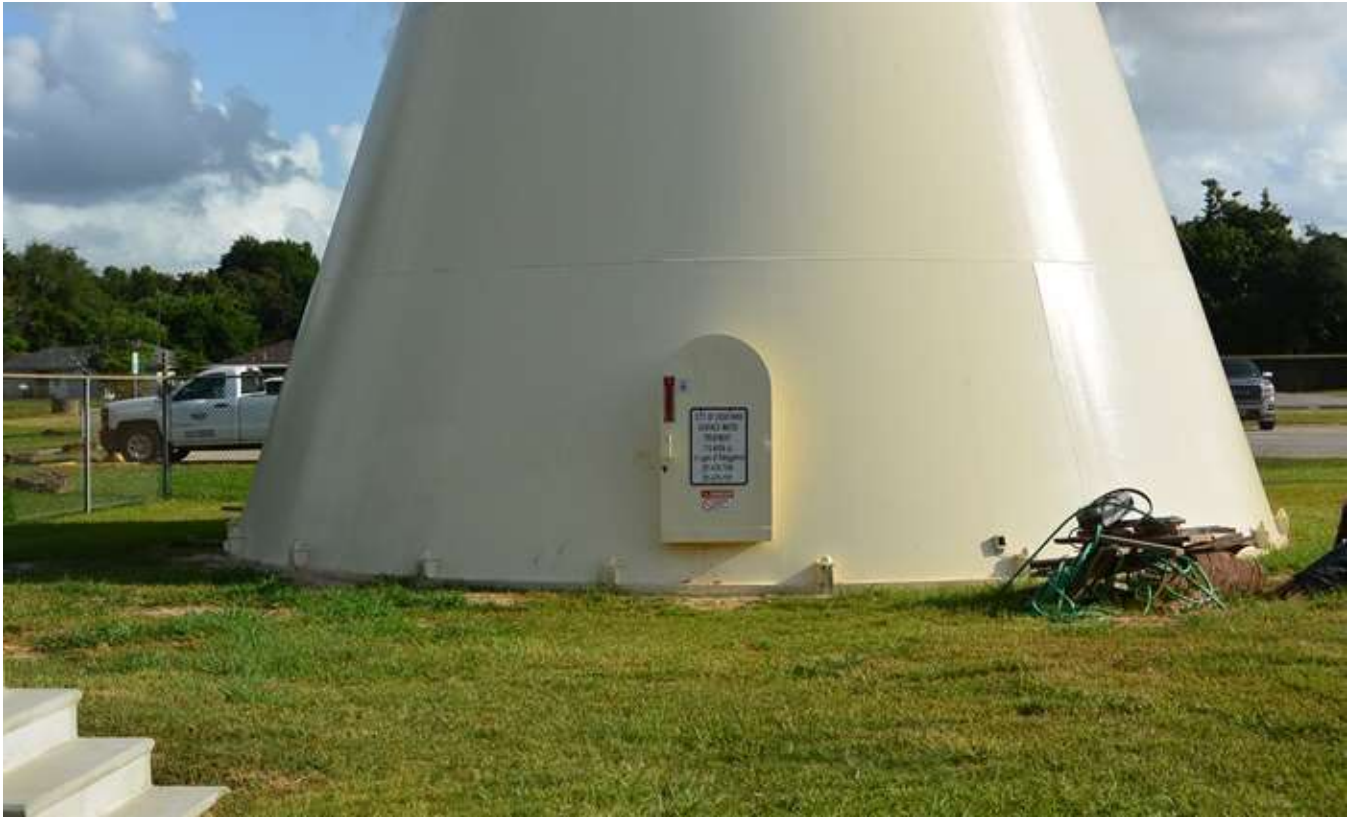
13. Base cone exterior and information and warning signs on the access door.

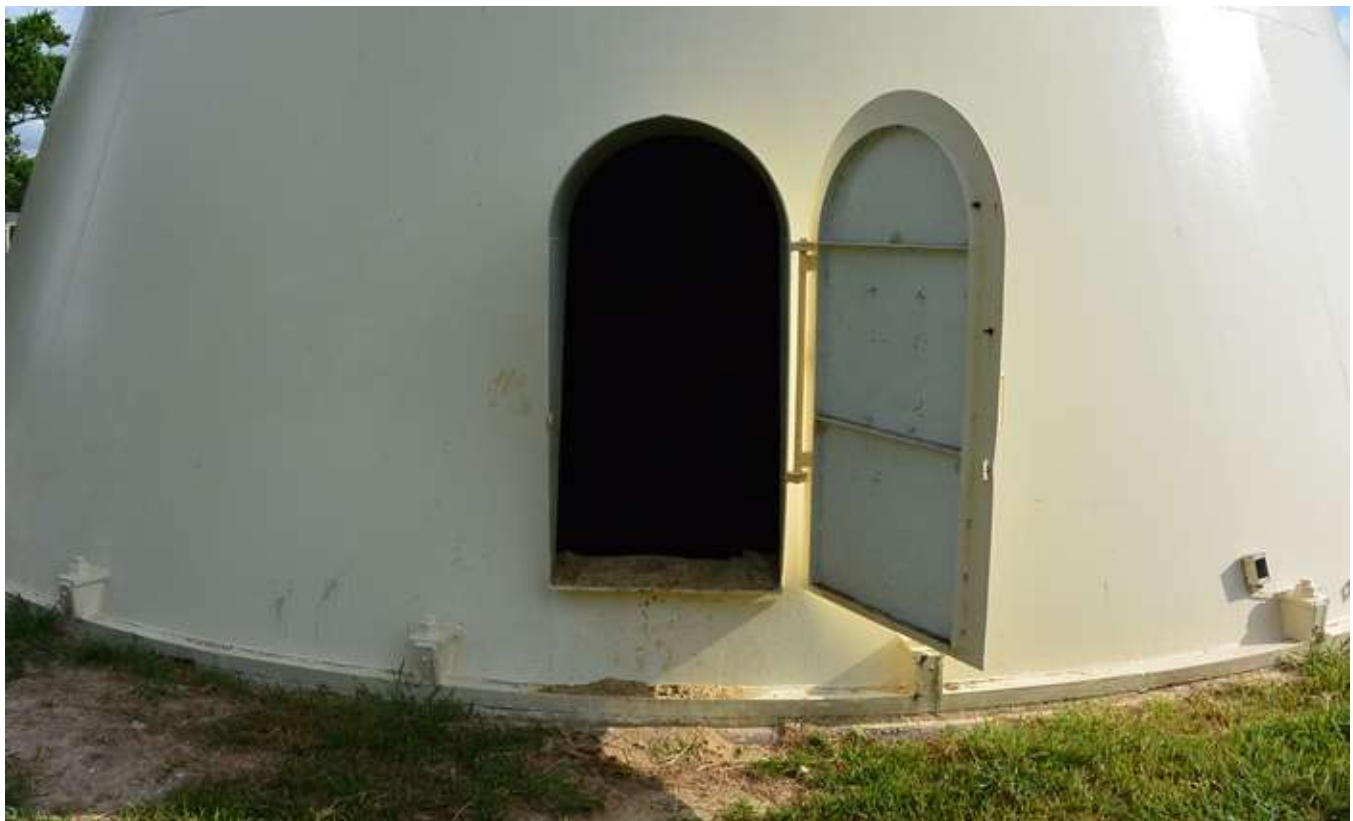
14. Base cone access door.

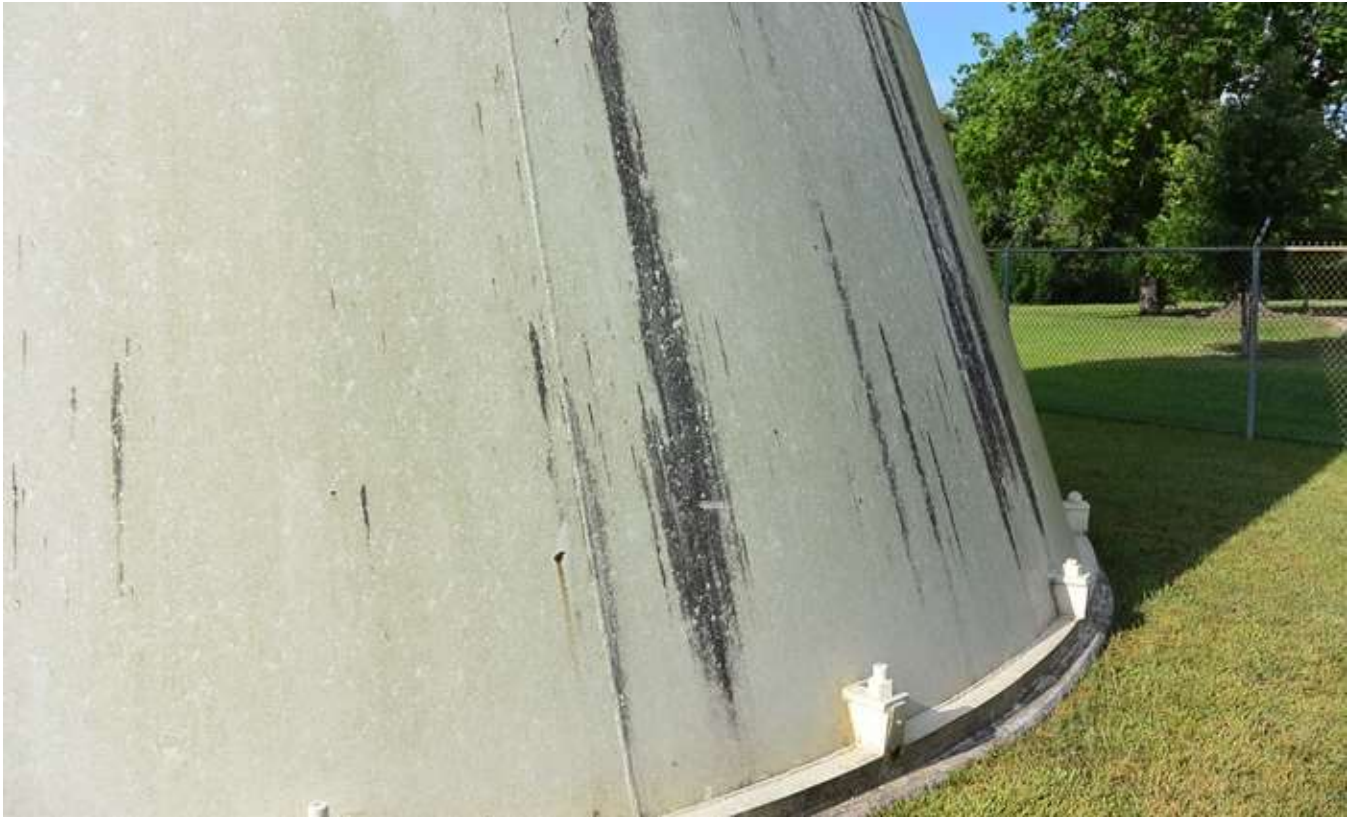
15. Mildew on the base cone exterior.

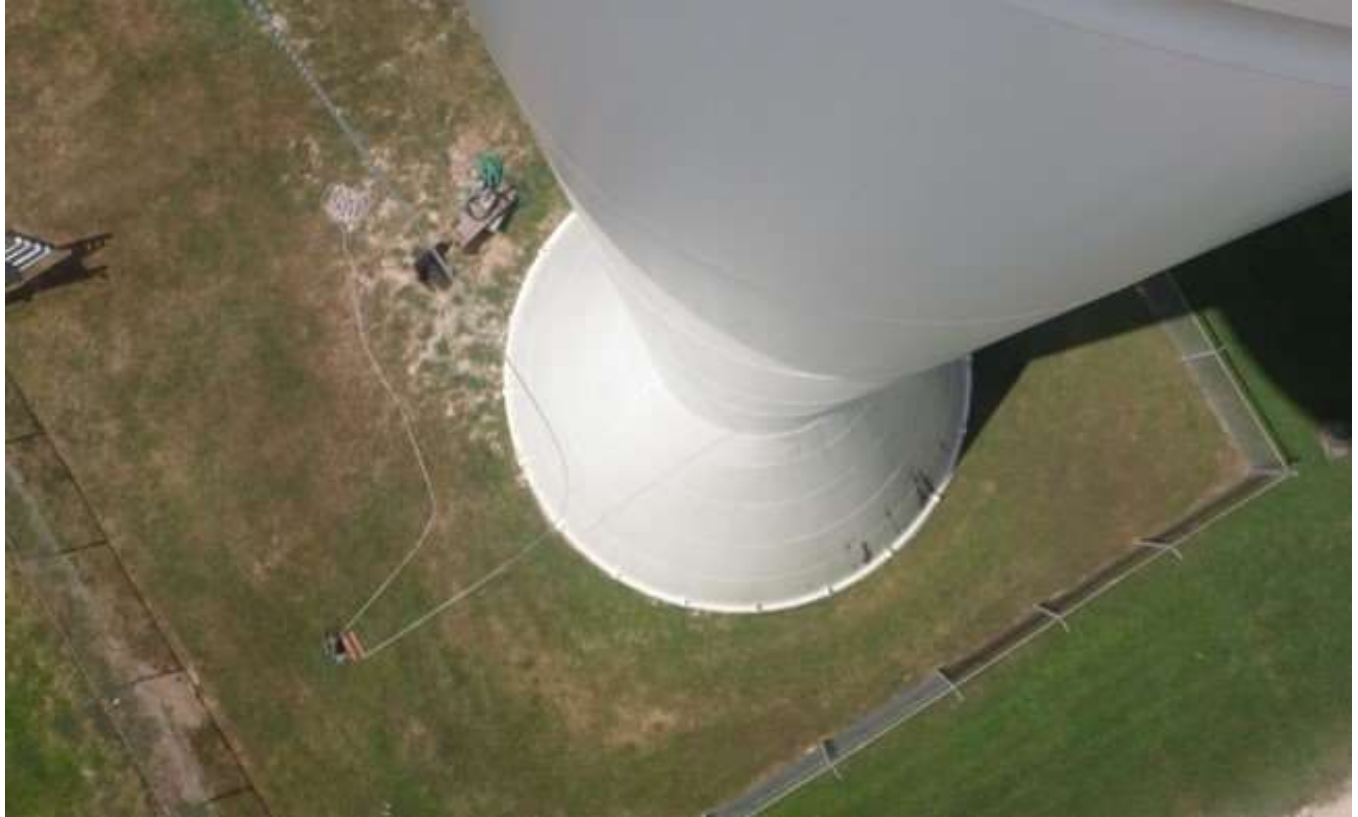
16. Base cone and support column exterior.

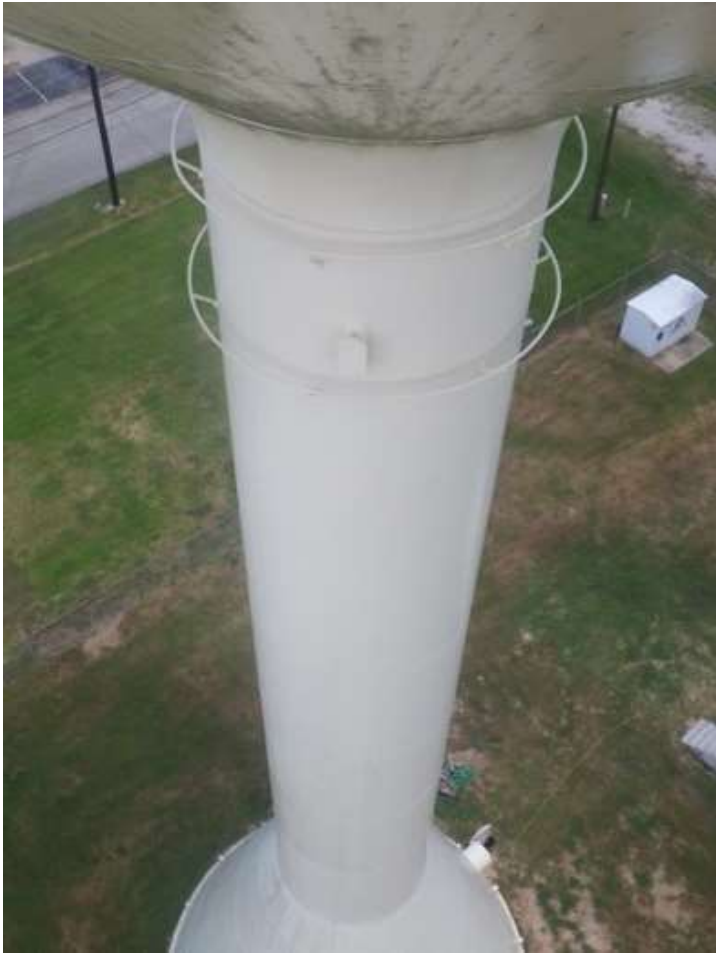
17. Support column, painter's manhole, and painter's rings.

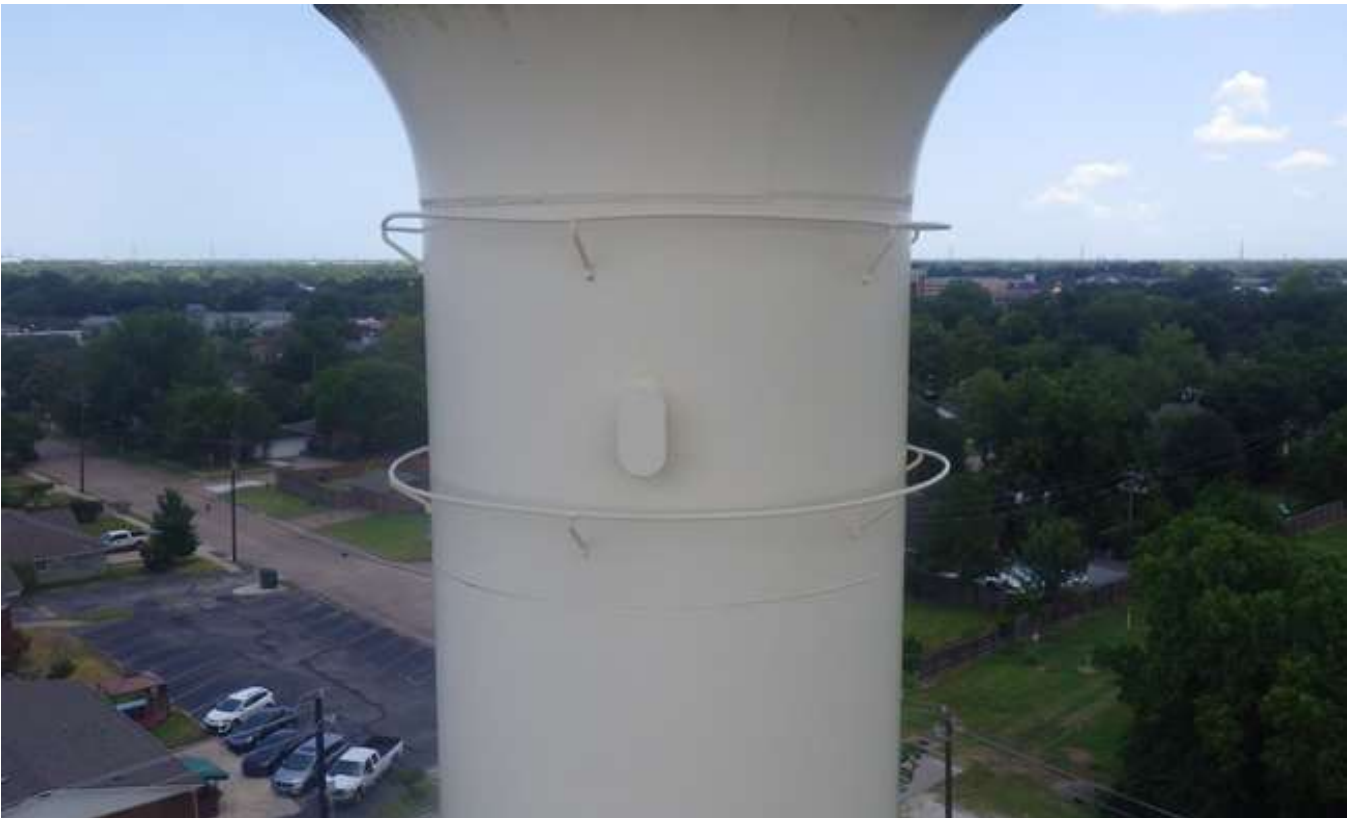
18. Painter's manhole and painter's rings near the top of the support column. Note bent painter's ring.

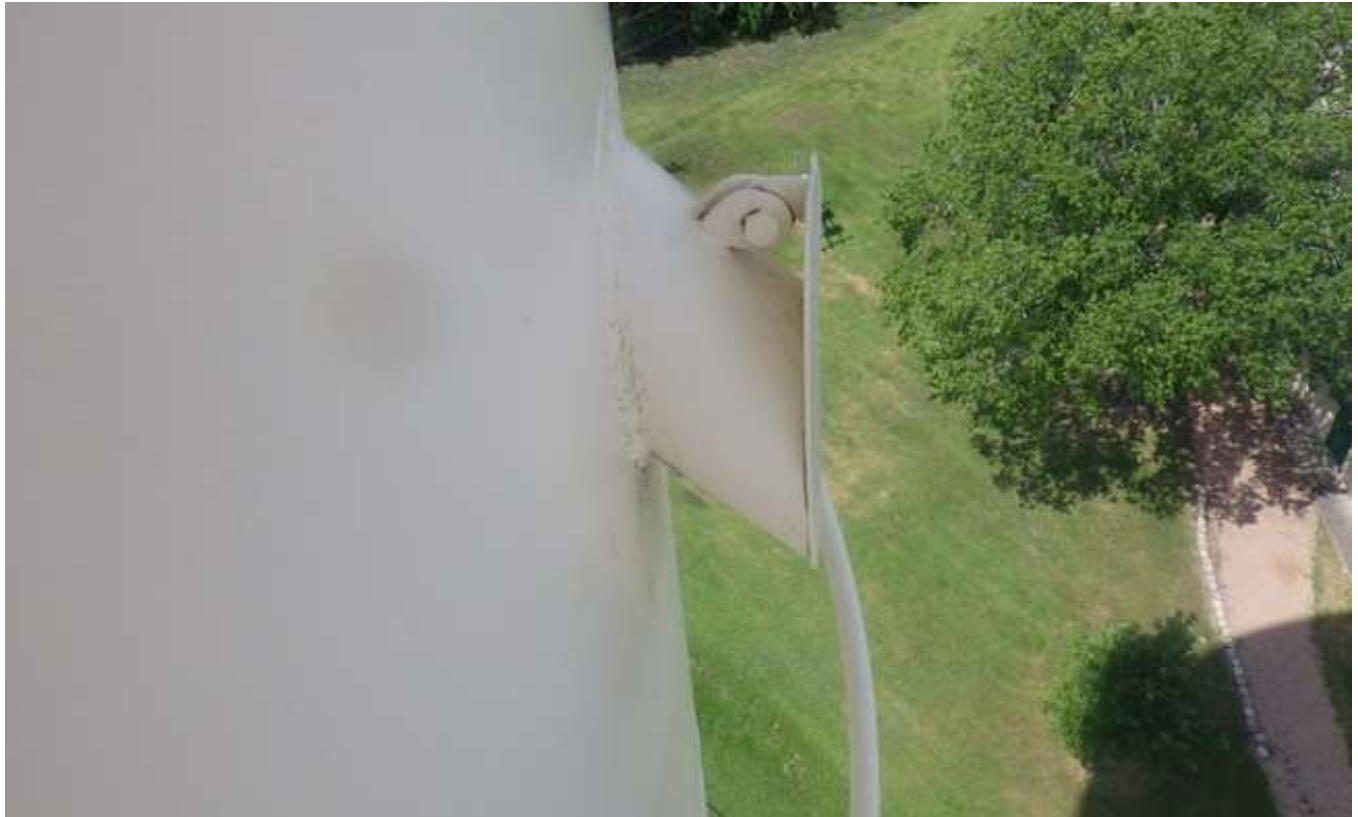
- ◆ the overflow pipe discharged near the top of the support column which allowed the potential of accelerated corrosion on the support column and base cone and the erosion of the soil due to effluent discharge,

- ◆ the overflow pipe projection from the support column was inadequate,
- ◆ the discharge end of the overflow pipe was not equipped with protective screening,

20. Stub overflow pipe discharge equipped with a flap gate near the top of the support column.

These deficiencies should be corrected.

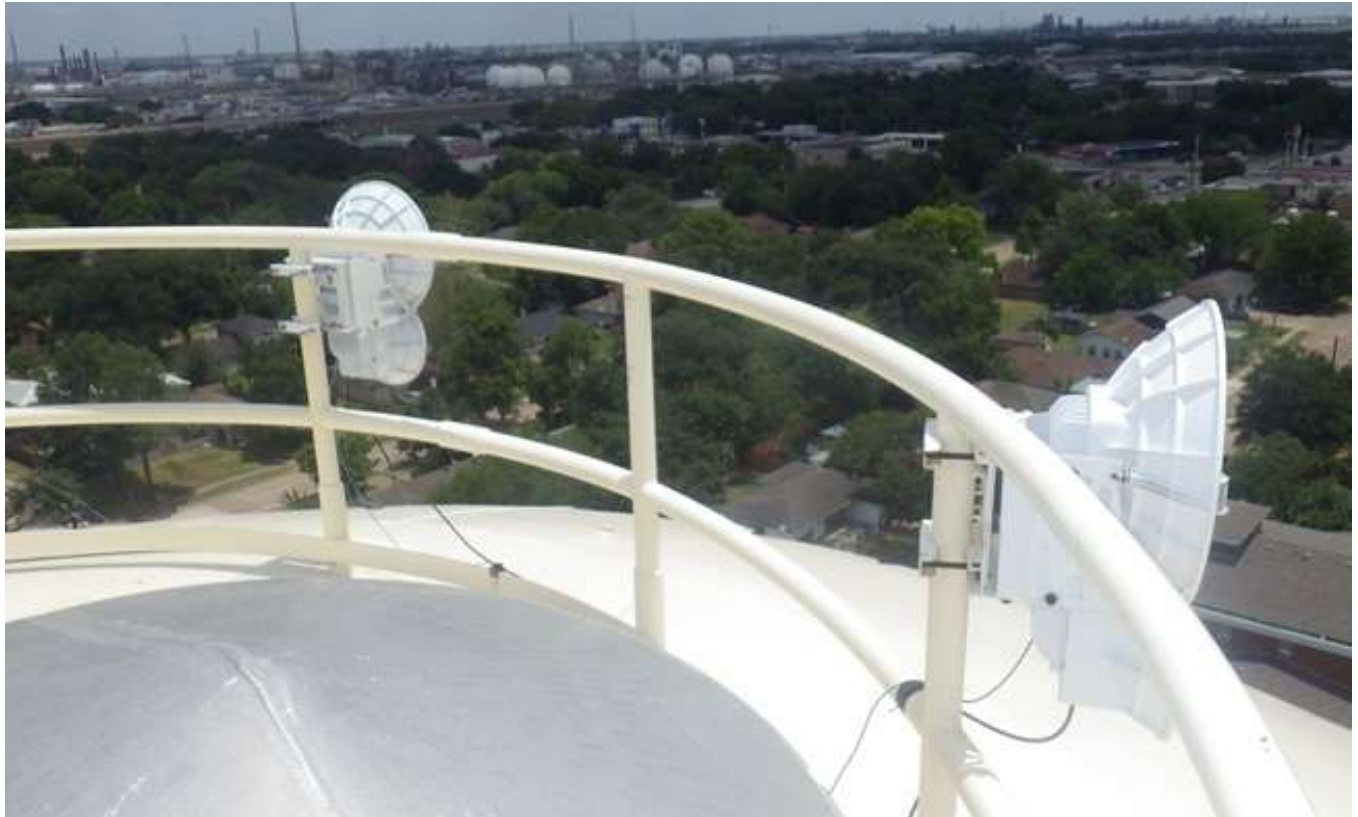
34. Antennas attached to the roof safety railing.

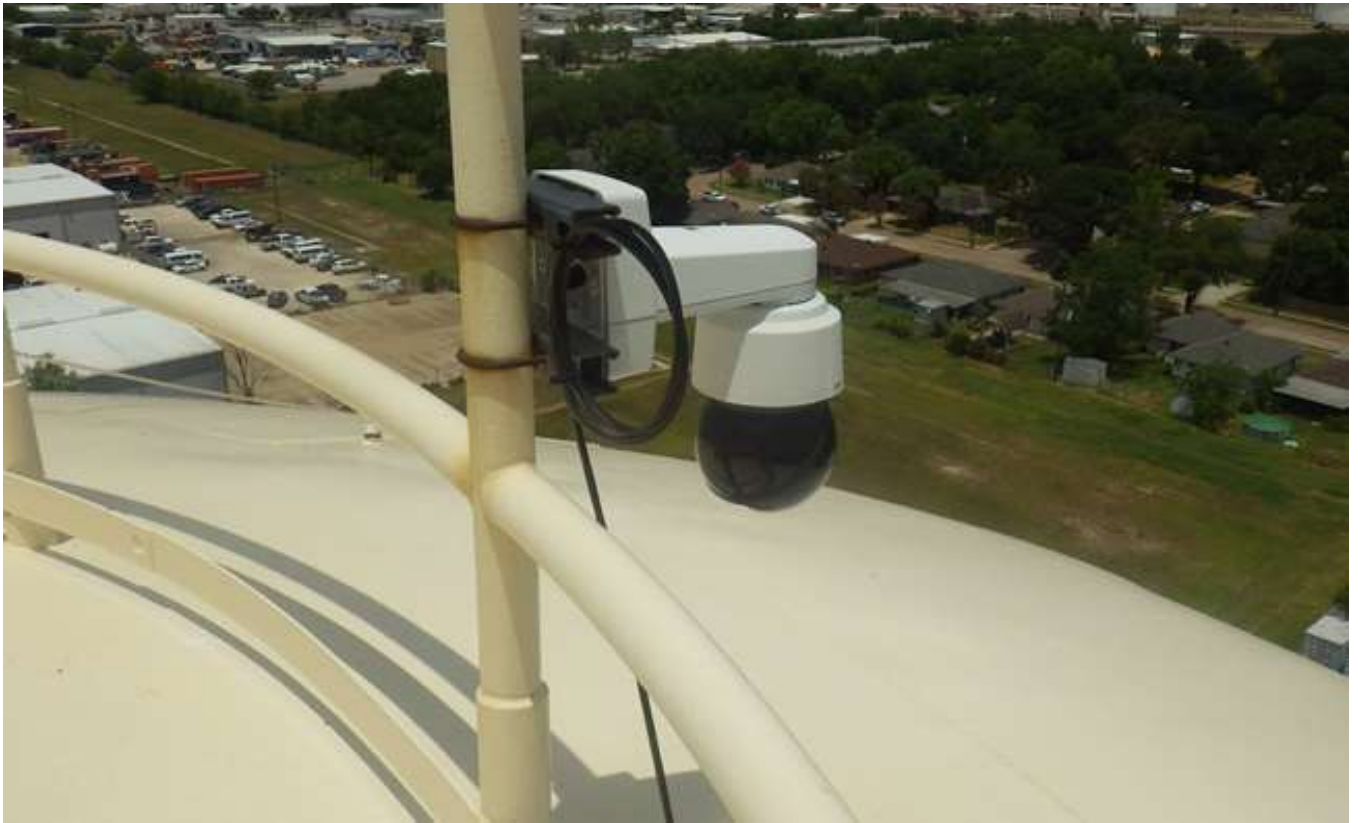
35. Surveillance camera attached to the roof safety railing.

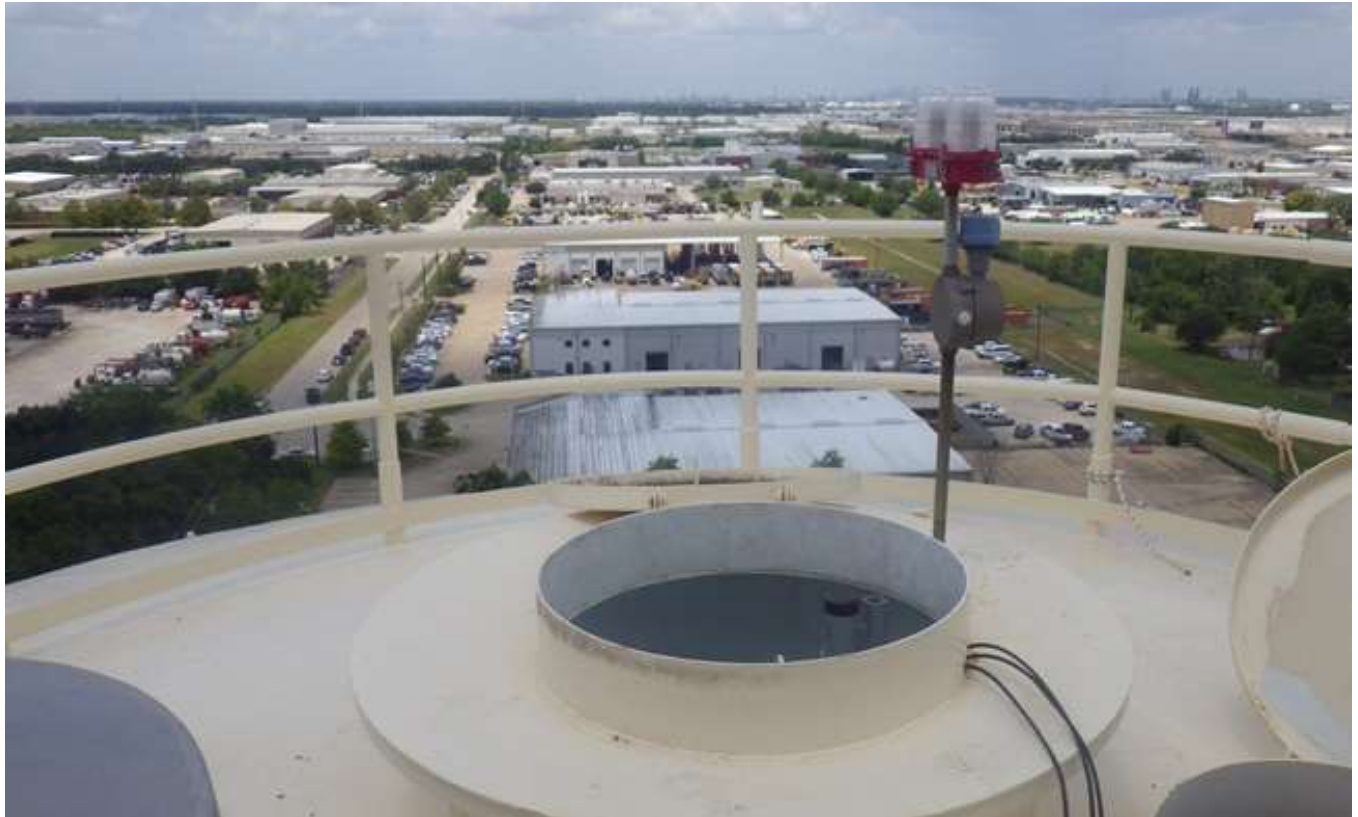
36. Roof safety railing, access tube roof manhole, and roof obstruction lights. Note cables extending through the manhole curb.

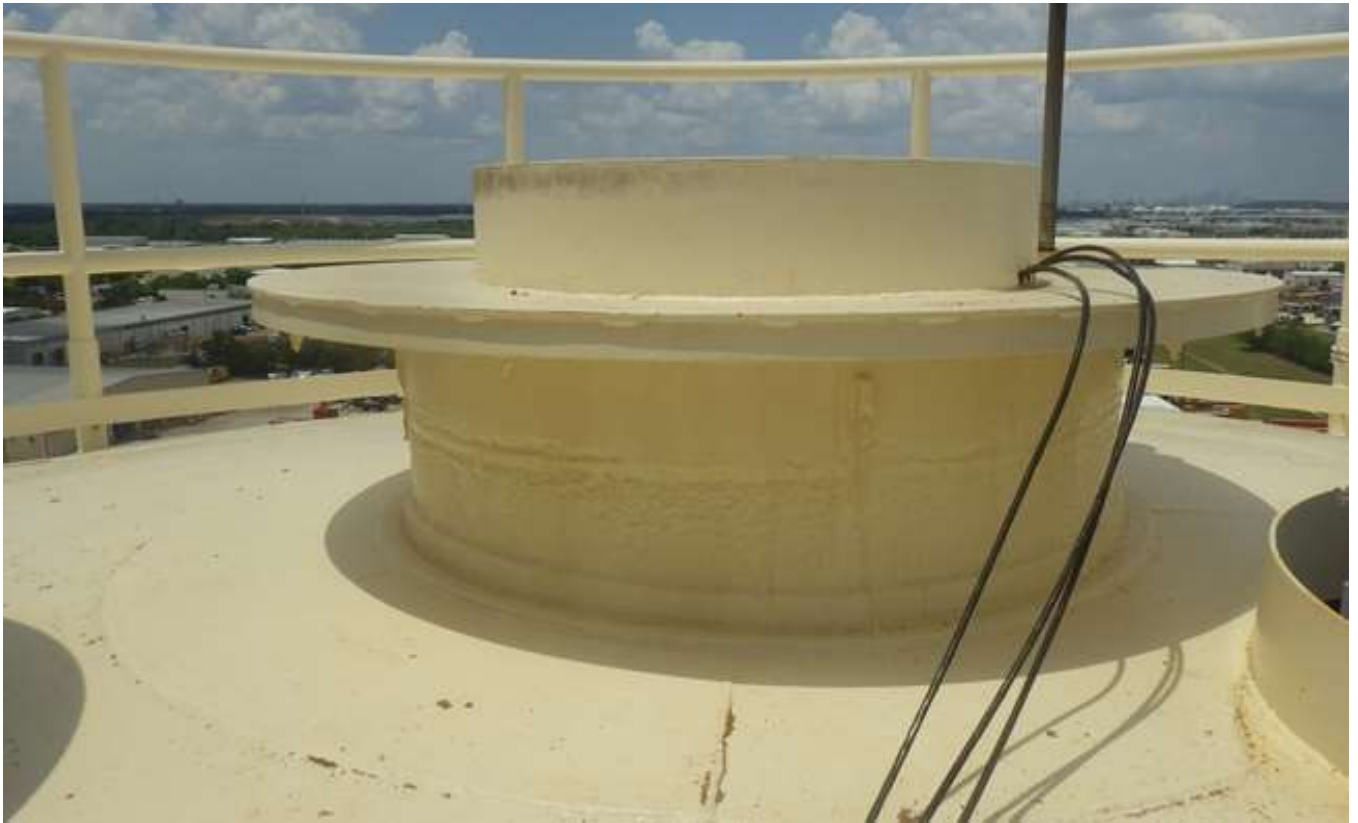
- ◆ the sand, debris, and conduits on the damaged concrete floor created a trip hazard,
- ◆ the ladder head clearance at the condensate platform manhole, top platform manhole, and access tube roof manhole was inadequate (OSHA 29 CFR 1910.23(d)(13)(ii)),

37. Access tube roof manhole. Note cables extending through the manhole curb.

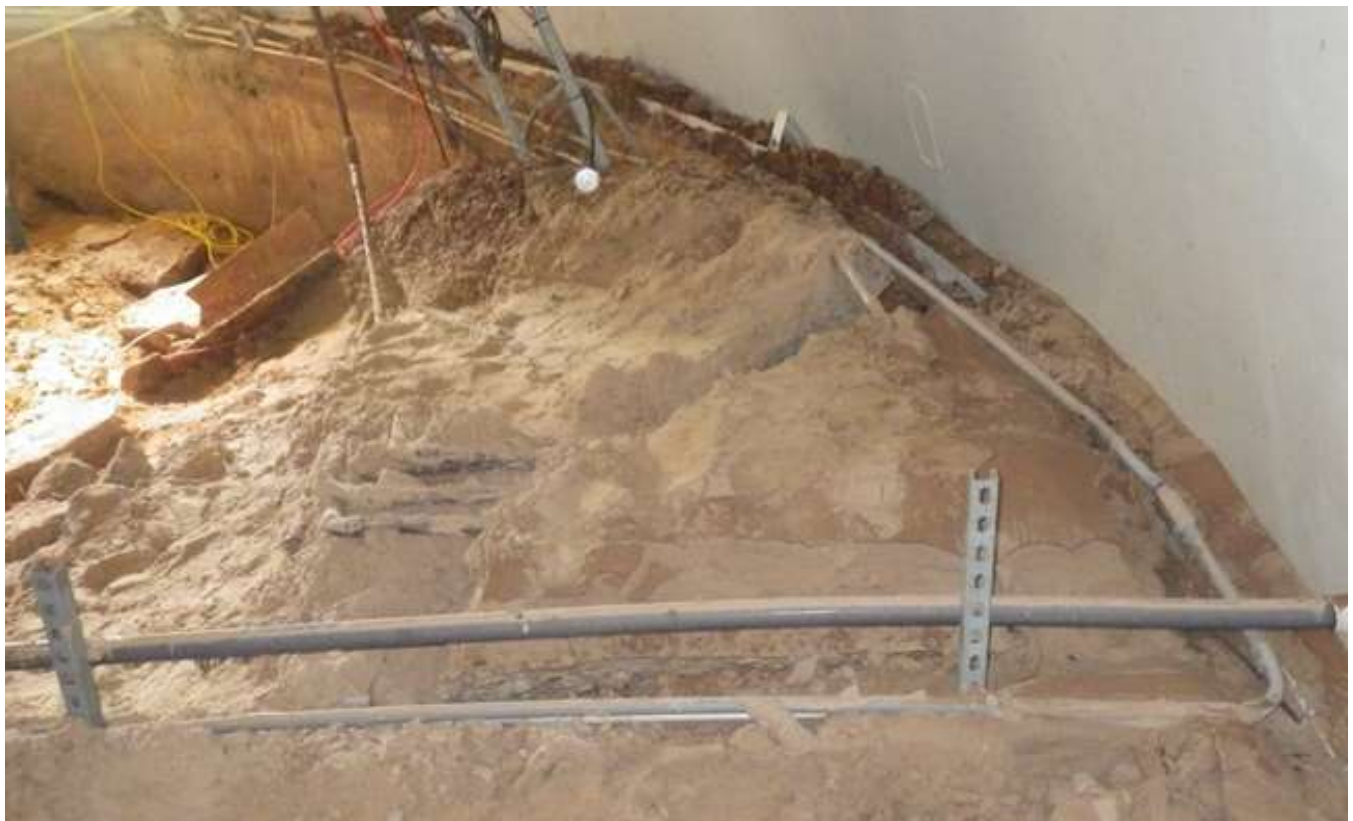
54. Conduits above severely damaged base cone floor.

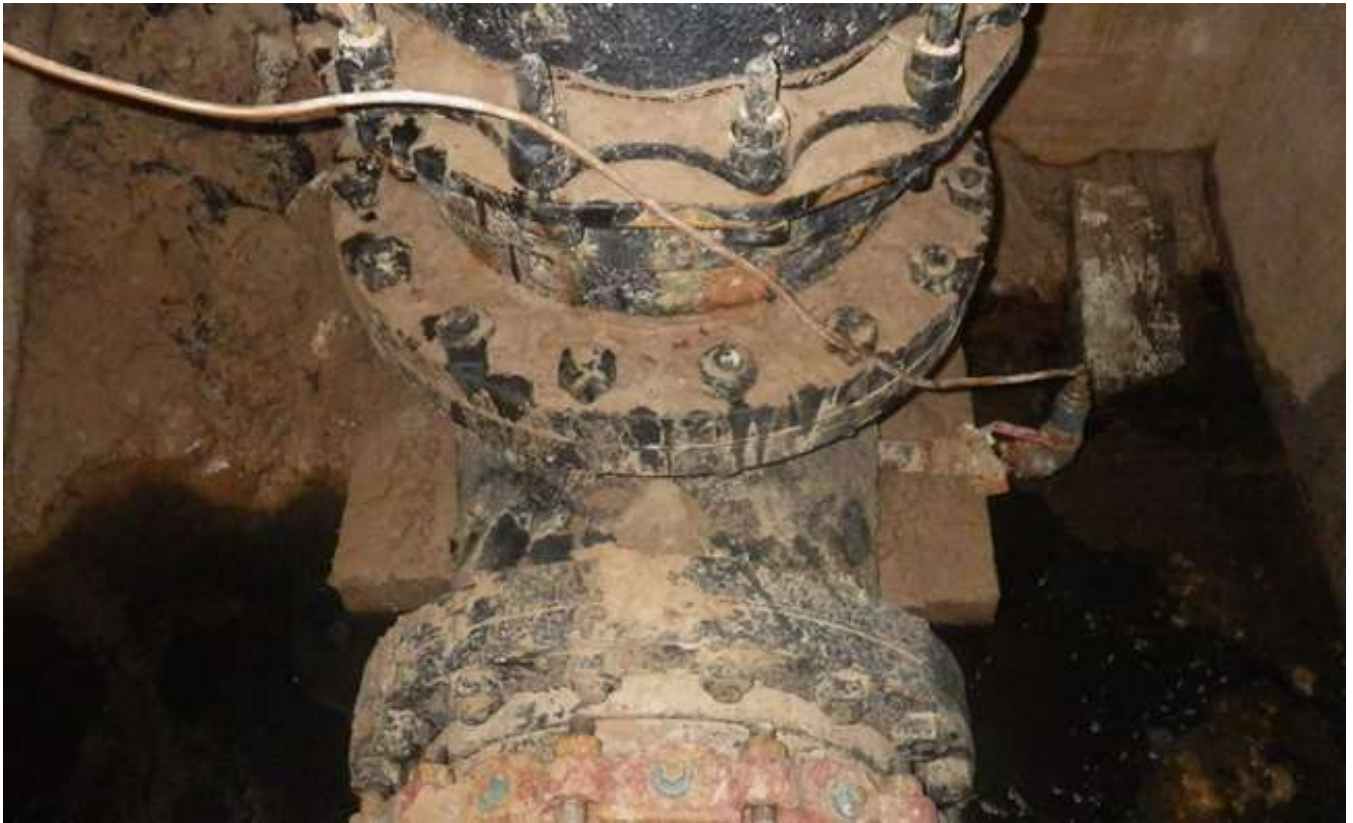
57. Piping in the pipe pit.

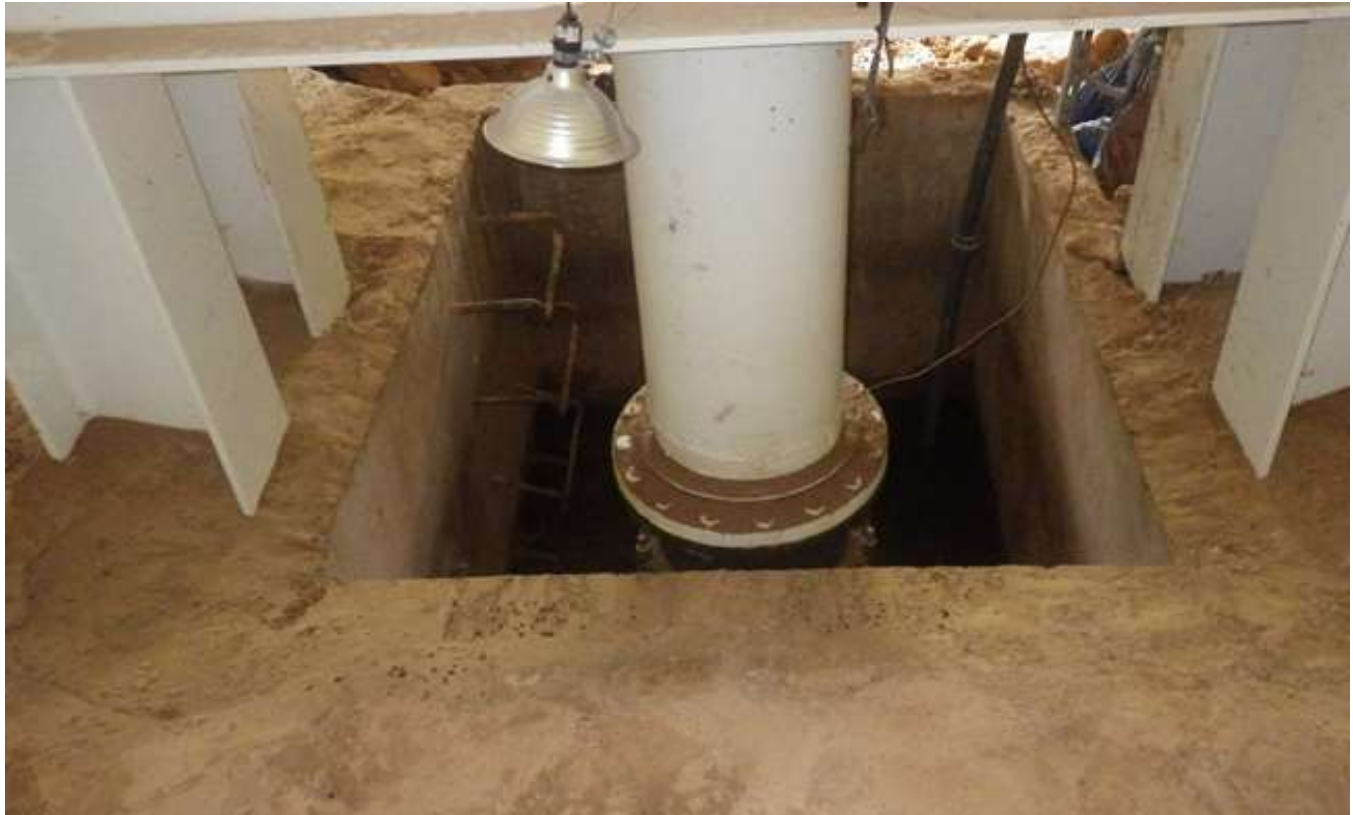
58. Inlet/outlet pipe extending from the pipe pit.

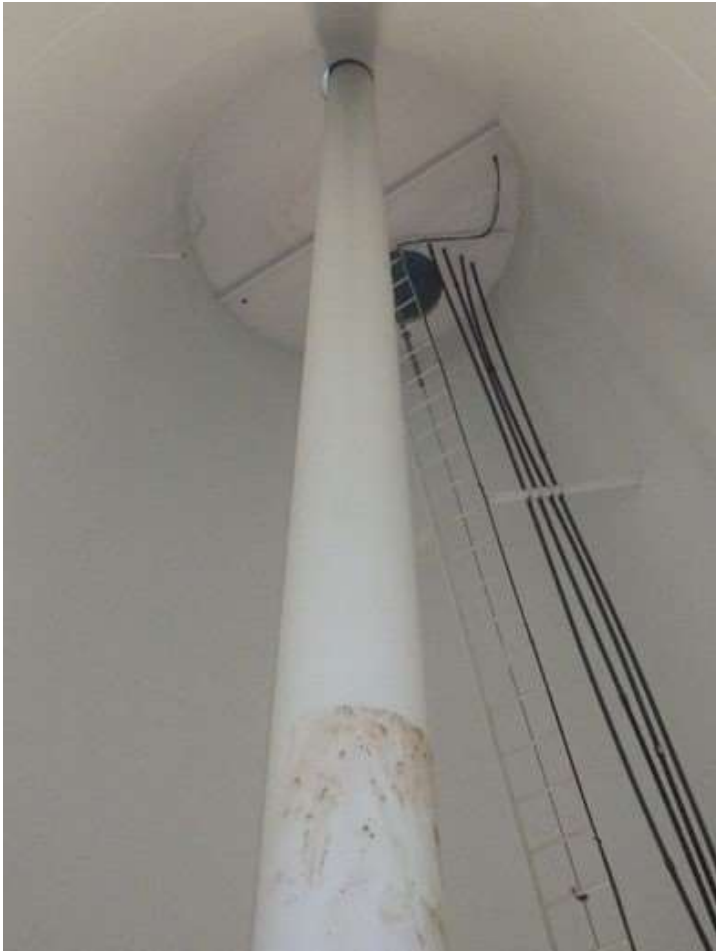
61. Inlet/outlet pipe extending up the base cone and through the condensate platform.

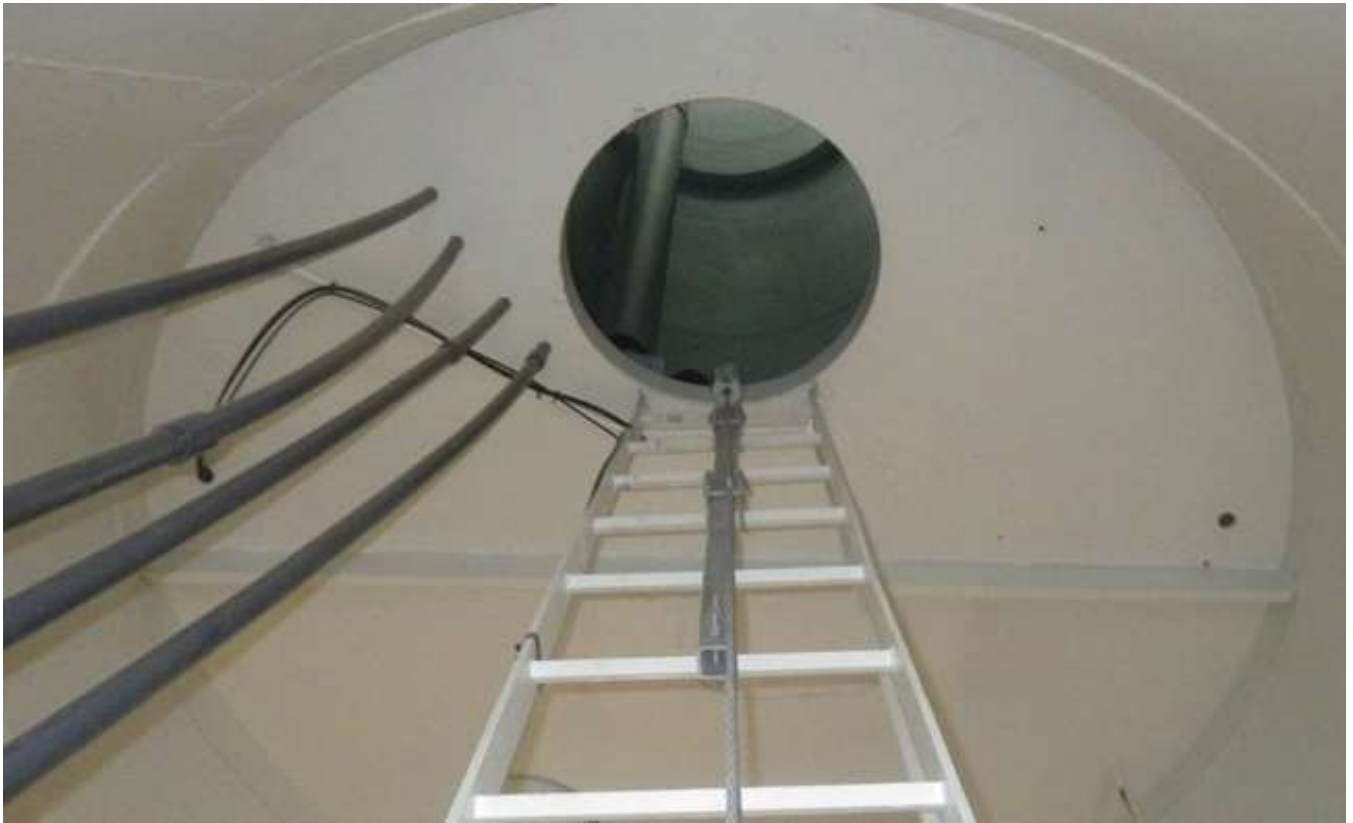
63. Base cone ladder, safe-climbing device, and cables.

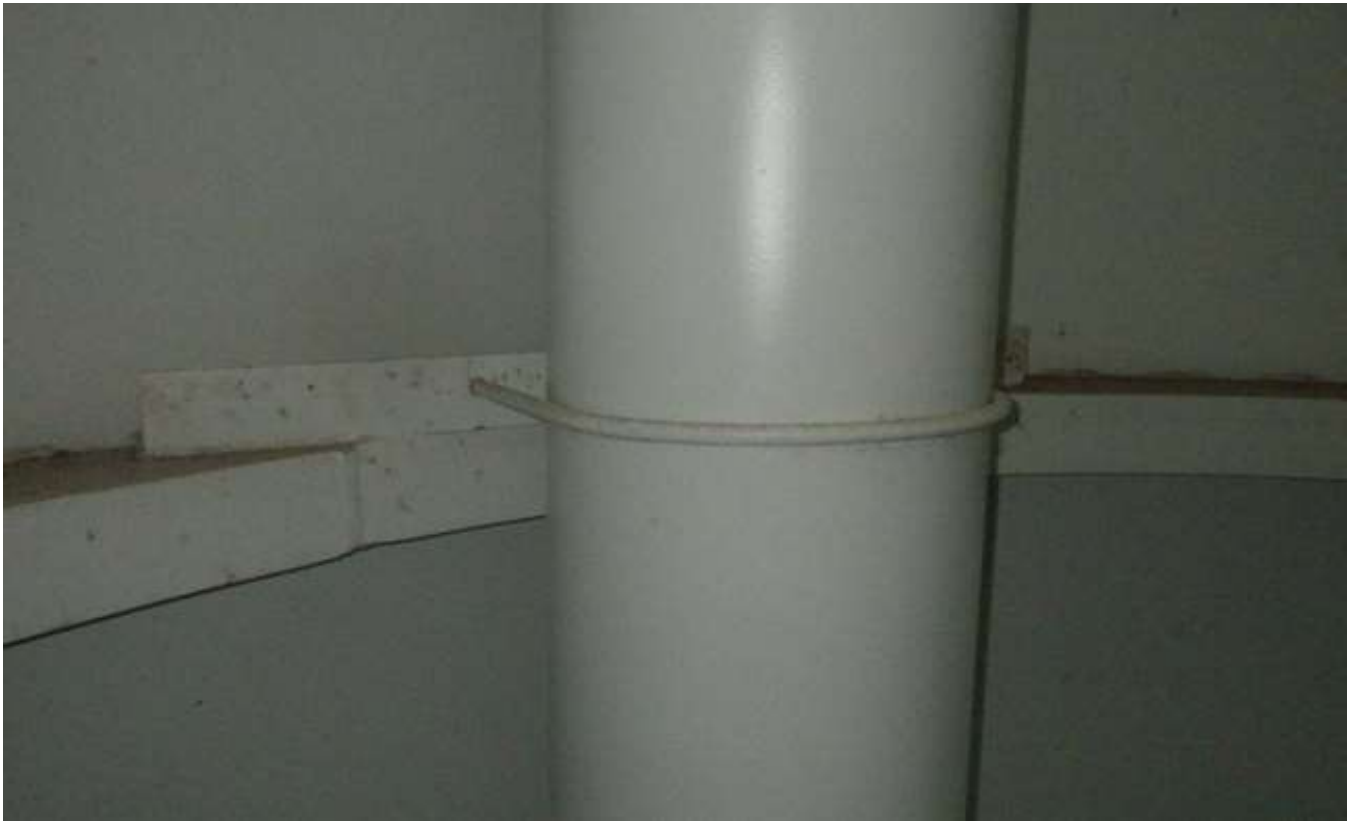
66. Inlet/outlet pipe extending up the support column.

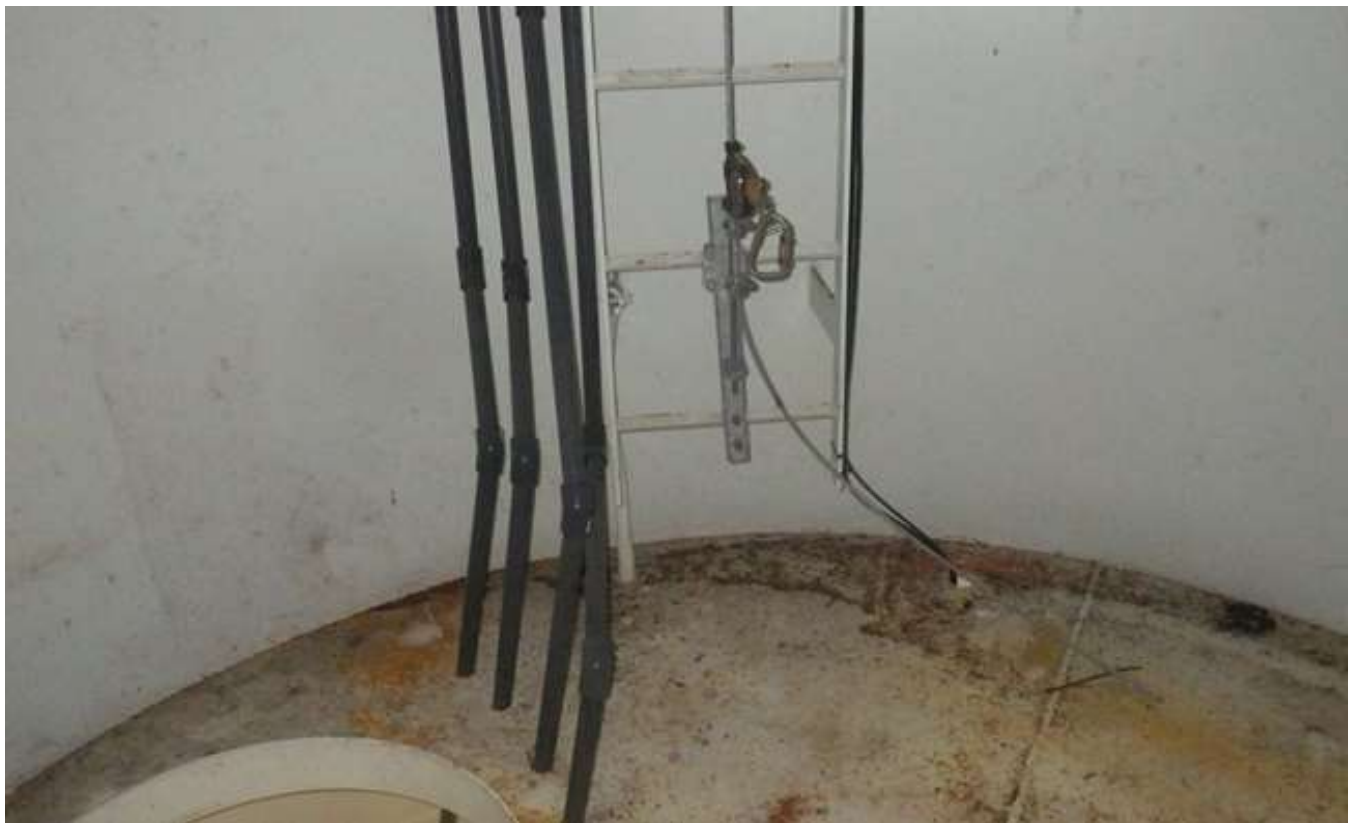
67. Inlet/outlet pipe U-bolted to bracket attached to the support column stiffener.

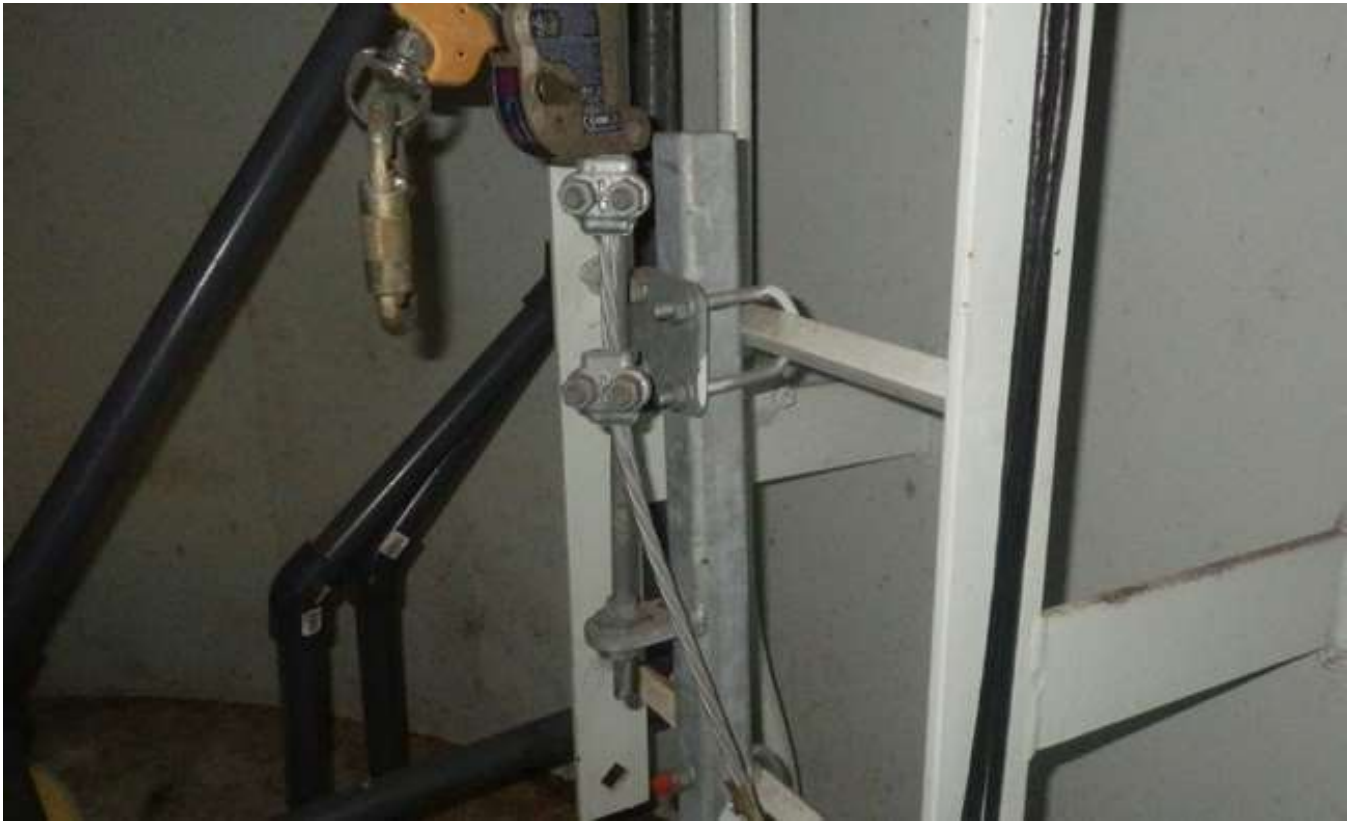
68. Support column ladder, safe-climbing device, and cables.
