EVALUATION OF THE 250,000 GALLON WELDED STEEL SINGLE-PEDESTAL SPHEROID

**“AVON STREET TANK”
DEER PARK, TEXAS**

THE CITY OF DEER PARK

July 25, 2023

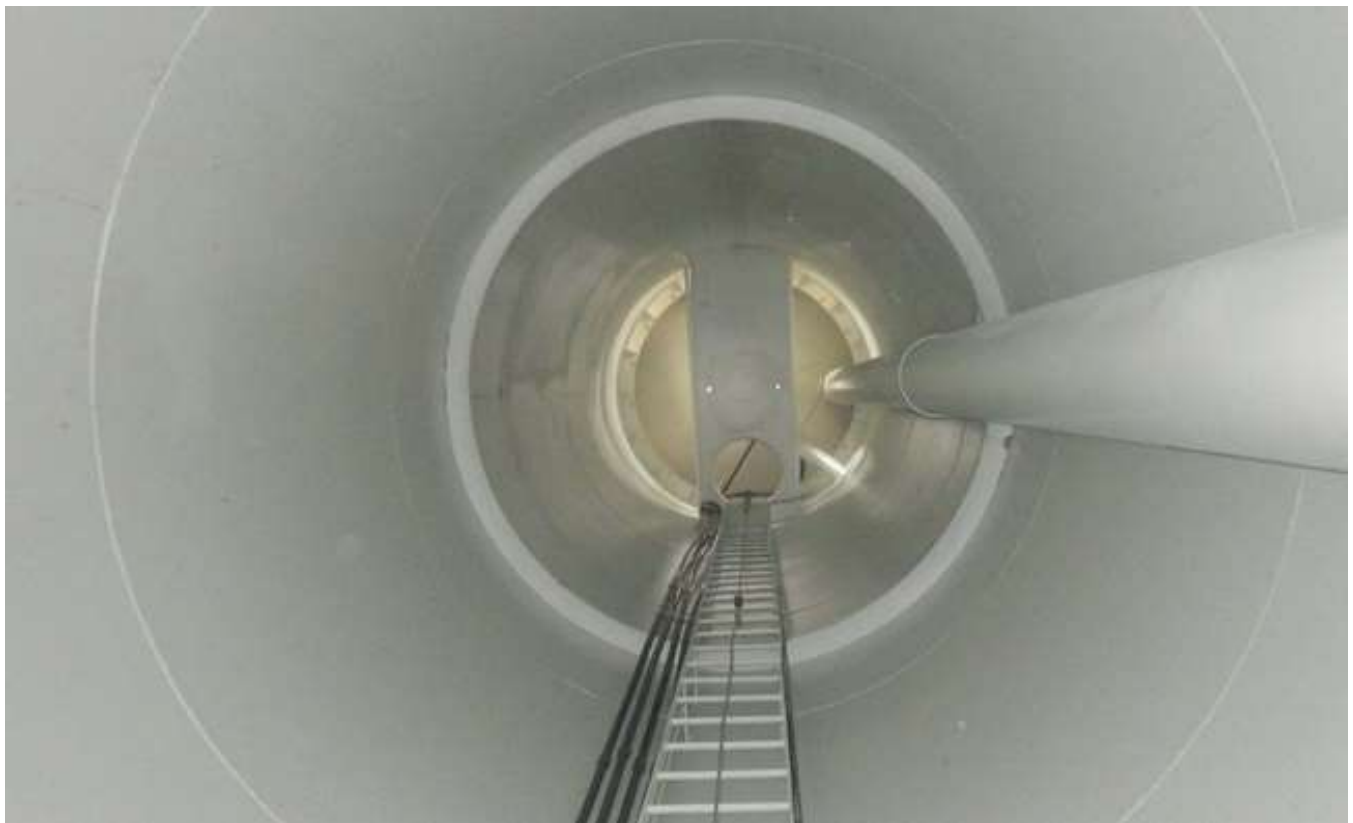
69. Support column ladder, safe-climbing device, and cables.

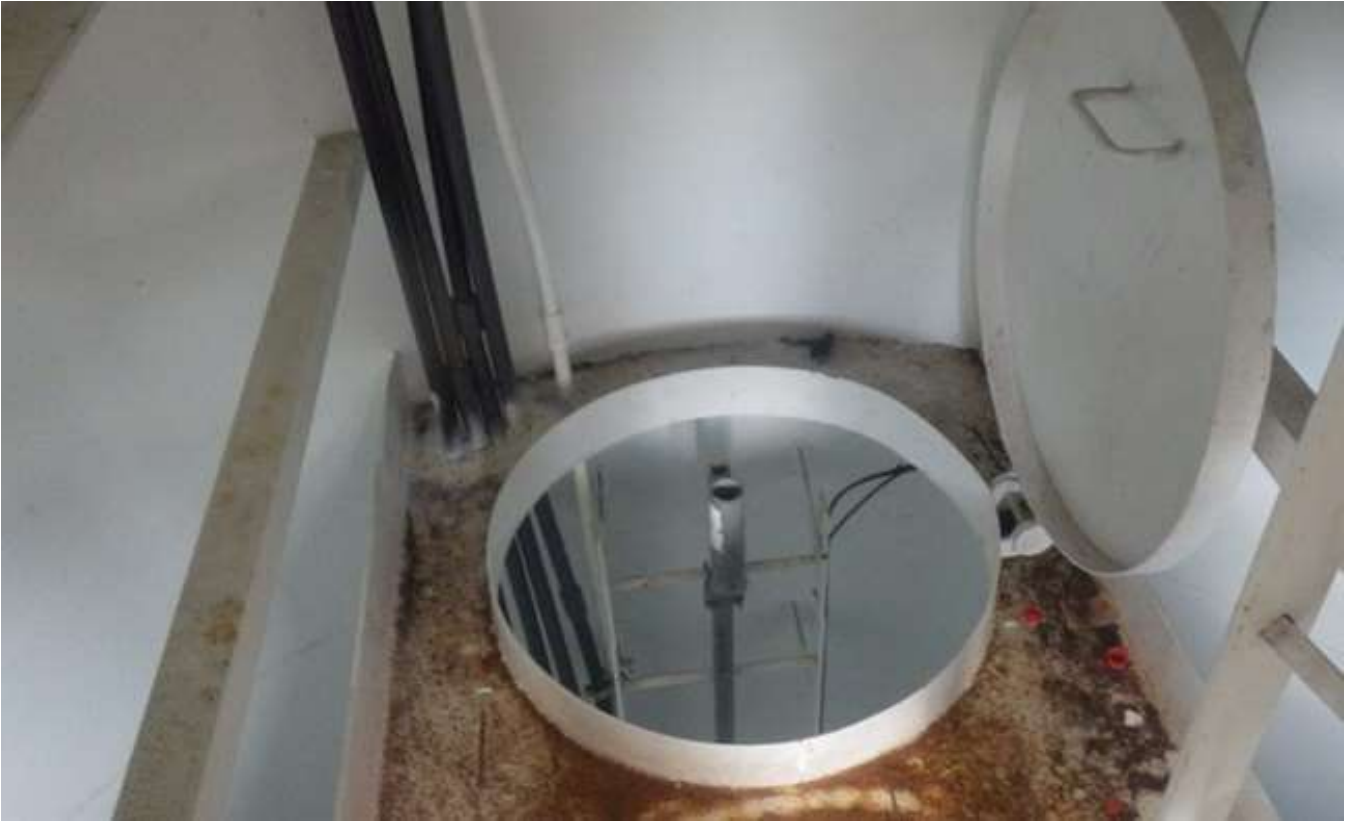
70. Support column ladder, safe-climbing device, cables, inlet/outlet pipe, and top platform.

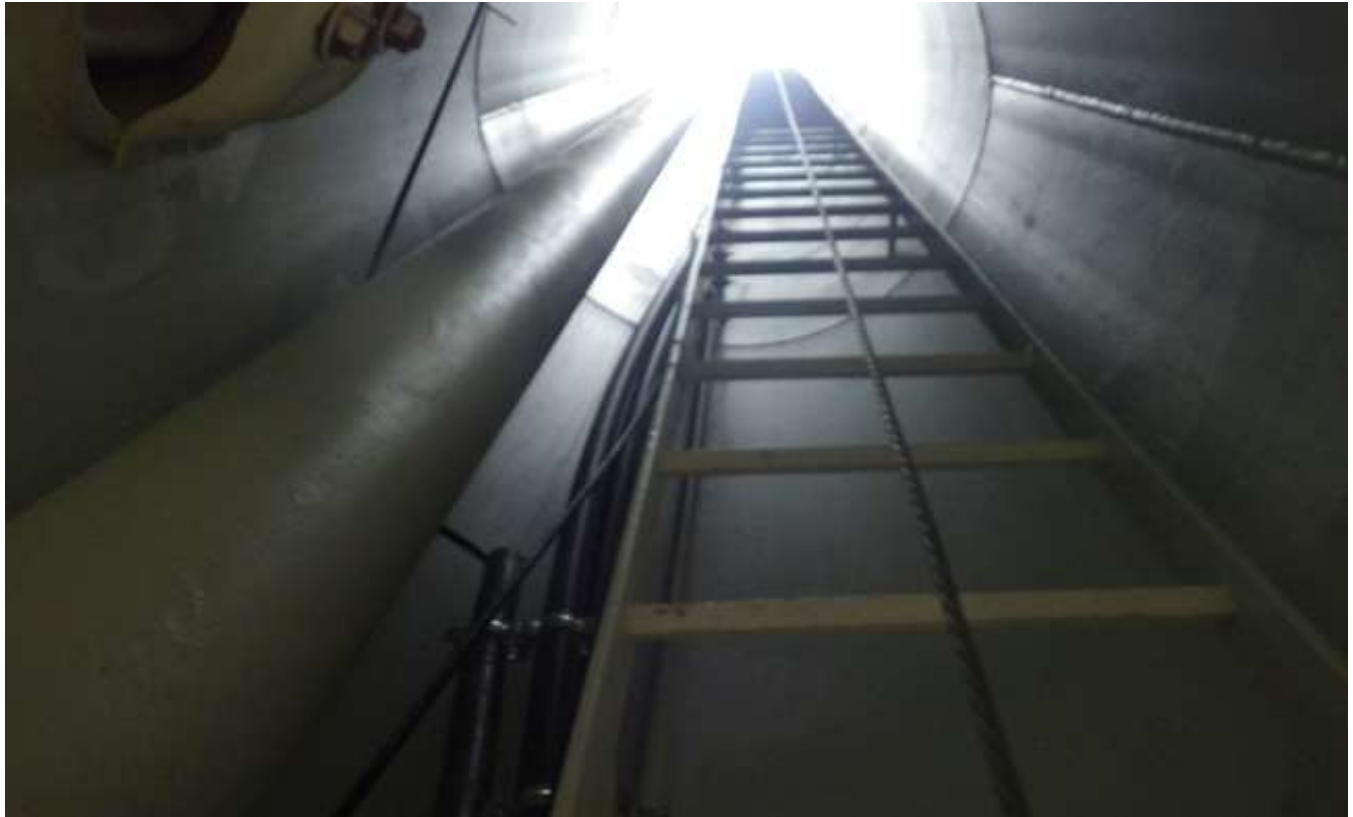
79. Interior dry access tube.

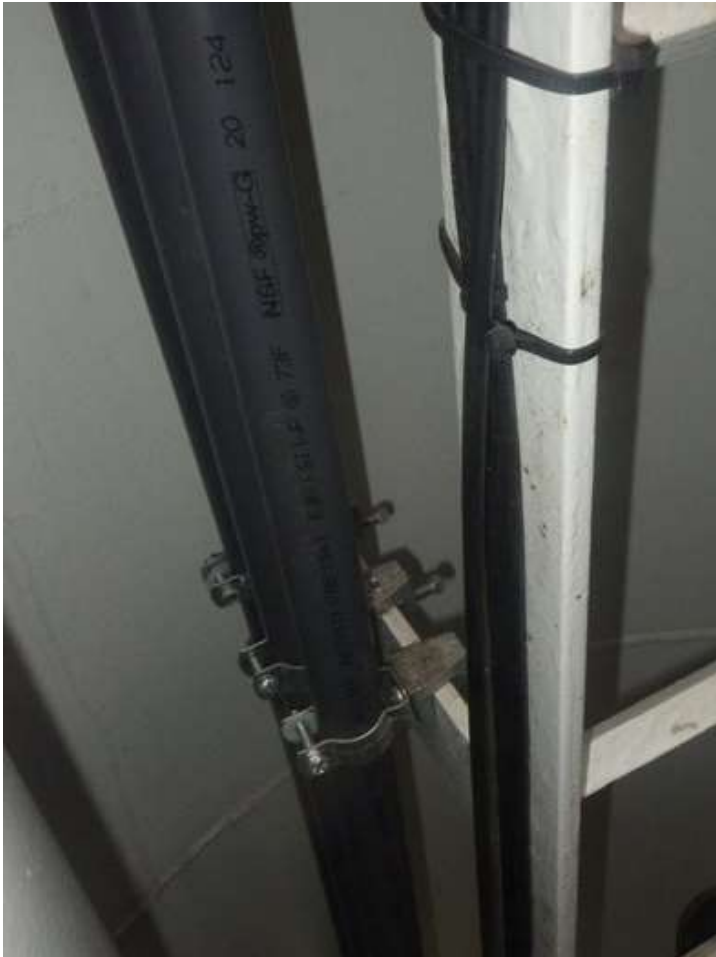
80. Interior dry access tube ladder, safe-climbing device, cables, and overflow pipe.

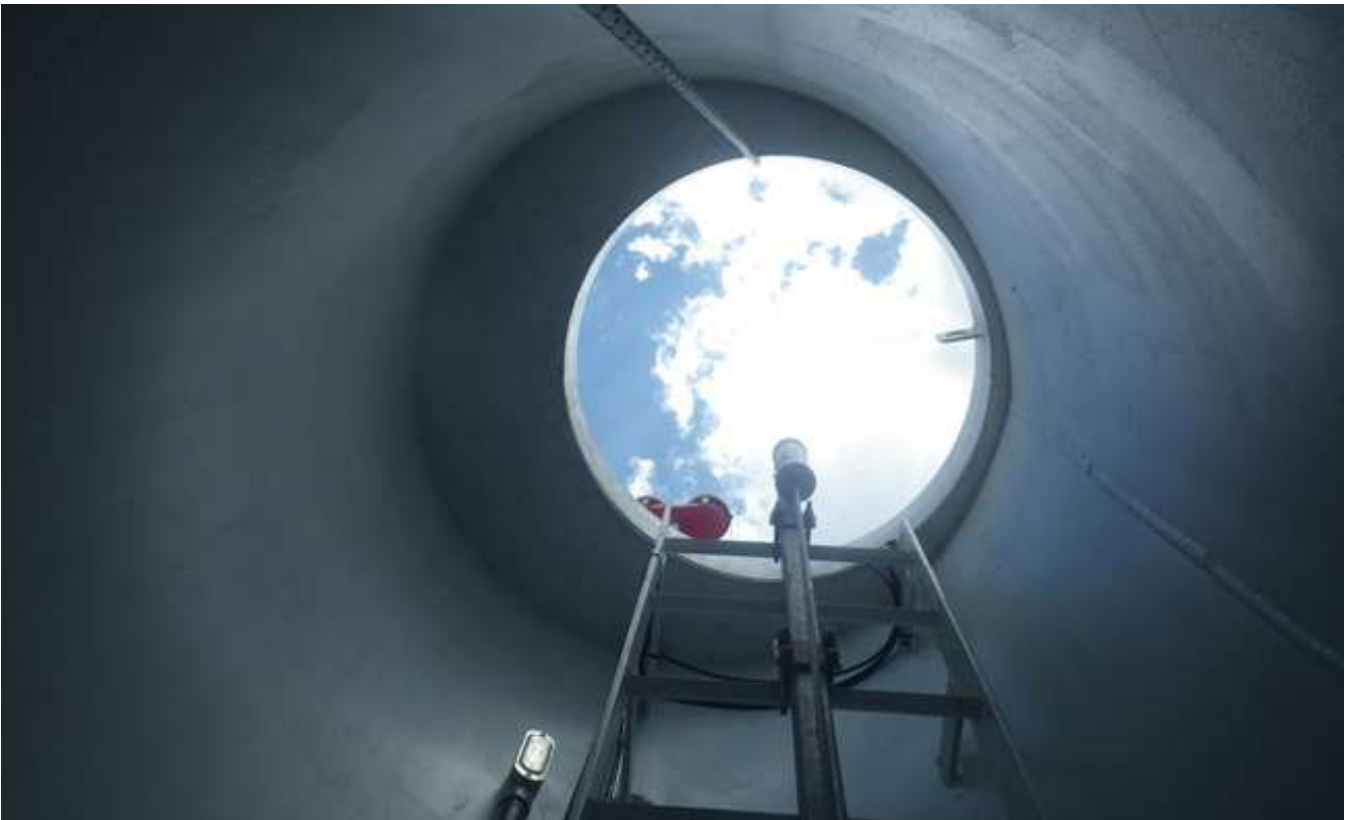
81. Cables attached to the interior dry access tube ladder brackets and side rail.

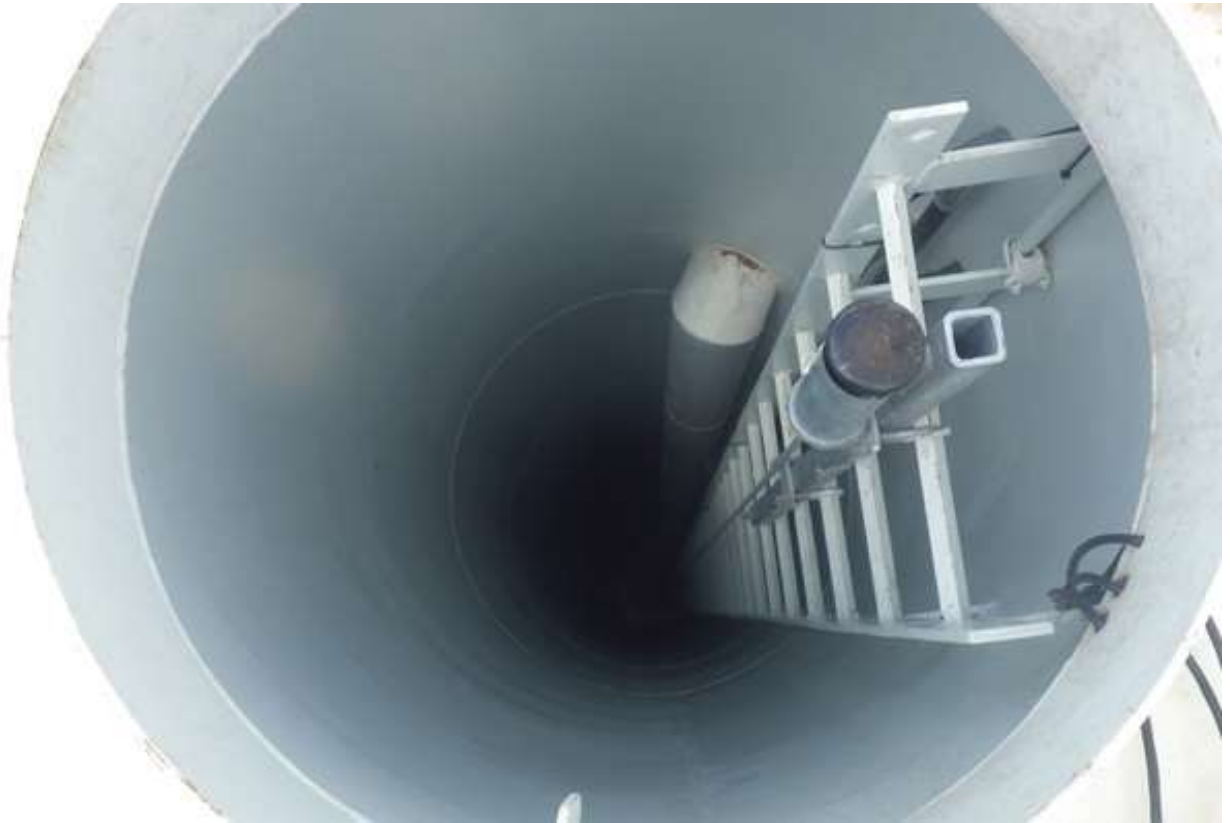
82. Interior dry access tube ladder and safe-climbing device.

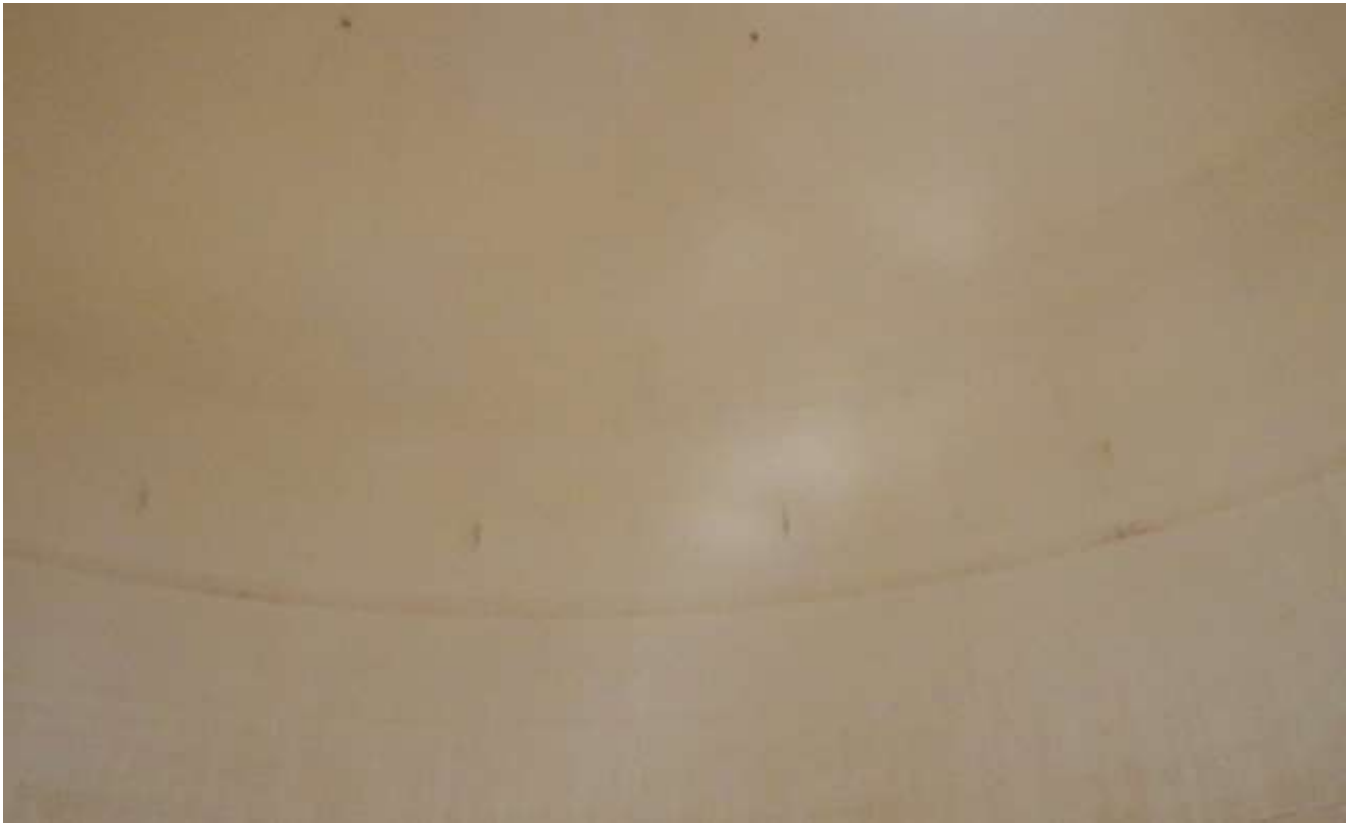
88. Minor corrosion and rust staining on areas of the roof interior.

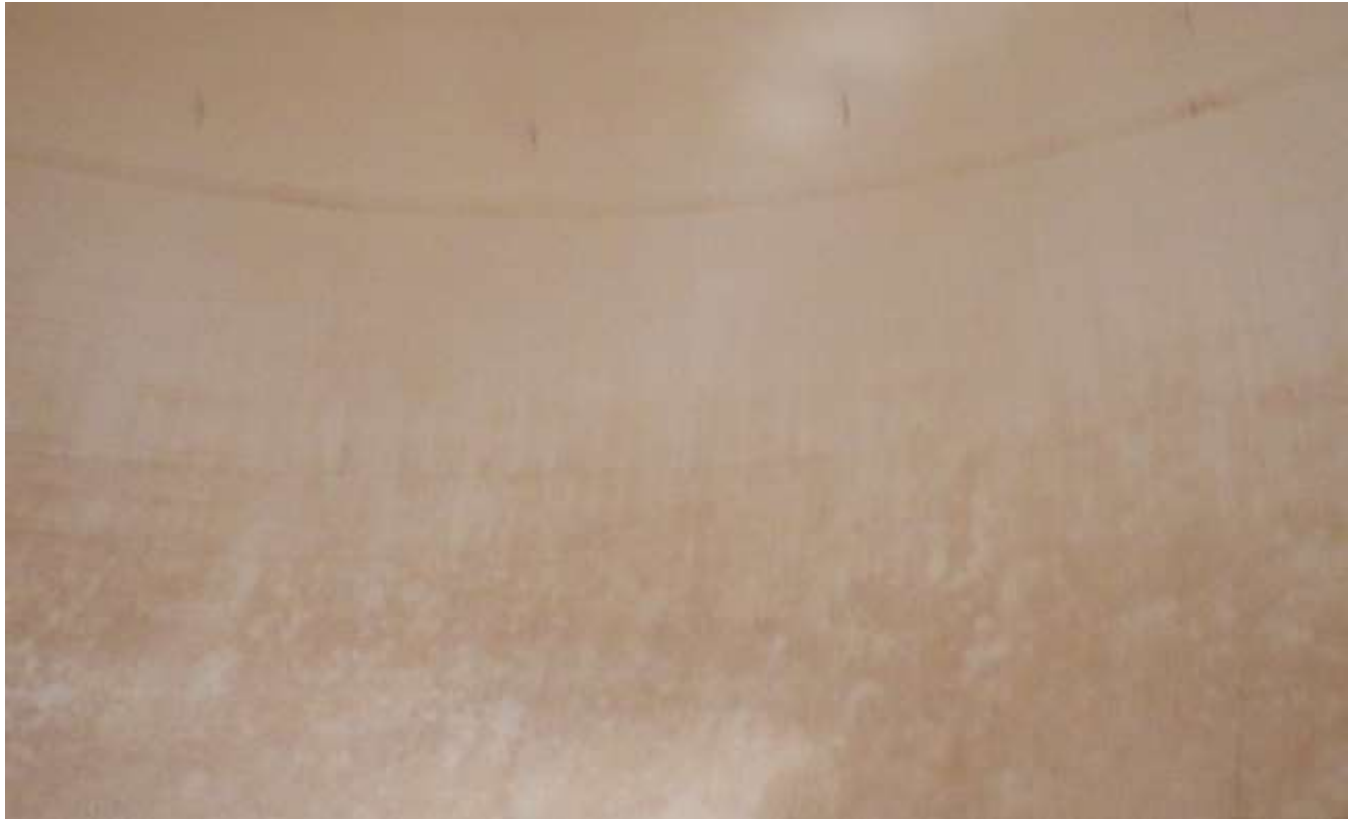
89. Roof and shell interior.

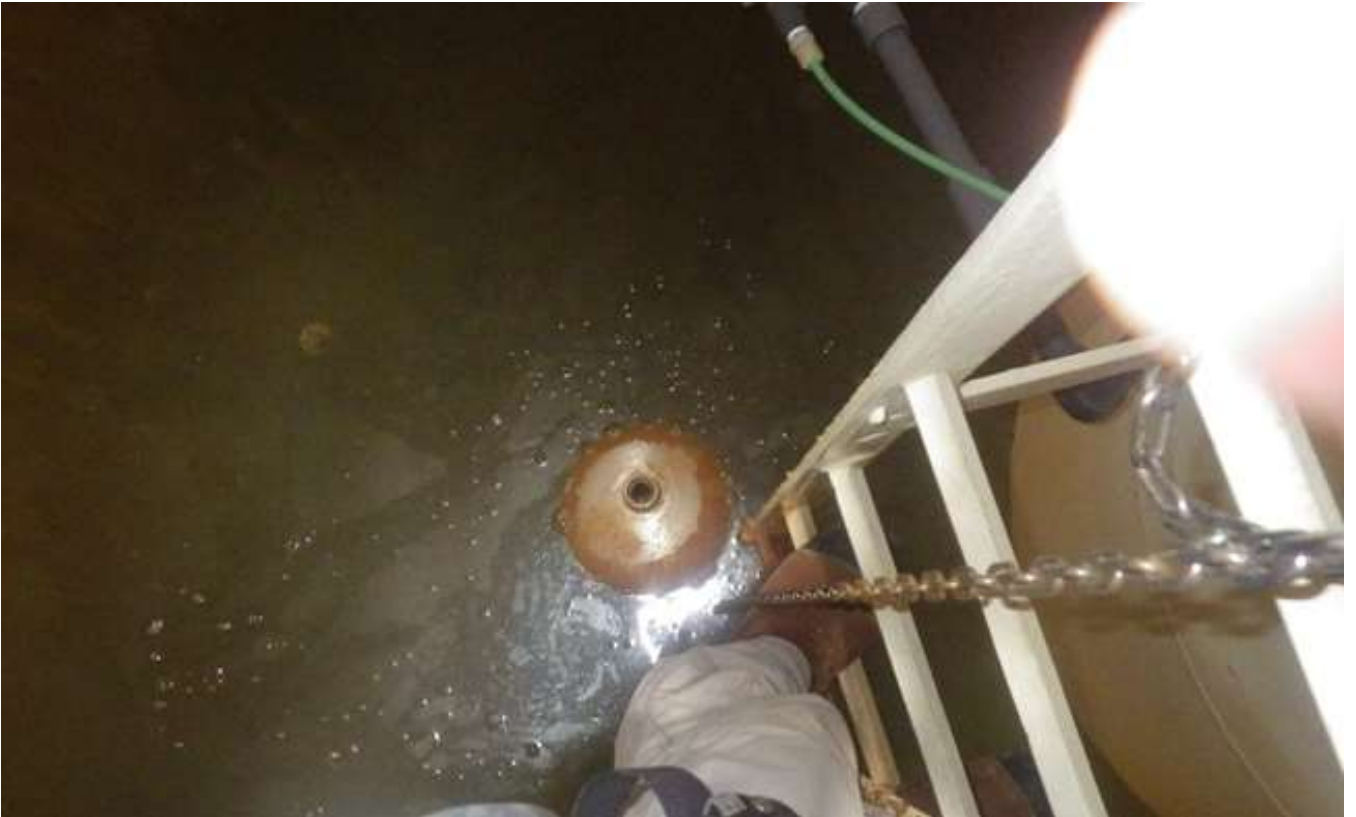
101. Equipment piping adjacent to the interior wet container ladder.

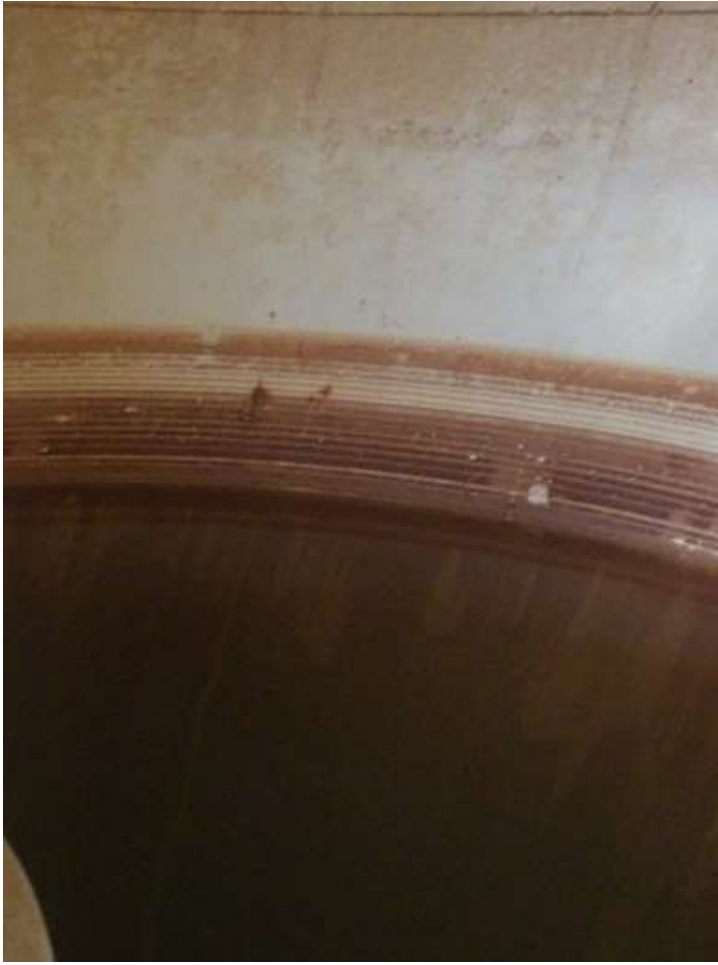
102. Equipment suspended inside the container.
