# Deer Park Community Center

Joint Workshop

July 23, 2018

## COMMUNITY CENTER – OBSERVATIONS SURVEY

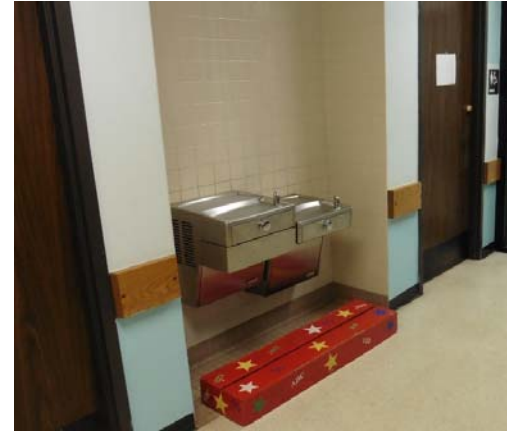
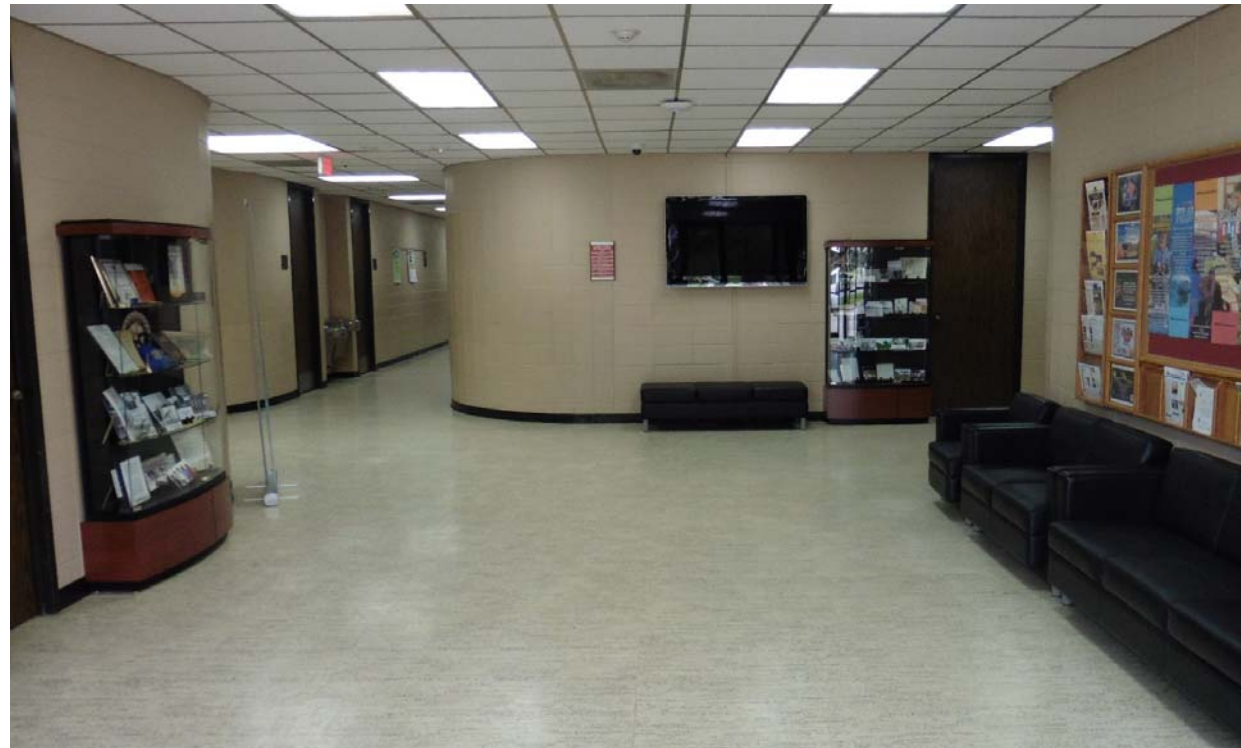
## COMMUNITY CENTER – FLOOR PLANS

- Very little of original building meets current accessibility standards
- Any significant work to public spaces would trigger necessary code related updates and improvements
- Somewhat functionally obsolete
  - Entrances & Control
  - Visibility
  - Lack of locker rooms
