CERTIFICATE OF SUBSTANTIAL COMPLETION FOR
DEER PARK GIRLS SOFTBALL RENOVATIONS PHASE I
301 WEST X STREET, CITY OF DEER PARK, TEXAS

PUNCH LIST

Project: Deer Park Softball Field Renovation

A site visit was conducted on May 1, 2019.

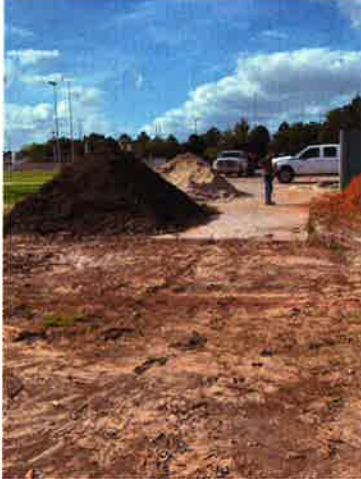
Item 8-10

7.	Fire Lane Striping at main sidewalk entrance	Finish striping the fire lane on the driveway at the main sidewalk entrance to the complex.	5/1
8.	Fire Lane Striping at hammerhead	Finish striping the fire lane at the hammer head on the west side of the new parking area.	5/1

9.	Hammerhead	Install "No Parking on Grass" sign. See sheet L1.01.	5/1
10.	Hammerhead	Remove piles of dirt. Coordinate with the City on where they want the dirt relocated. 5/1 Update: Per Eugene Wyble, City requested the dirt piles remain on the pavement. Eugene stated the Fire Marshal had no objection to the fire lane turn around being blocked.	5/1

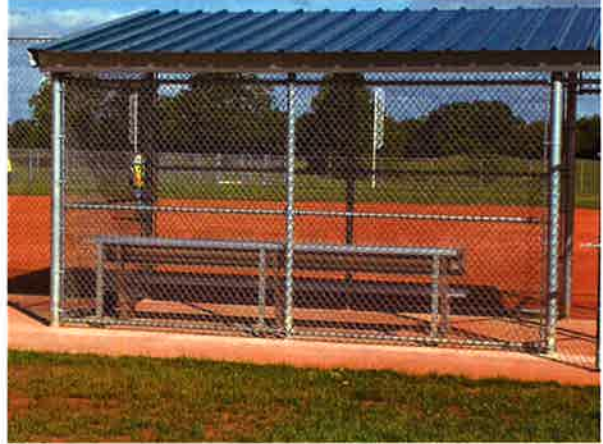
Item 12-14

11.	Electrical Conduit	Cut all electrical conduits to grade. 5/1 Update: This item has not been completed.	5/1
12.	Dugouts	Check the dimensions of the dugouts. See detail 3 on sheet L3.06 for dimensions. 5/1 Update: Unknown if this was completed. Tandem to verify and provide an update.	5/1

13.	Dugouts	Verify the placement of the player bench within the dugouts. See detail 3 on sheet L3.06 for dimensions. 5/1 Update: Per Eugene Wyble, this item was not completed. Eugene to coordinate with City staff to decide on if the benches need to be moved or can remain in the current location.	5/1

14.	Dugouts	All dugout outlets need to be accessible. Any outlet that is not centered on the fence, should be turned 90 degrees to face the fields. 5/1 Update: This item has not been completed.	5/1

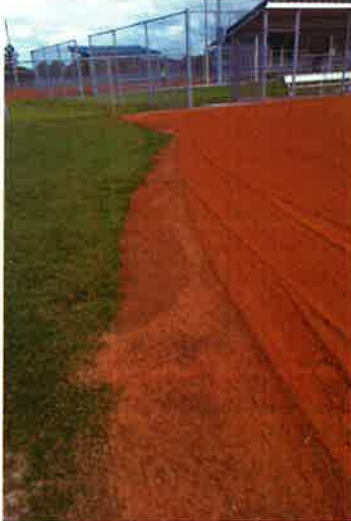
| 33. | All fields | Lip issues at each field is impeding infield drainage. It is imperative that surface drainage flow across infield, lip and out the back of field (outfield fence) effectively. Nearly every field has sod too high at lip, the migration of red dirt into the turf was not part of the grooming |

procedure, and some instances the infield grade dips lower than the lip area.

Item 26: applies to all fields, lip condition

26.	Play fields	See attached notes on site plan for play field punch items. 5/1 Update: Play fields are not ready for use and thus the check will be completed when the fields are ready. See below for updates to the punch list based on the preliminary review.	
	Field #1	<ol style="list-style-type: none"> 1. Low spot in right center field 2. Low spot at outfield fence 3. Center to left field – re-nozzle as needed to match GPM with rotor pattern 4. Center to right field – re-nozzle as needed to match GPM with rotor pattern 5. Dead grass behind 3rd base 6. Edge the infield lip then chemically eradicate spreading bermuda (runners) on the clay surface 	
	Field #2	<ol style="list-style-type: none"> 1. Dead grass behind 1st and 2nd bases 2. Low spot at outfield fence (center field) 3. Irrigation head off at 3rd base 4. Edge the infield lip then chemically eradicate spreading bermuda (runners) on the clay surface

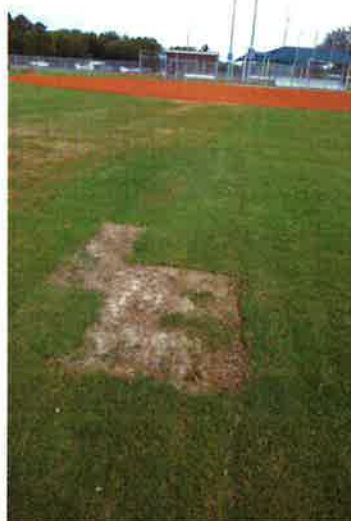
Field #3	<ol style="list-style-type: none"> 1. Low spot at lip behind 1st & 2nd base 2. Dead grass center field 3. Edge the infield lip then chemically eradicate spreading bermuda (runners) on the clay surface 	
	Field #4 (practice)	<ol style="list-style-type: none"> 1. Several dead grass spots throughout outfield

Item 26: applies to all fields, dead grass patches

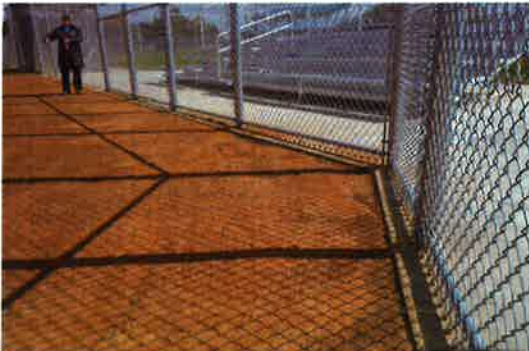
Item 32:

| 32. | All Fields | Red dirt elevation is too low at backstop curbing. This 1"-1½" exposed lip will create a playability issue. Raise elevation to flush with top of backstop curb |

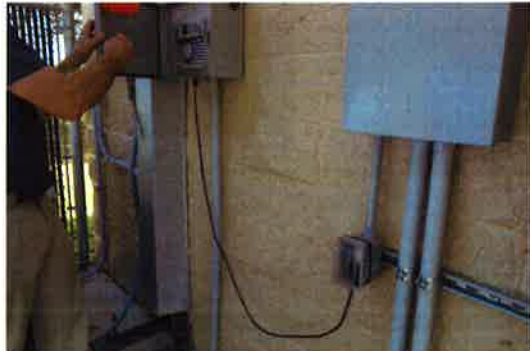
Item 34:

34. Irrigation
 controller

Place electrical cord in conduit. Intent of contract documents was to hard wire the electrical connection and not have a plug-in connection for the controller. Hard wire connection is required.
