# Building Observations Survey ©2016

## Deer Park Community Center Deer Park, Texas

**Building Survey for Deer Park Community Center,  
610 East San Augustine Street, Deer Park, Texas**

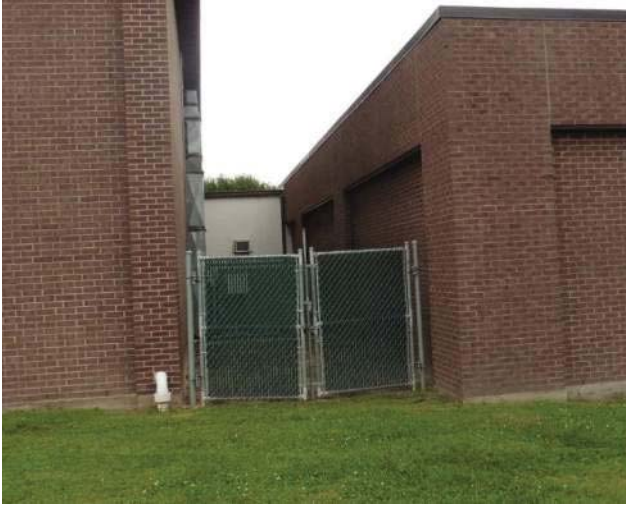
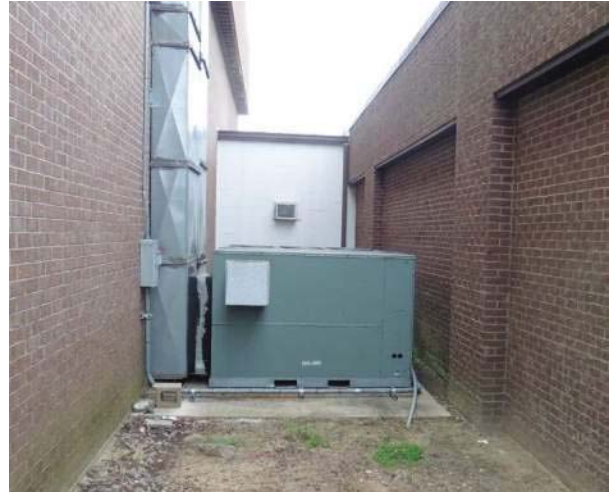
Mechanical courtyard between community center and gym

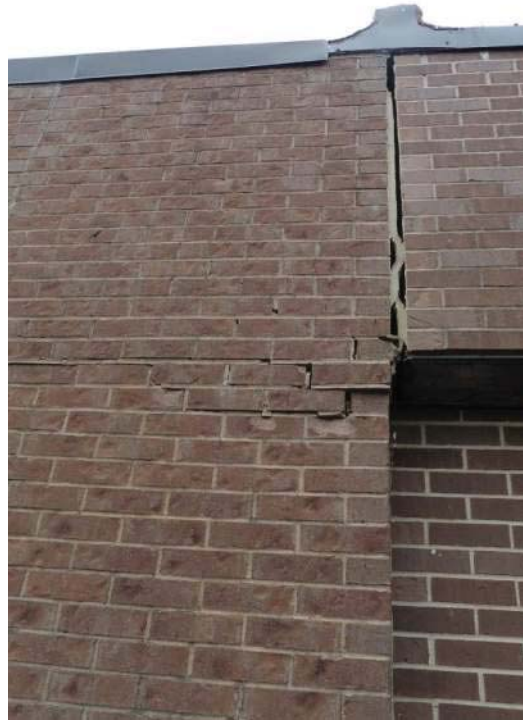
As noted elsewhere in this survey, the community center (especially the addition) has been experiencing significant structural movement for some time. This movement manifests in cracking and separation of cladding materials, which is creating unacceptable water intrusion and water damage. These are significant problems which must be continually maintained and patched. However they are symptomatic of larger challenges and cannot

Examples of structural movement damage

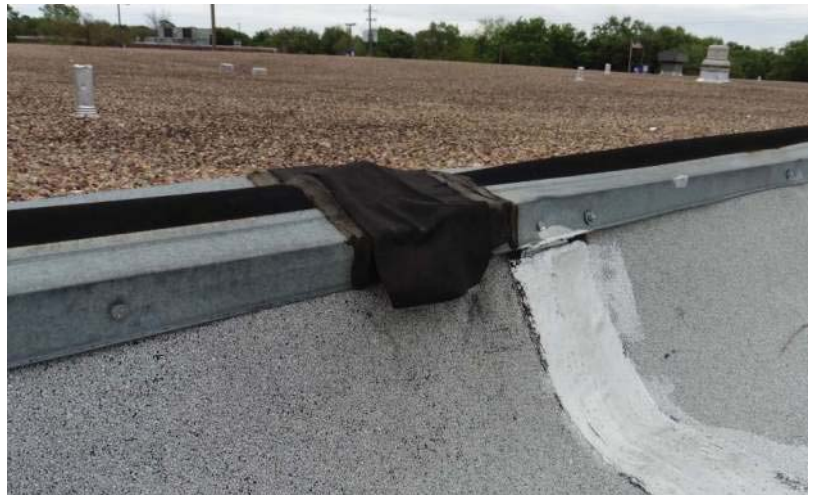
As for the addition, the record drawings are not clear with regard to roof slope, but it visually appears to be proper, or at least more sloped than the original. It is a gravel ballasted built-up roof, so the membrane was not directly observed. Evidence of minor ponding was observed. The addition is also internally drained, having primary and secondary systems. The expansion joint between the two roofs shows signs of movement and ongoing repair, but stops at the edge of the building. We find it unusual that the expansion joint does not continue down the exterior walls between the old and new. Significant movement at these locations is evident as spoken to elsewhere in this survey. According to the record drawings, the addition has 3" of roof insulation. This is also insufficient by contemporary codes.

Condition of roof at addition

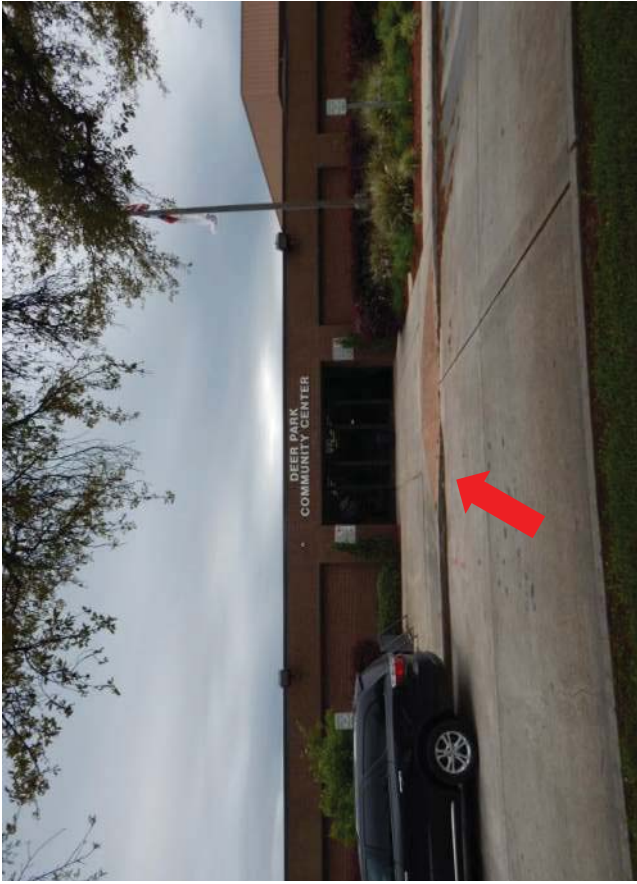
#1 Photo of front entry

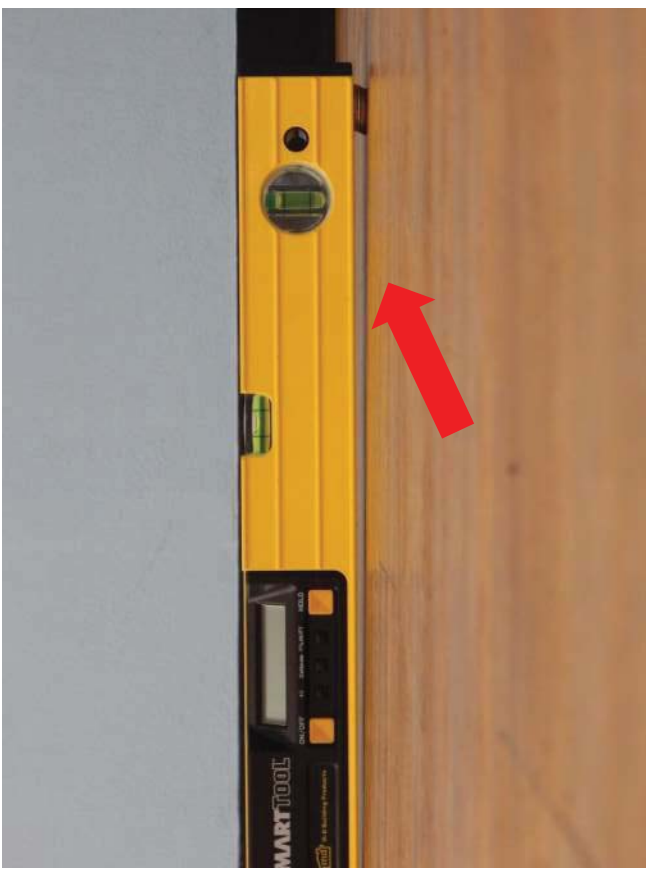
#43 Level on floor showing sloping down toward the North East corner at approximately 1/8" per foot

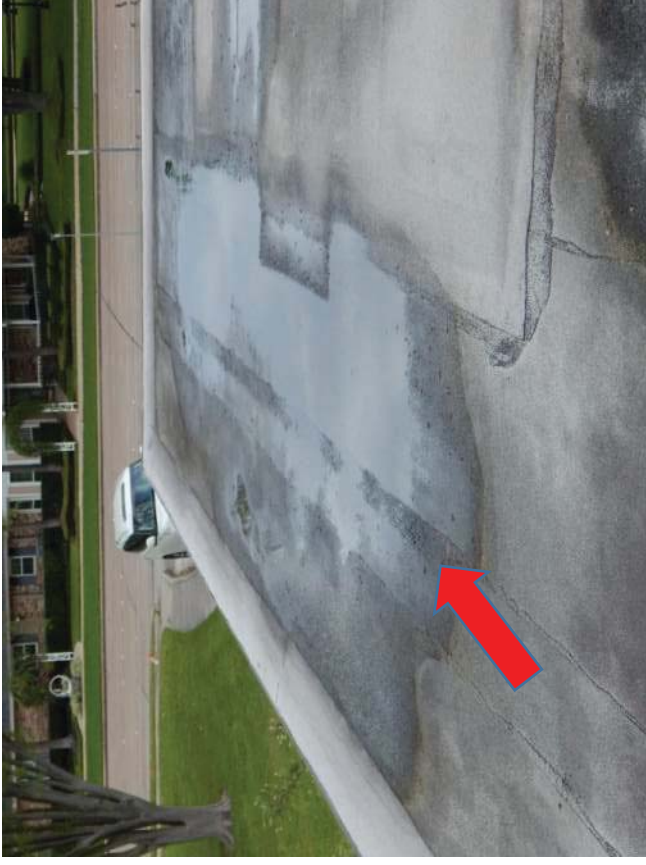
#51 Roof over phase one of community center showing standing water

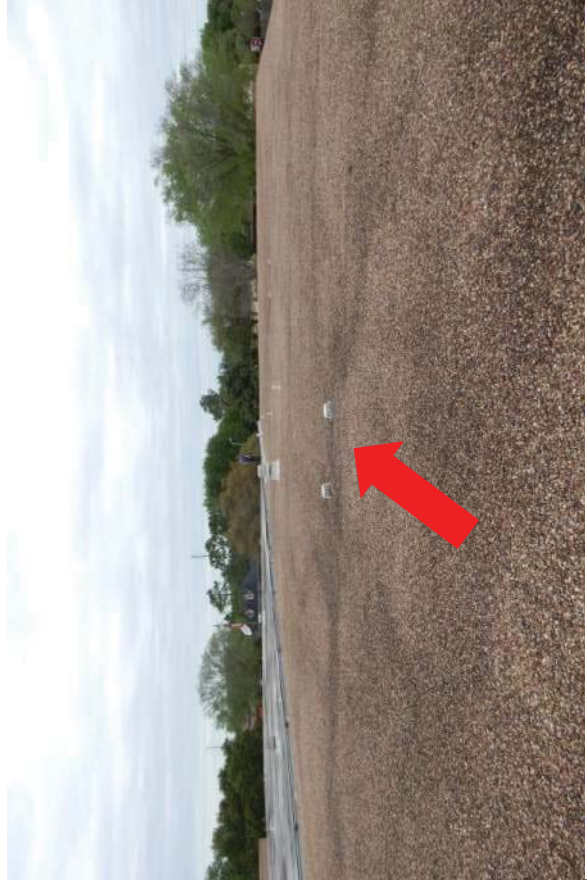
#53 Roof over phase two of community center showing roof drain and emergency drain

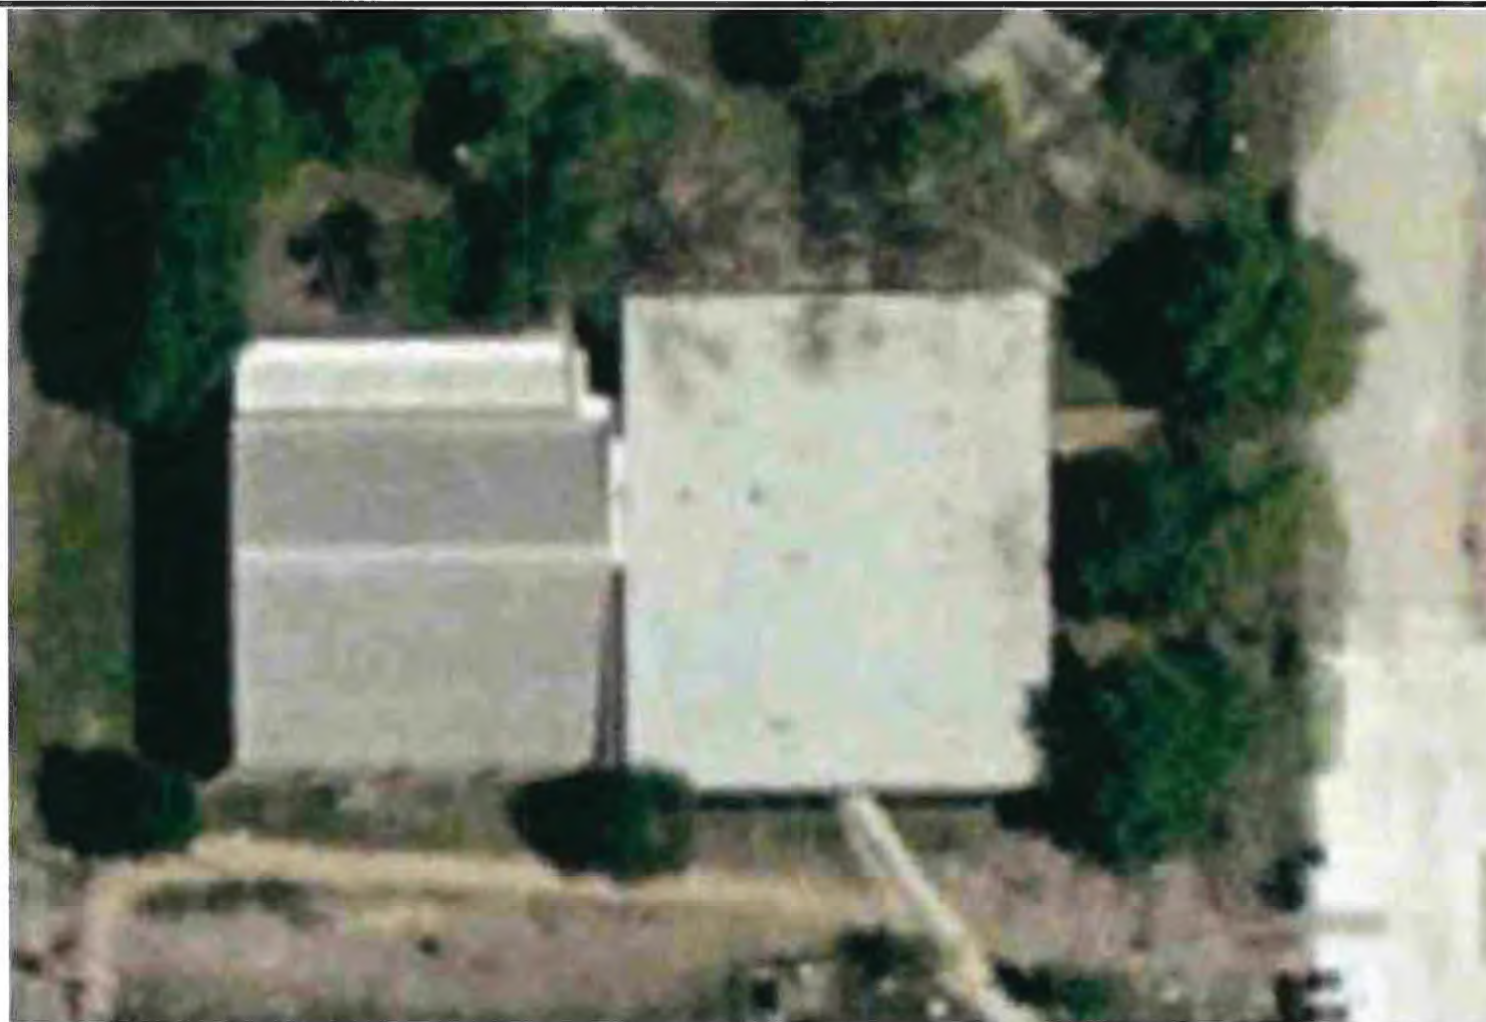
**Figure 9 – Aerial Site Plan April 2006**  
**Deer Park Community Center**  
**Deer Park, Texas**  
Source: Google Earth  
Terracon Project No. F3128529  
September 30, 2013

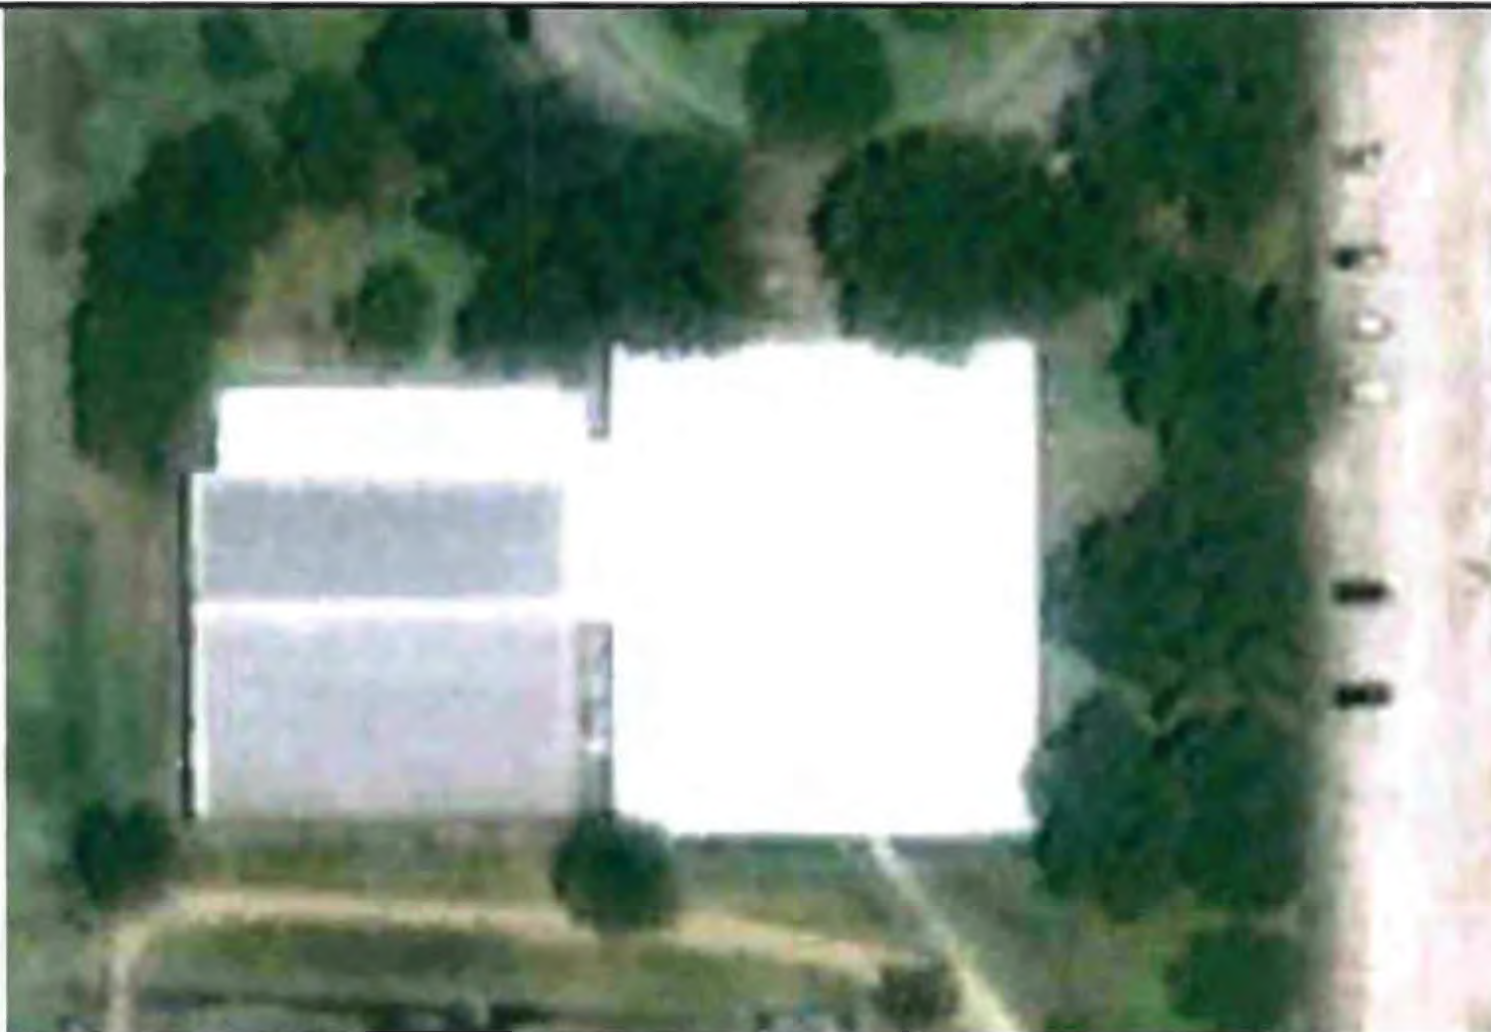
**Figure 10 – Aerial Site Plan July 2005**  
**Deer Park Community Center**  
**Deer Park, Texas**  
Source: Google Earth  
Terracon Project No. F3128529  
September 30, 2013

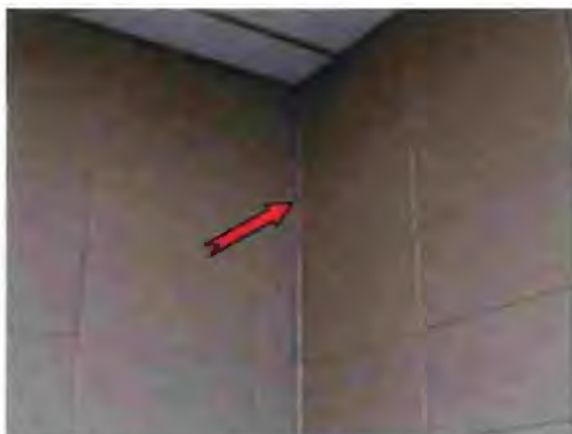
**Photo #24** Crack at corner of concrete masonry unit walls
