EVALUATION OF THE 250,000 GALLON WELDED STEEL SINGLE-PEDESTAL SPHEROID

**“AVON STREET TANK”
DEER PARK, TEXAS**

THE CITY OF DEER PARK

July 25, 2023

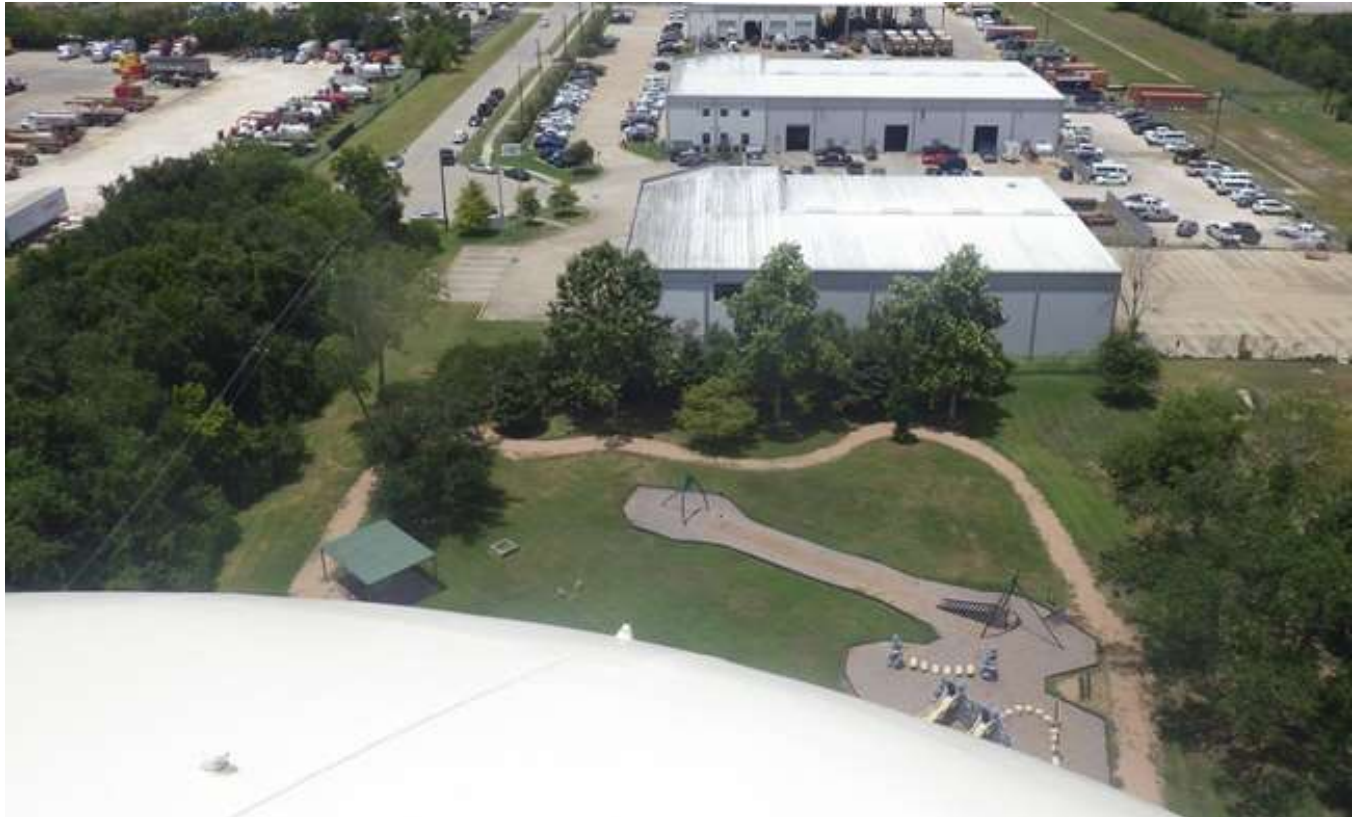
4. Surrounding area.

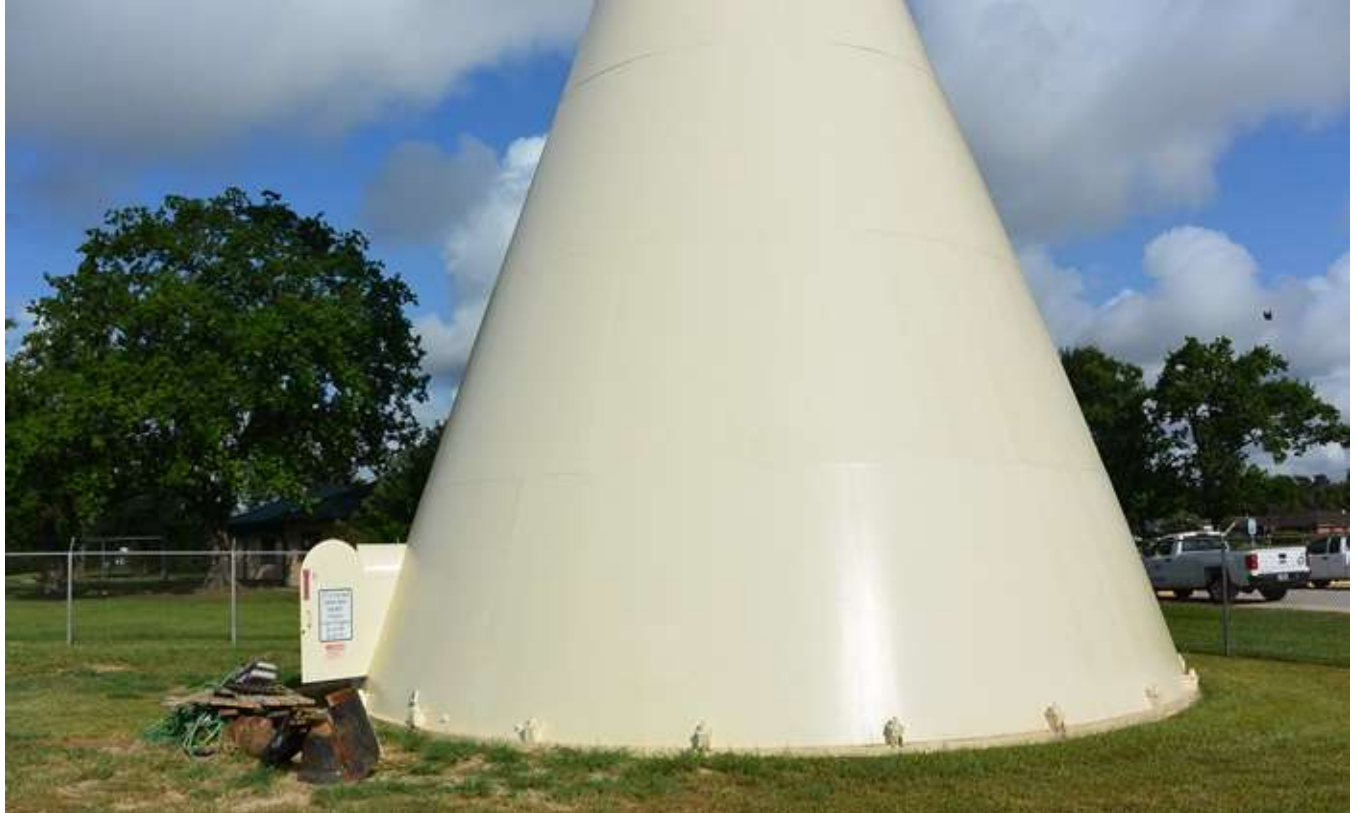
12. Base cone exterior.

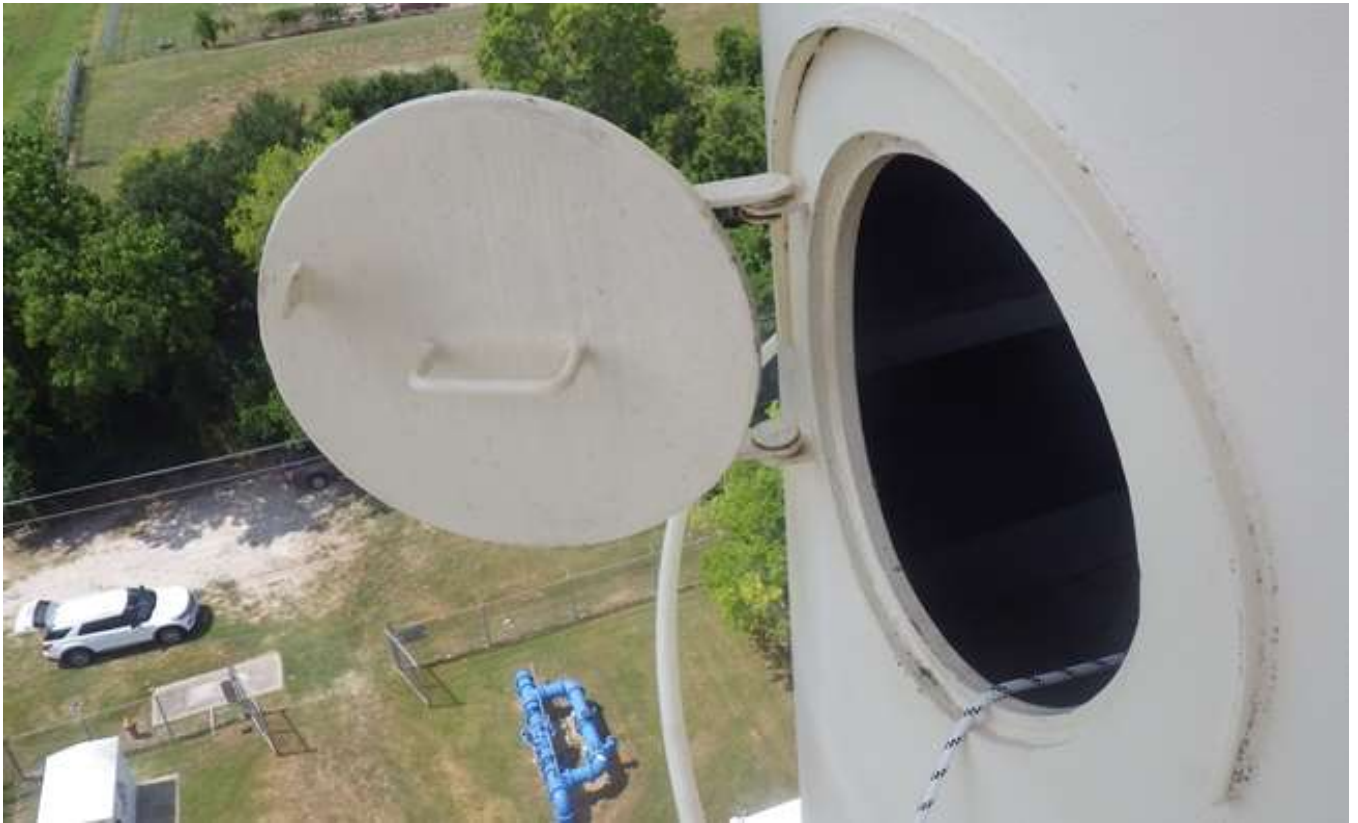
19. Painter's manhole.

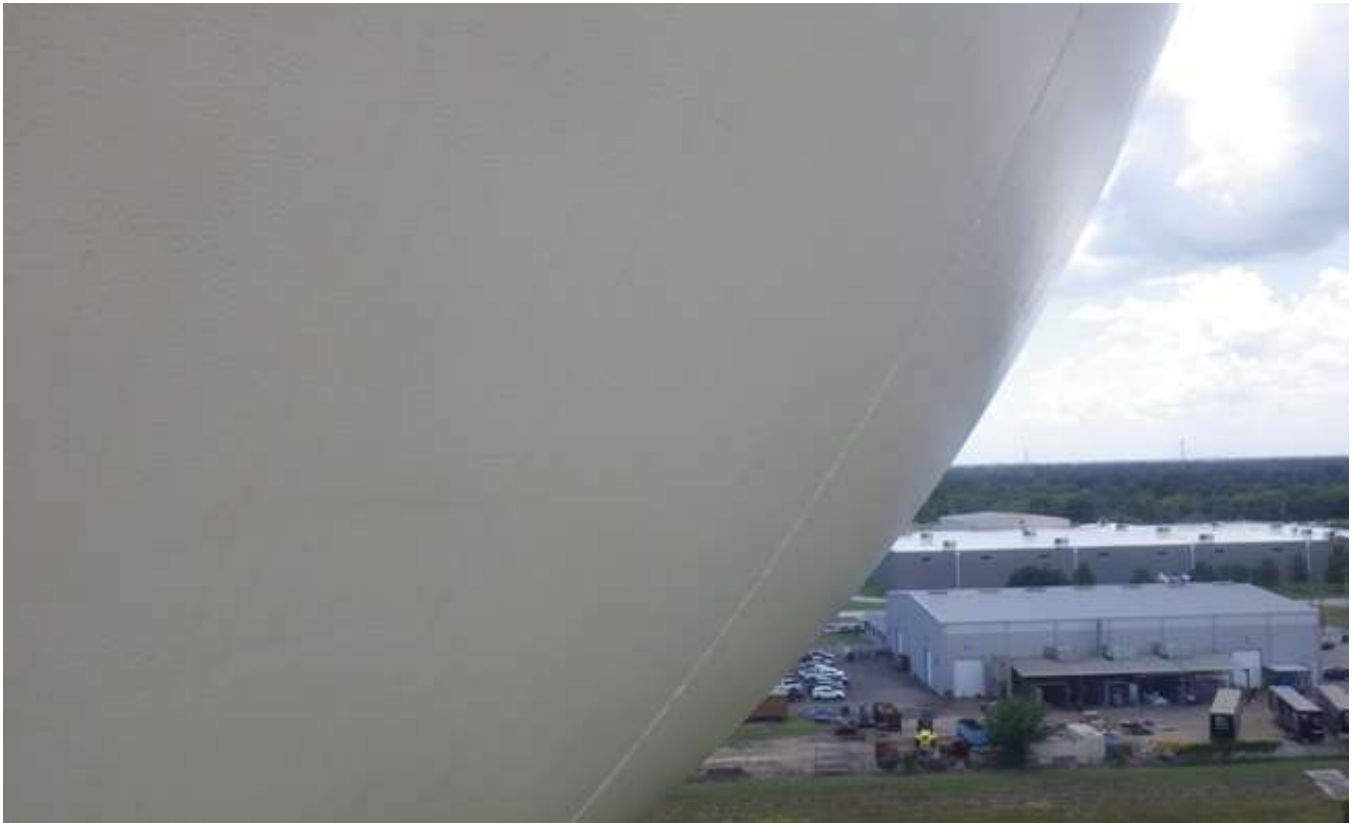
23. Bowl exterior.

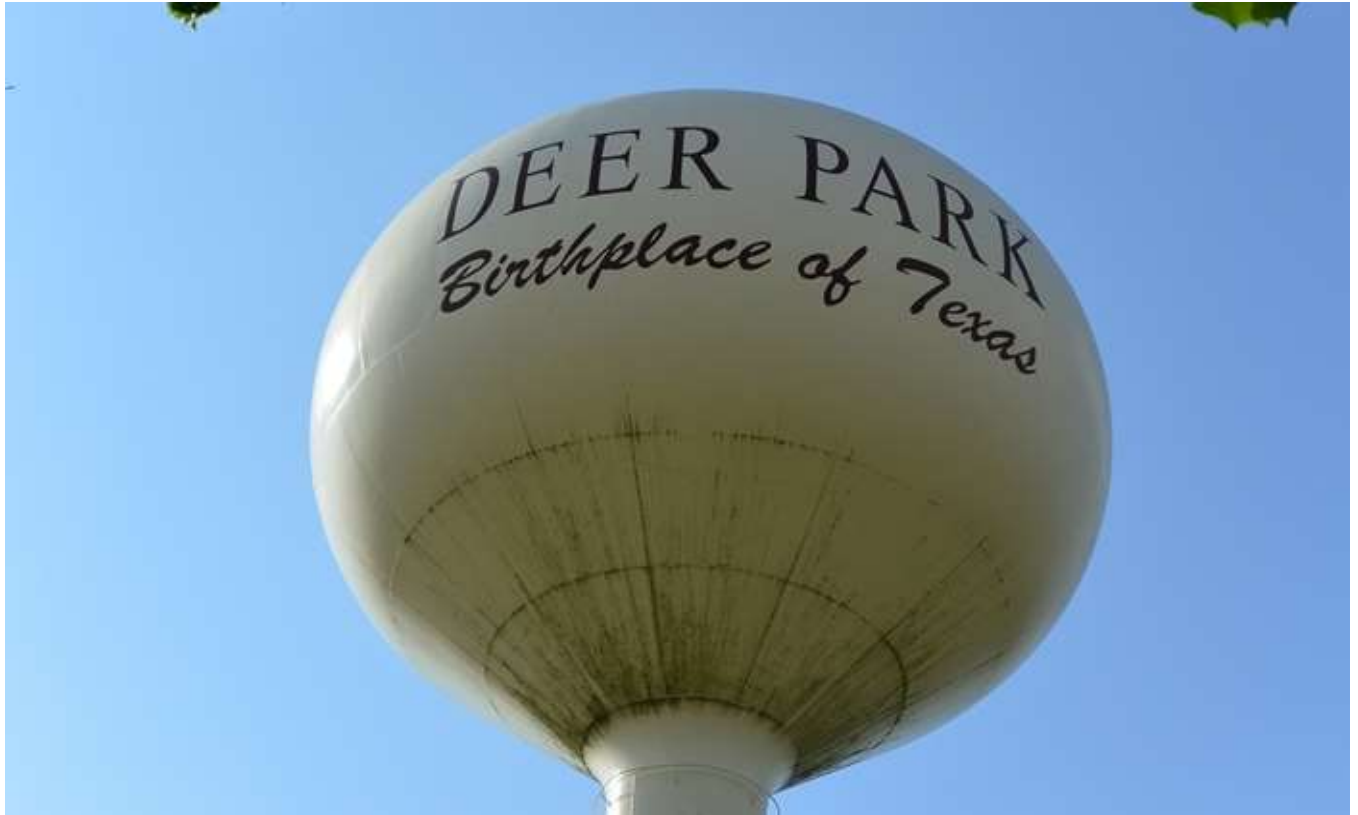
24. Mildew on the bowl exterior and signs on the shell exterior.

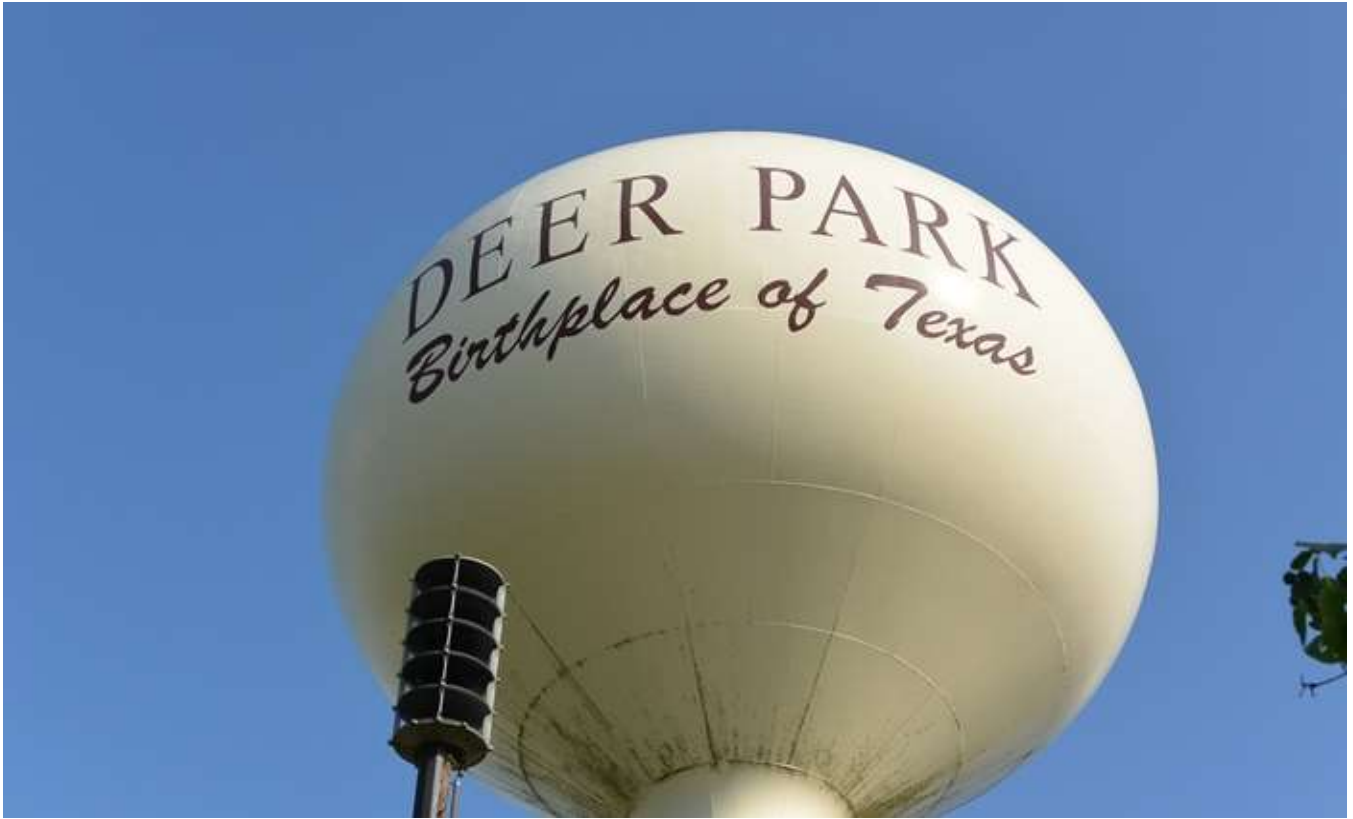
25. Mildew on the bowl exterior and signs on the shell exterior.

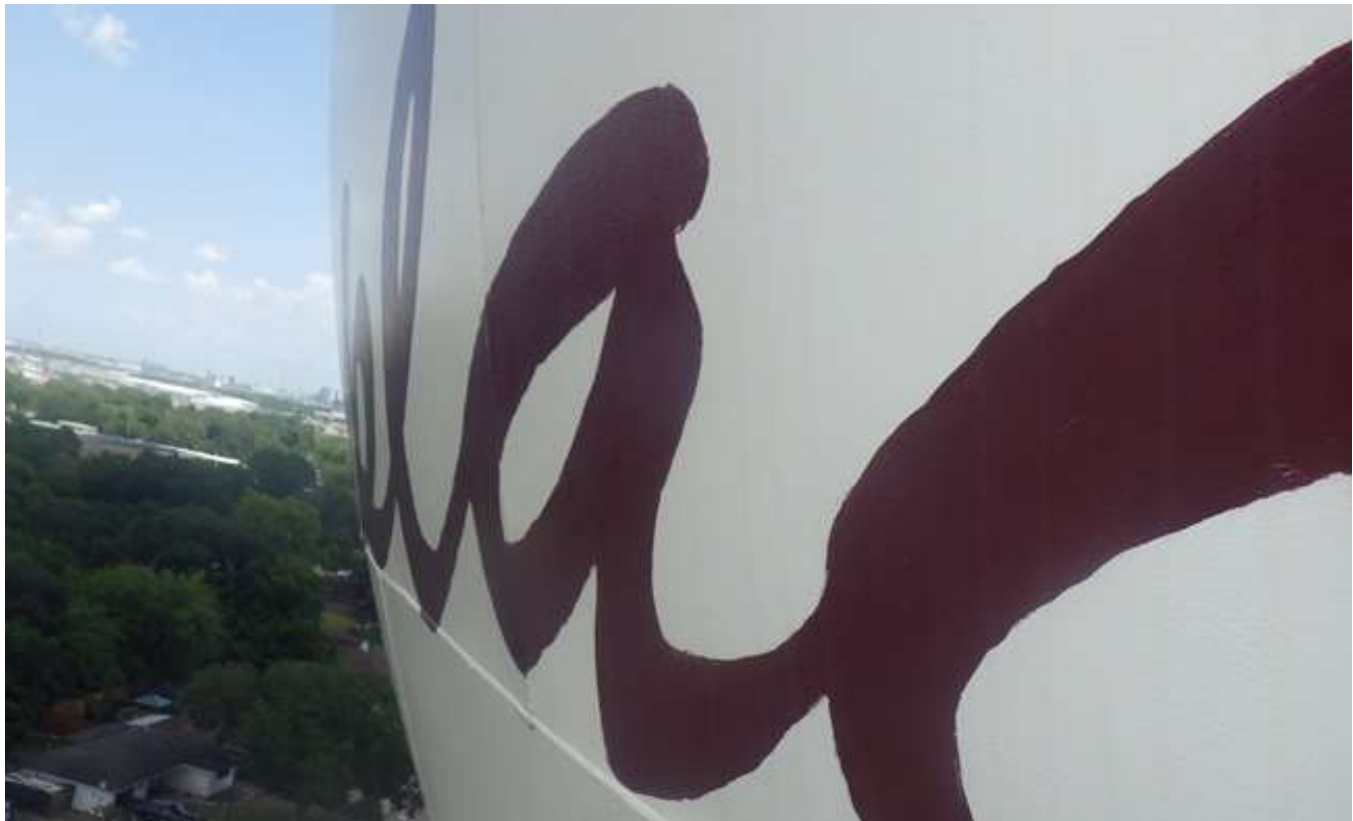
26. Sign on the shell exterior.

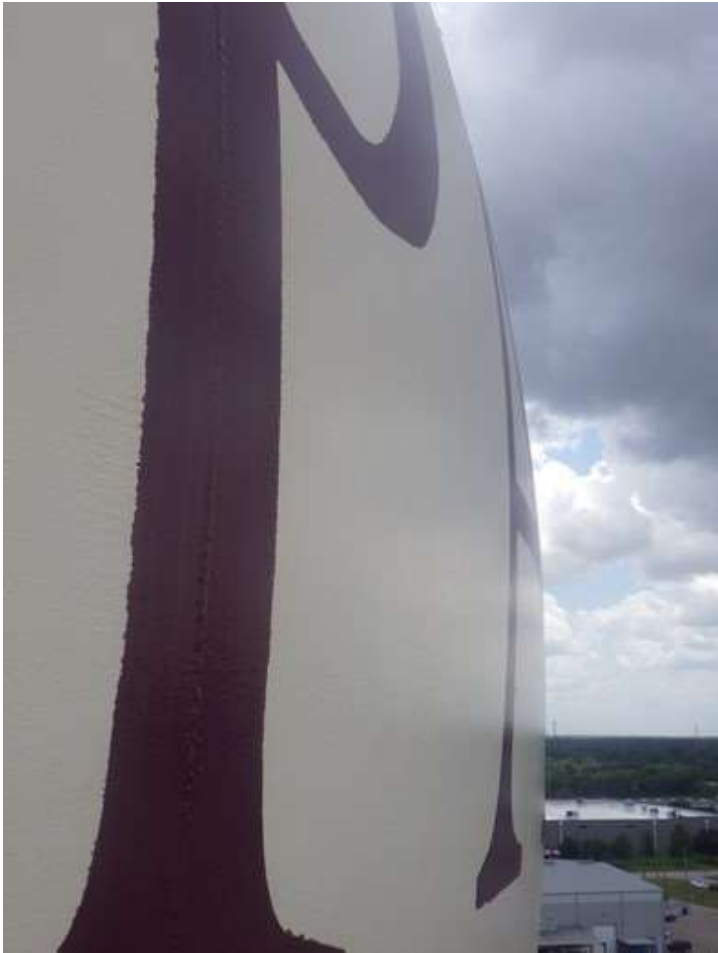
27. Sign on the shell exterior.

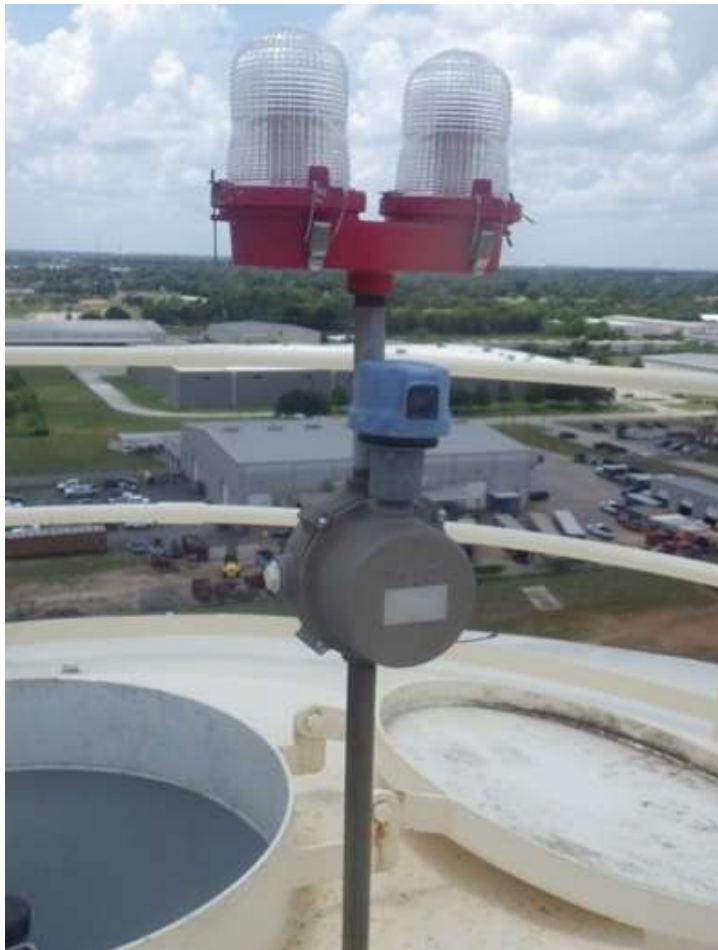
40. Obstruction lights and photoelectric cell attached to the access tube roof manhole flange.

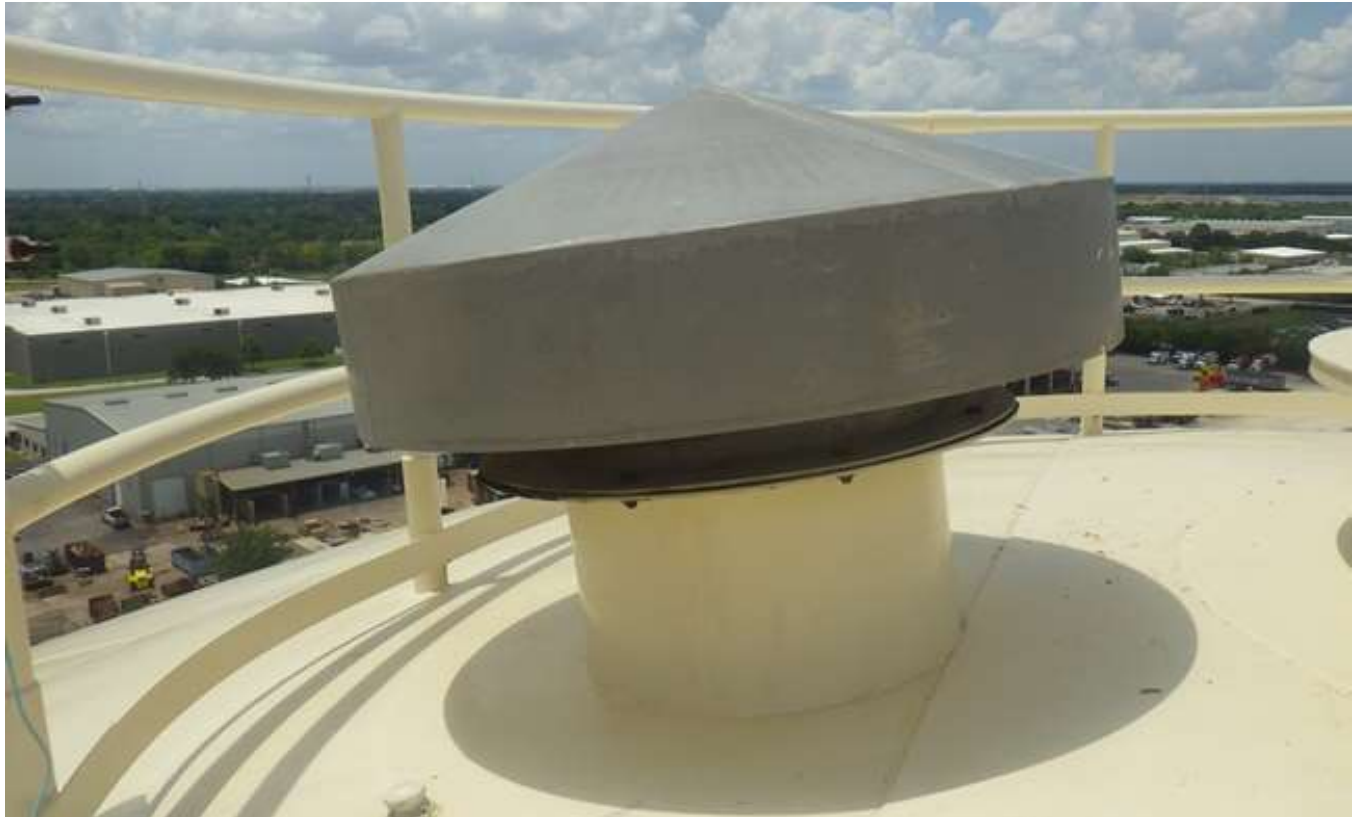
- ◆ the roof vent was not screened which would allow the ingress of birds and insects into the tank,
- ◆ the concrete floor of the base cone was severely damaged and the underlying fill disturbed, and

44. Roof vent.

These deficiencies should be corrected.

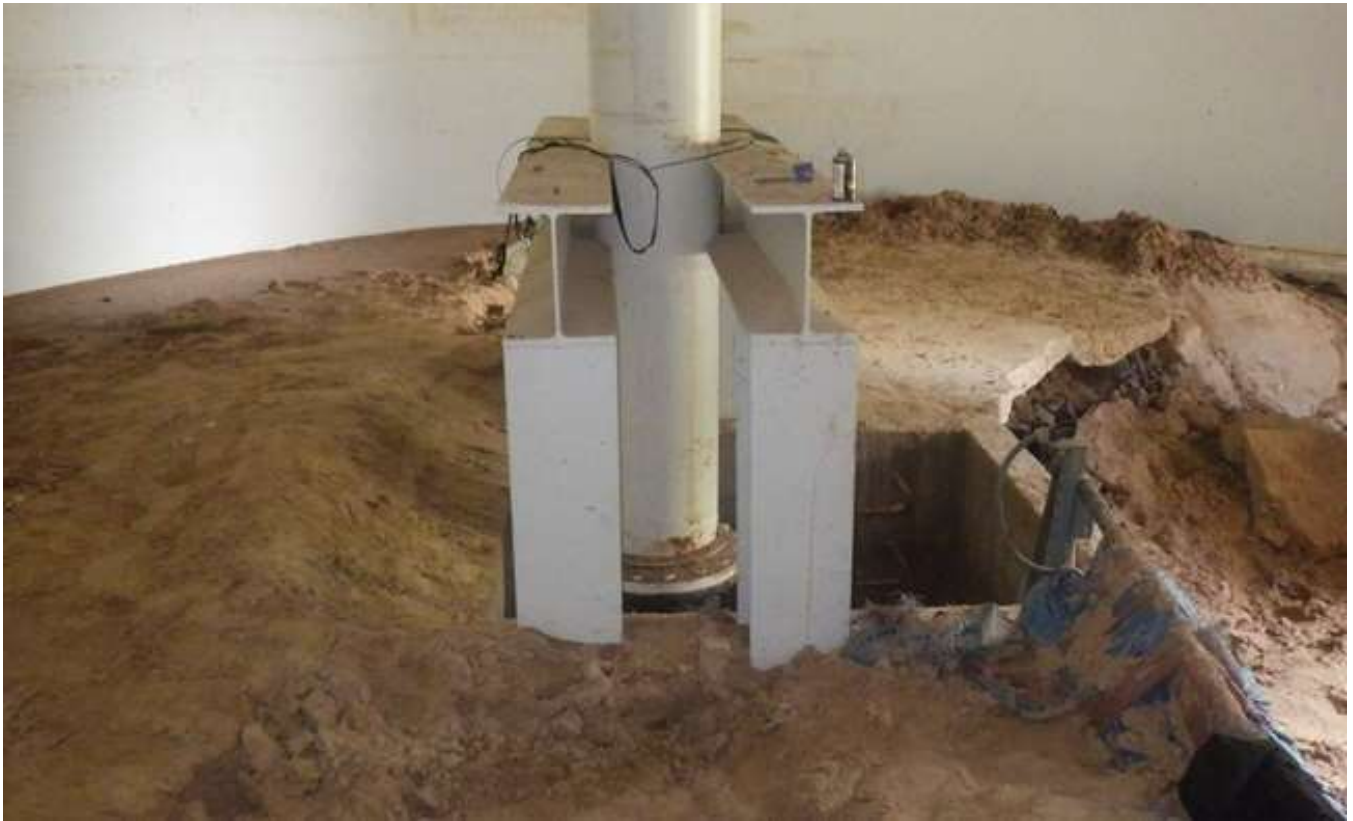
55. Inlet/outlet pipe extending from pipe pit in the base cone floor.

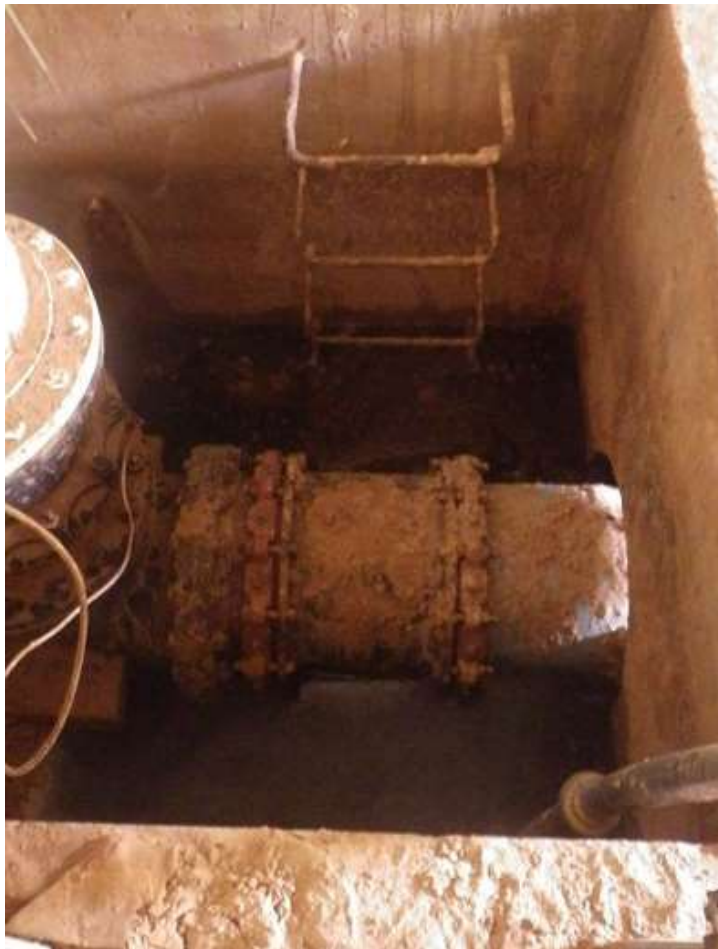
56. Access rungs and piping in the pipe pit.

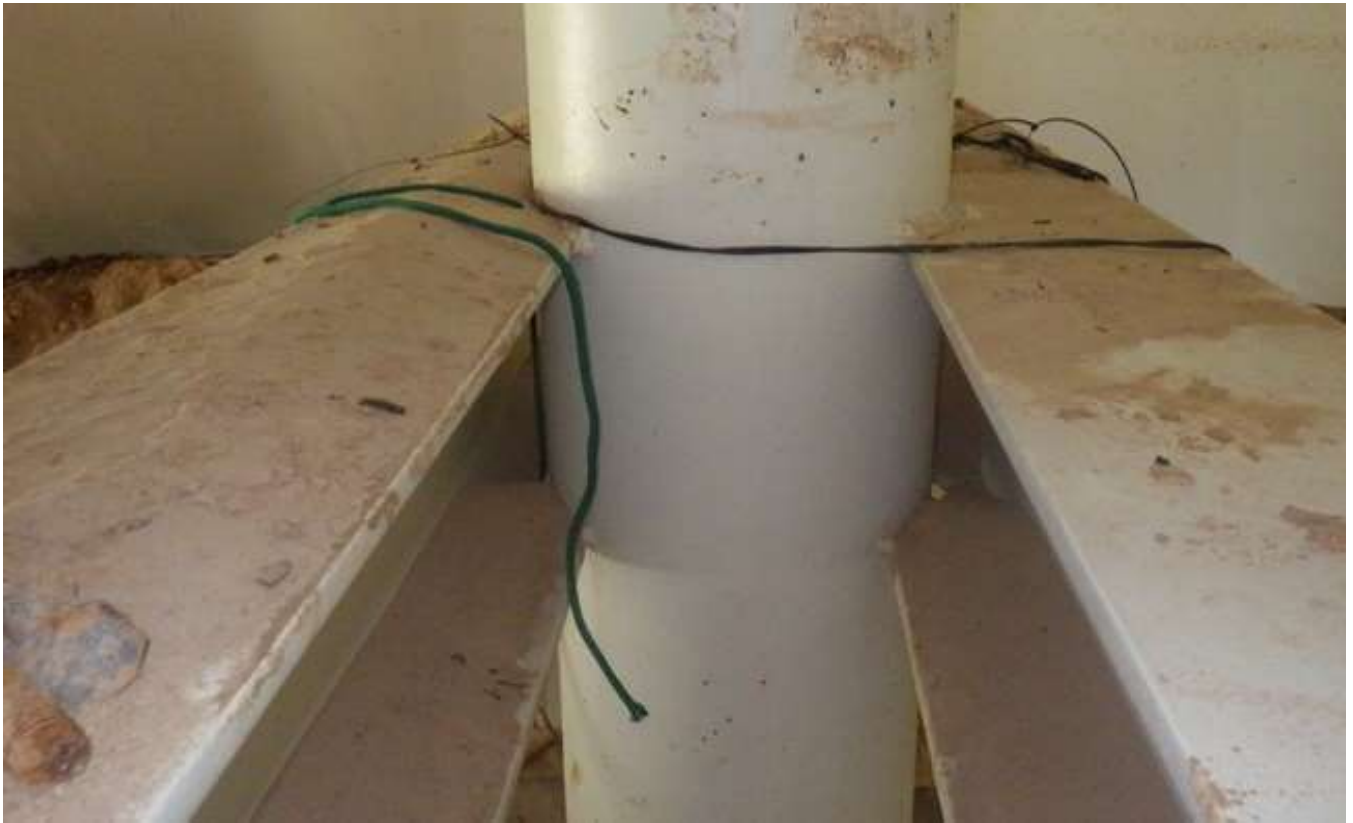
59. Inlet/outlet pipe and brackets.

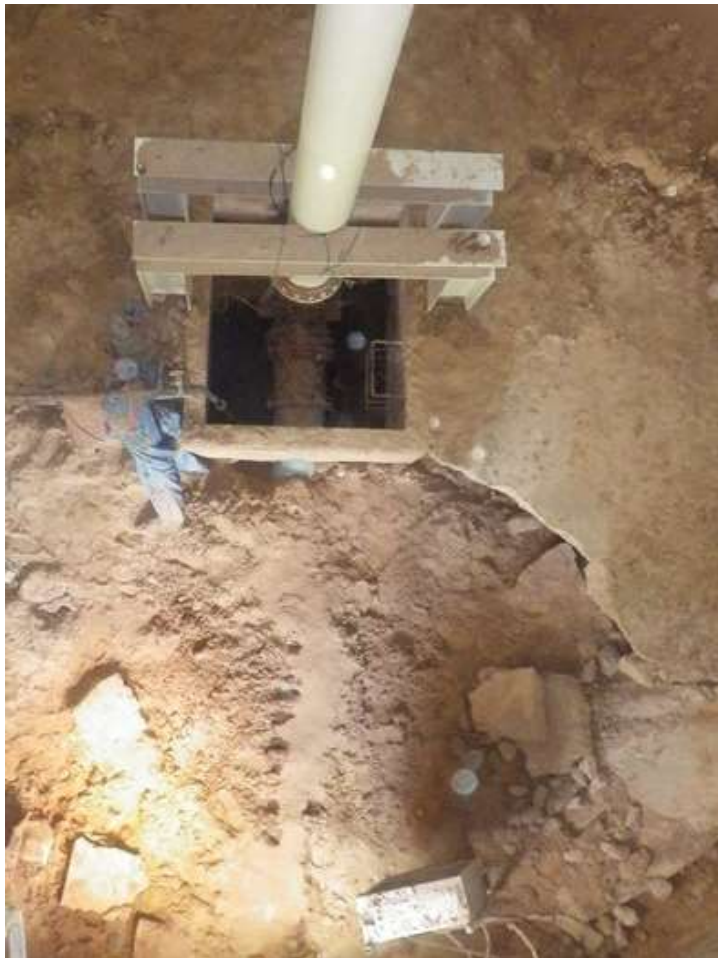
60. Inlet/outlet pipe extending from pipe pit.

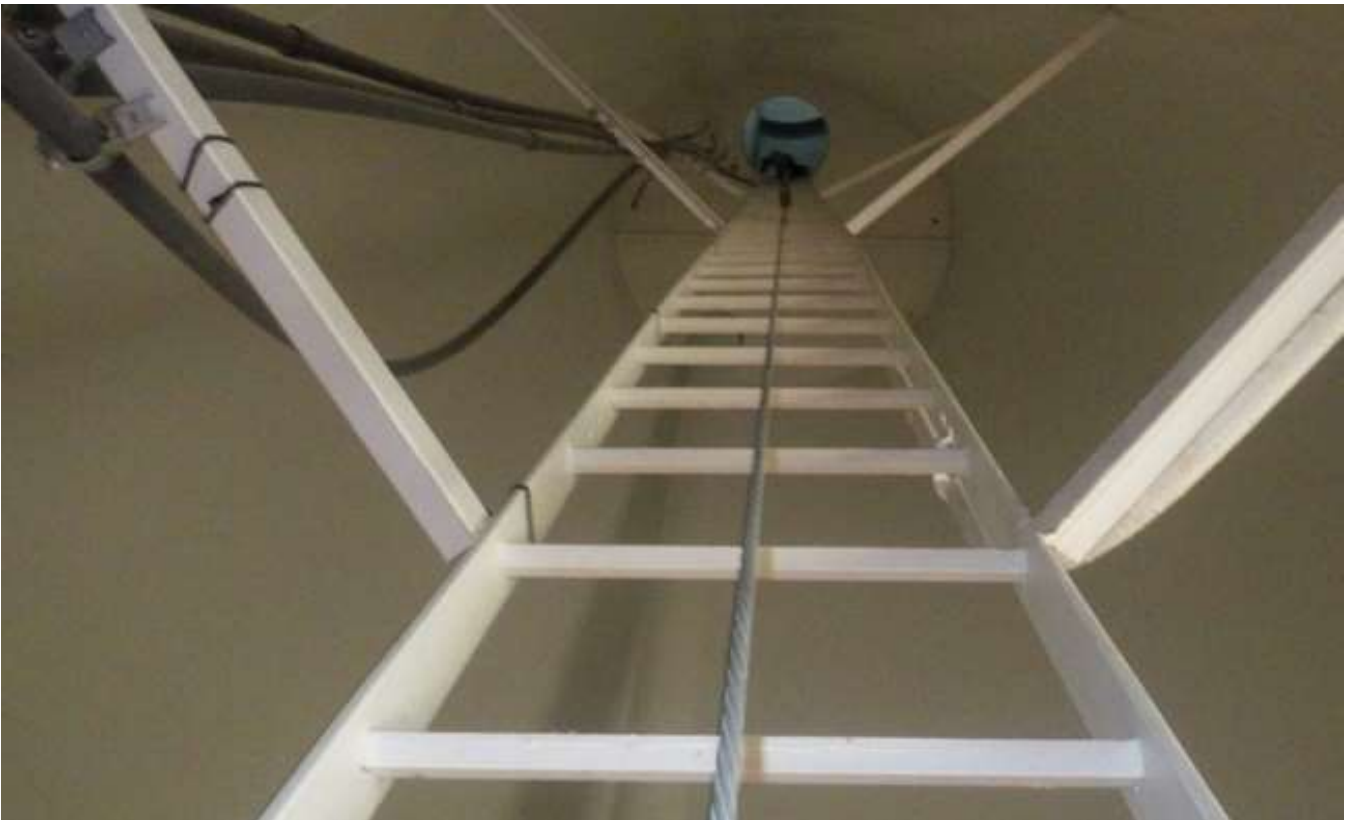
62. Base cone ladder, safe-climbing device, and brackets.

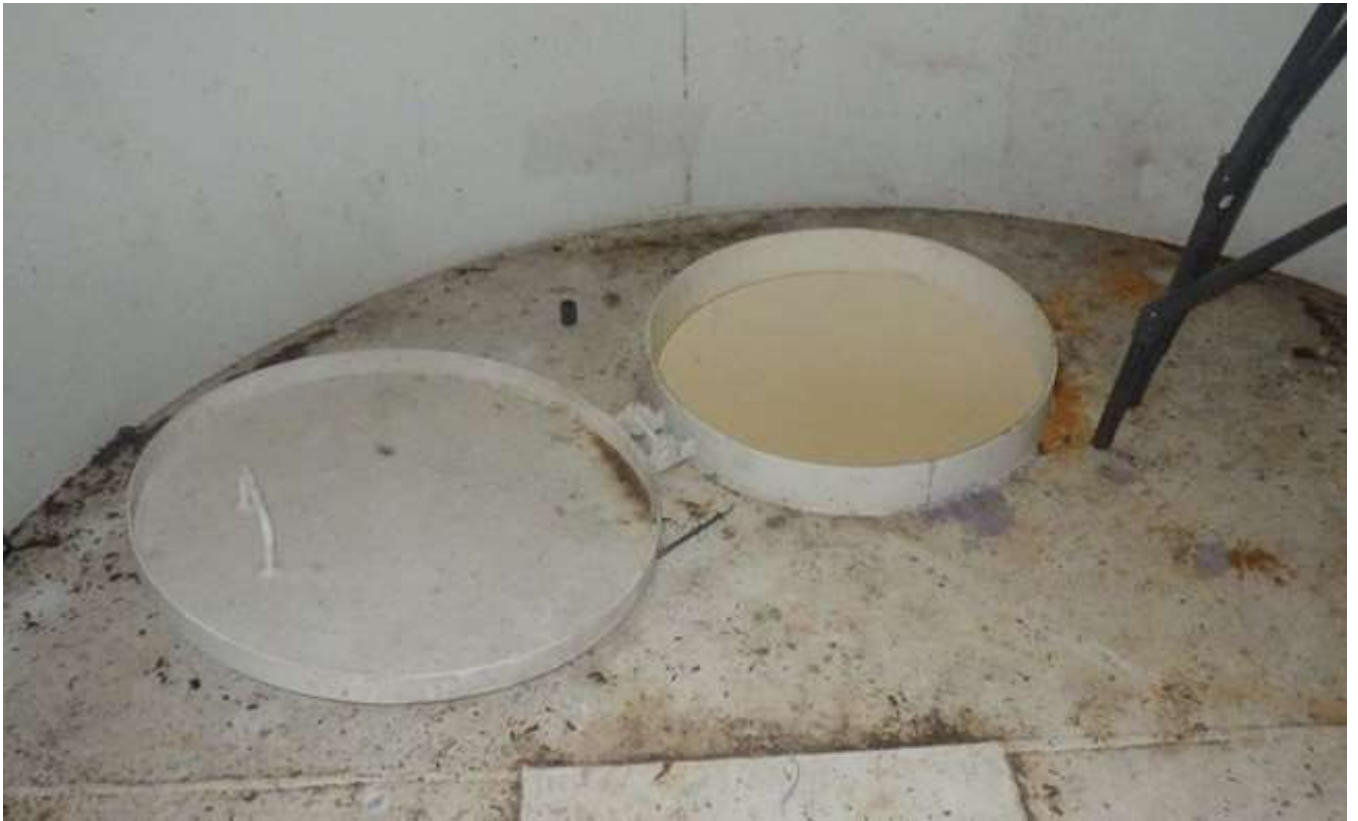
65. Condensate platform manhole.

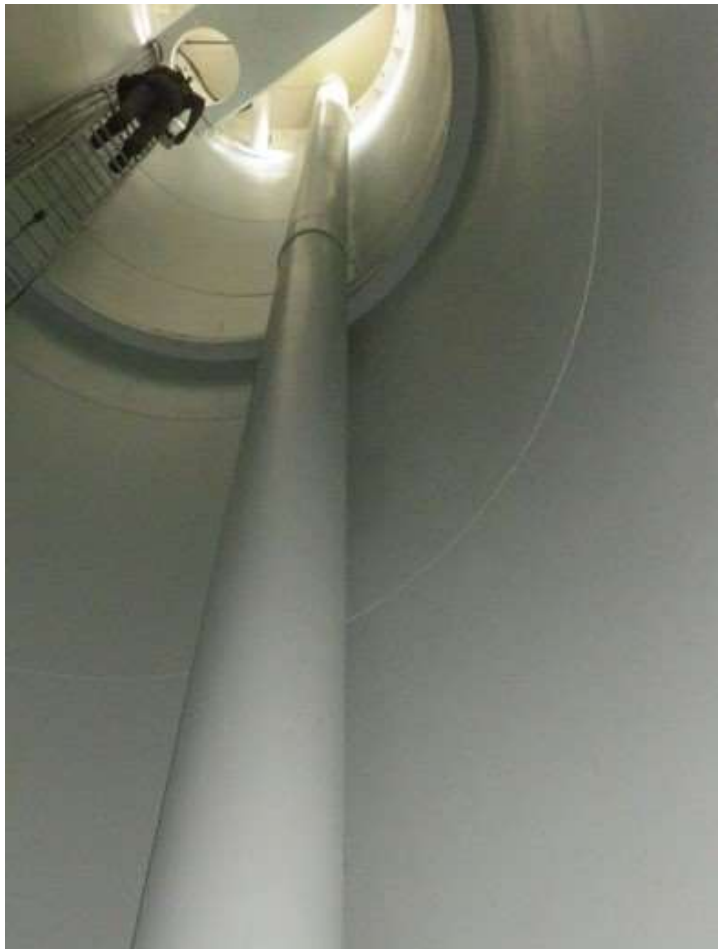
66. Inlet/outlet pipe extending up the support column.

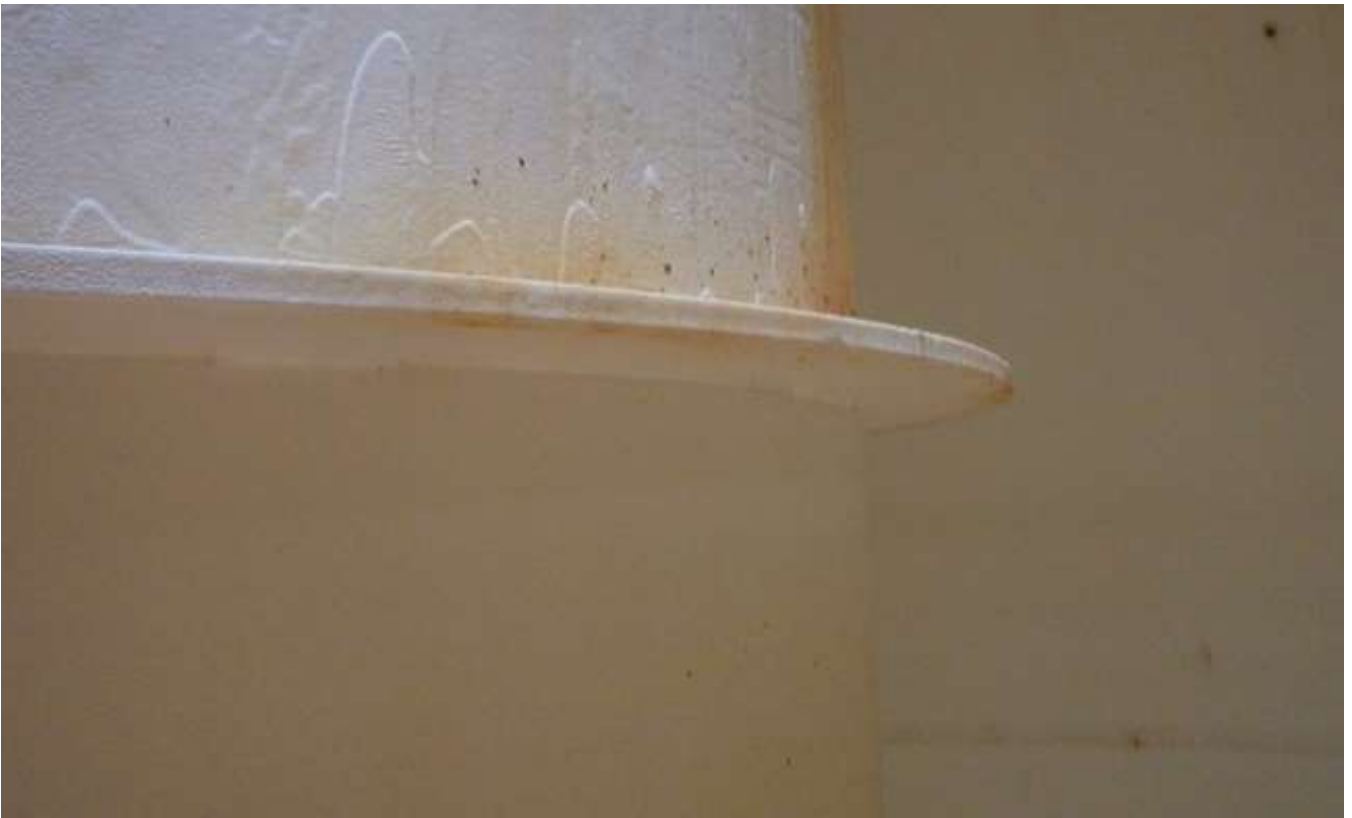
95. Interior wet access tube and bowl. Note water and silt on the bowl.
