Building Observations Survey ©2016

Deer Park Community Center Deer Park, Texas

**Building Survey for Deer Park Community Center,
610 East San Augustine Street, Deer Park, Texas**

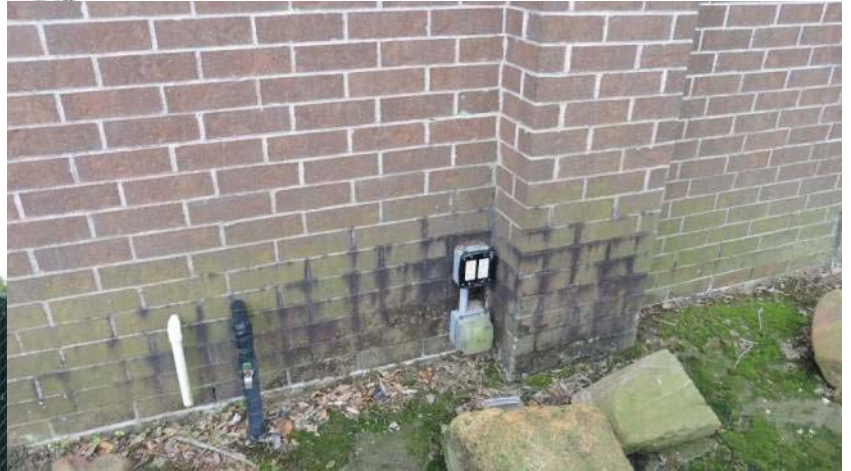
Mildew growth and damaged electrical

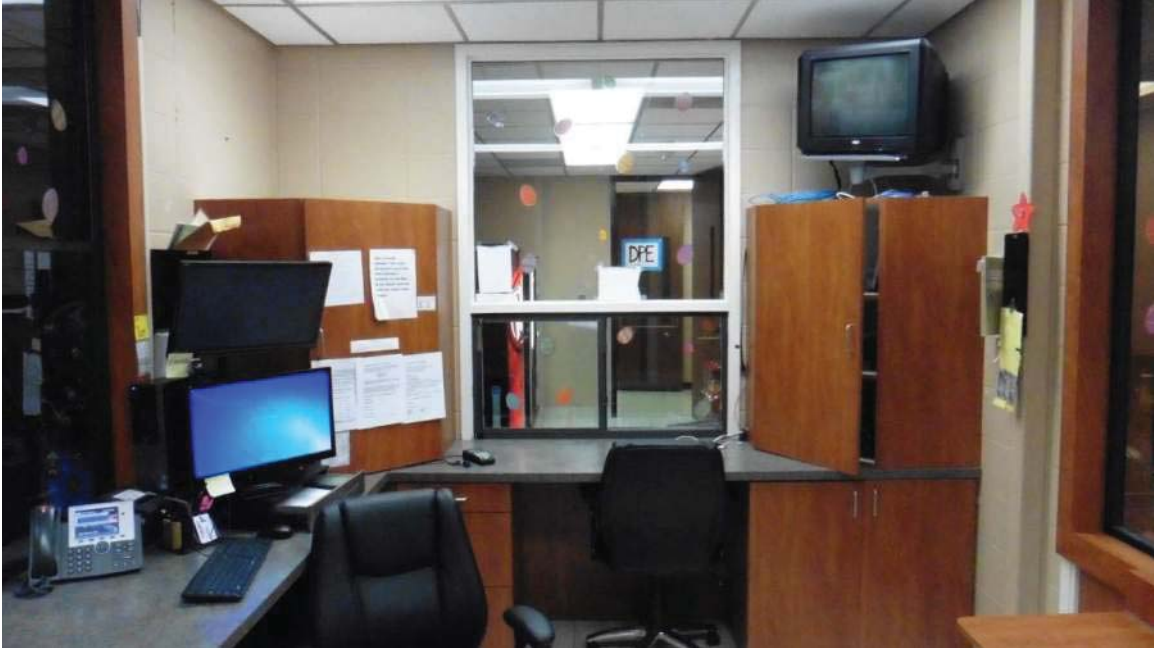
Example of makeshift office space – Community Center

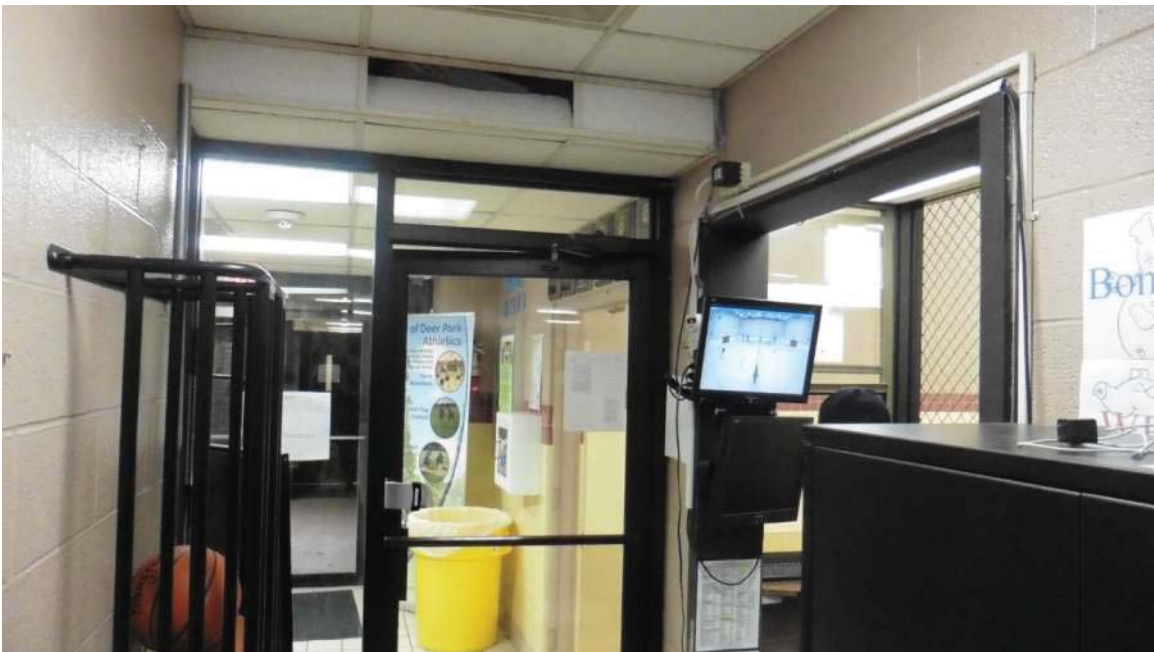
Example of makeshift office space – Gym

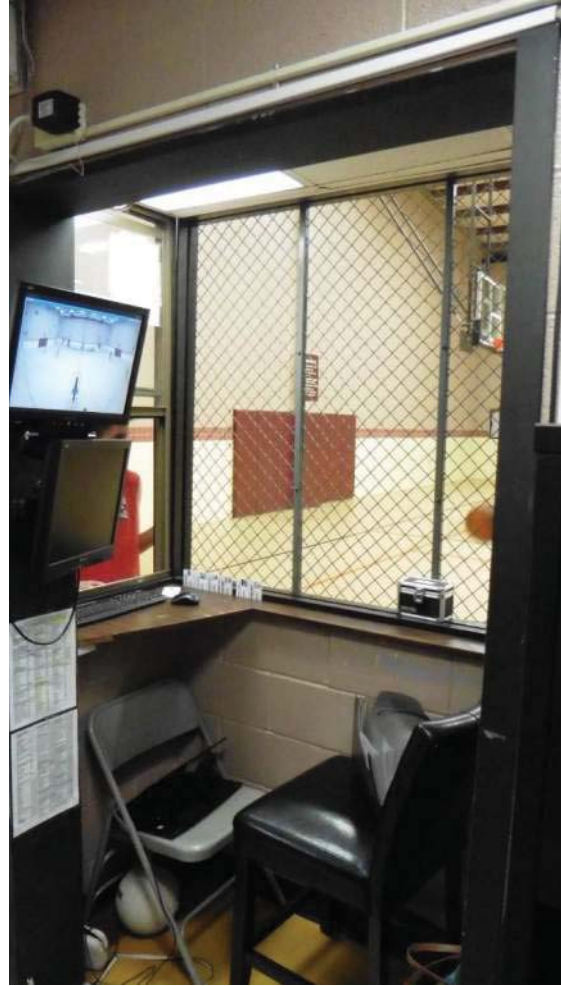
Gym Control

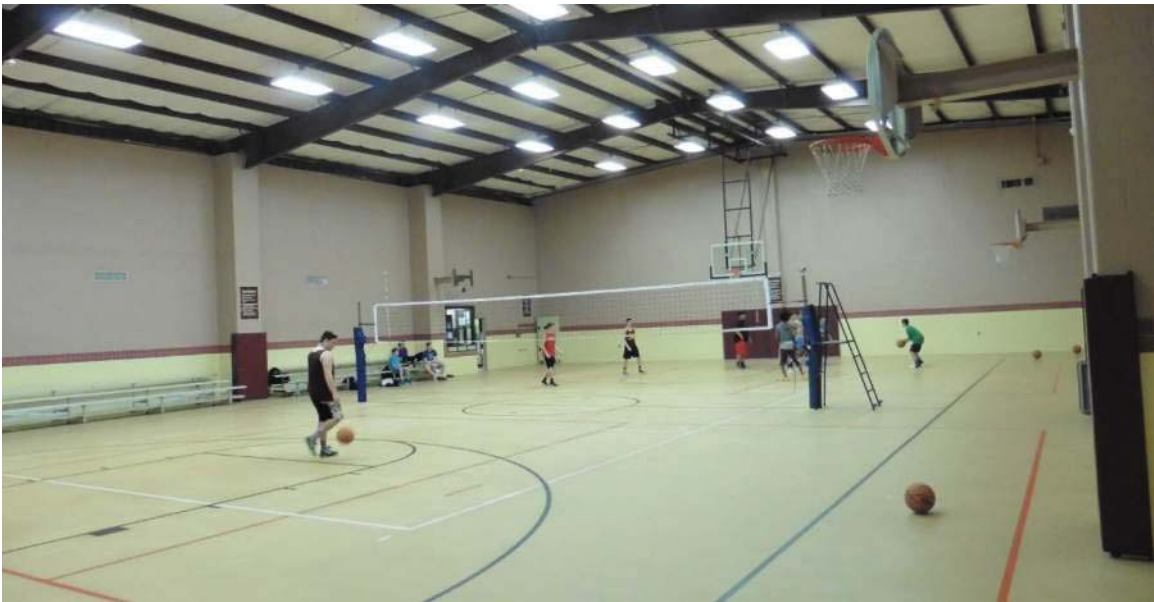
Gym Court

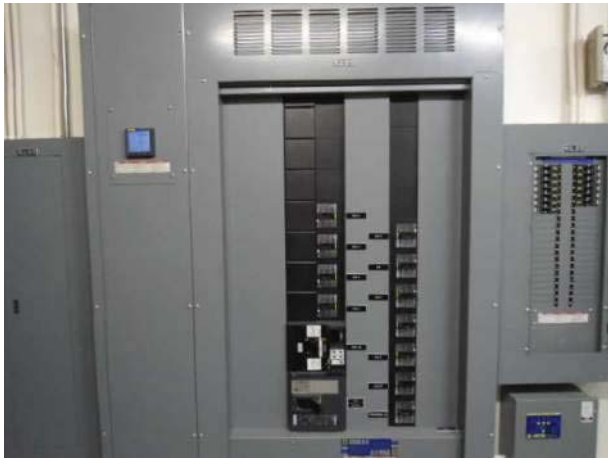
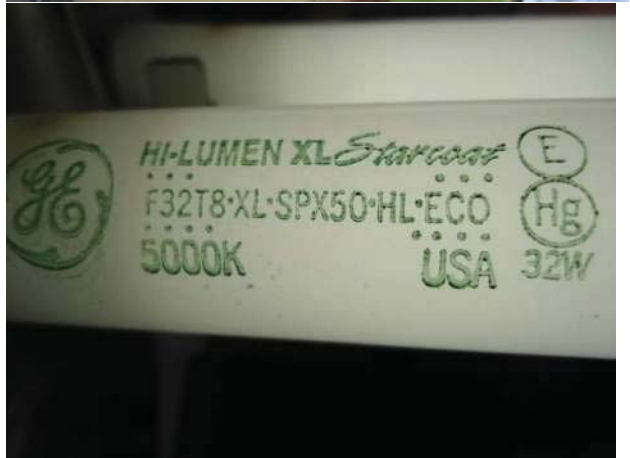
1. The main service and associated equipment (e.g. weatherhead, CT, gutter wire way, and safety switches) appear to have been reconstructed or replaced as detailed in the "Addition to Deer Park Community Center" design requirements (2006) and appear to be in serviceable condition.

2. Several safety switch enclosures serving exterior HVAC equipment (i.e. chillers serving Community Center, DX condensers and package units serving Gymnasium) appear to be substantially weathered and in poor condition due to being constantly subjected to environmental elements. Switches were not cycled to confirm operation.

3. Distribution and low voltage panels associated with the Community Center and Gymnasium appear to be in serviceable condition without unfilled spaces or circuit breakers labeled "bad".

4. General lighting fixtures inside appeared to be newly retrofitted with T8 lamps and reflectors for improved efficiency.
5. Exterior light fixtures were not operating due to the time of day but many fixtures appeared to be in poor or inoperable condition.

6. Several exit lights were tested in the original Community Center and Gymnasium facility and were inoperable. Exit lights were tested in the Community Center addition and were found to operate correctly with internal back-up batteries. A complex wide, after-hours test should be conducted to determine the extent of emergency lighting and deficiencies.

1. The system appears to be in good condition except for a number outdoor disconnect switches.
2. Outdoor security lighting should be upgraded with LED type light fixtures.
3. Since there is no dedicated computer power system, consideration should be giving to installing an isolated ground and surge protected system should computer failures or glitches be experienced.

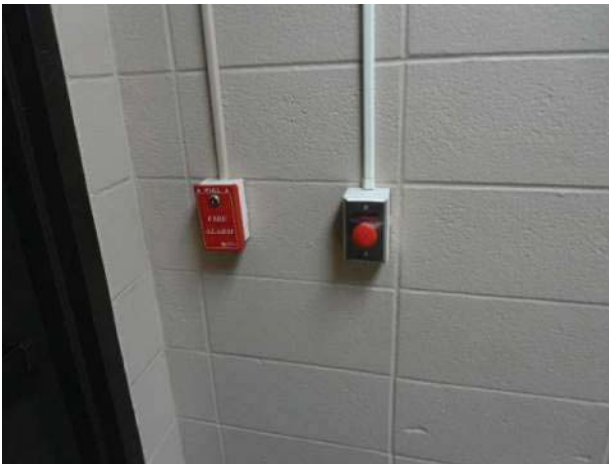
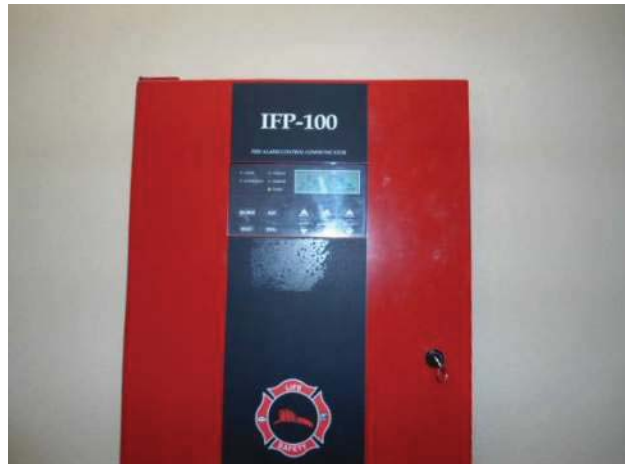
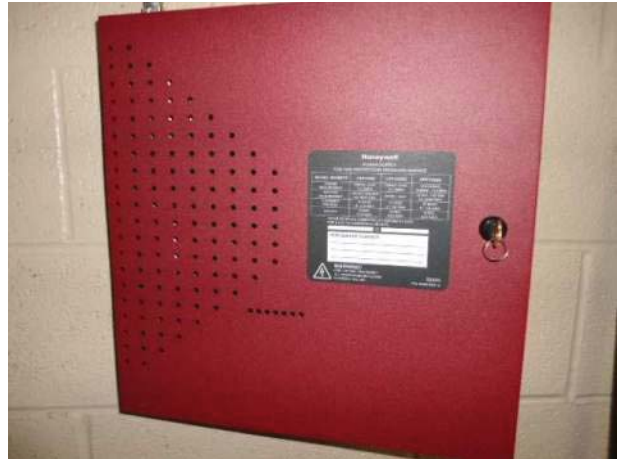
1. The system in the Community Center had no troubles or alarms on the panel display and appears to be serviceable. An extensive review of the system was not conducted but appears to be installed in compliance with the "Addition to Deer Park Community Center" design requirements. The system has current maintenance and inspection tags.
2. A Honeywell power supply was noted in the Gymnasium facility. Devices appear to have been upgraded, consistent with the Community Center.

1. The fire alarm system appears to be operable and well maintained. Although not required, consideration should be given to upgrading the system to the latest codes.

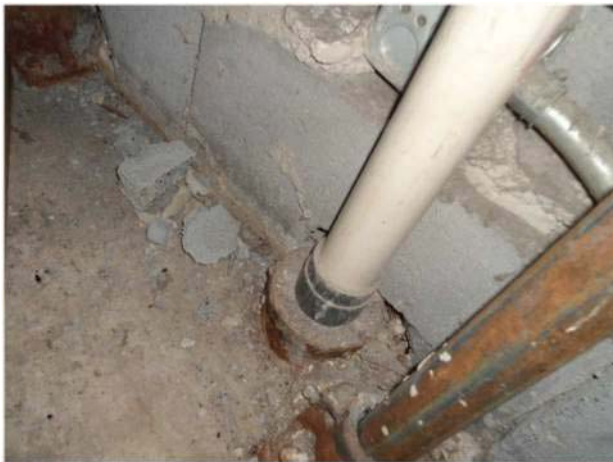
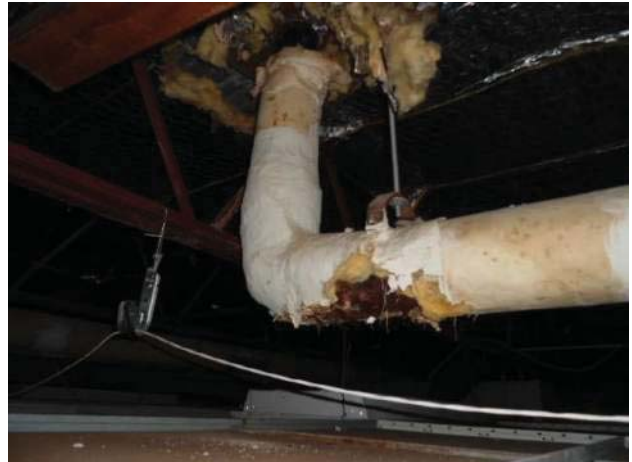
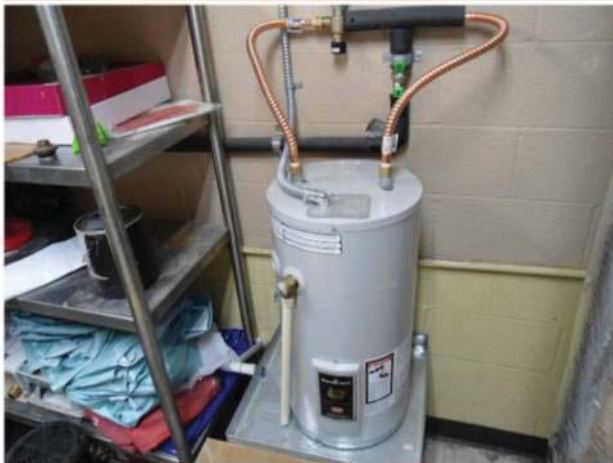
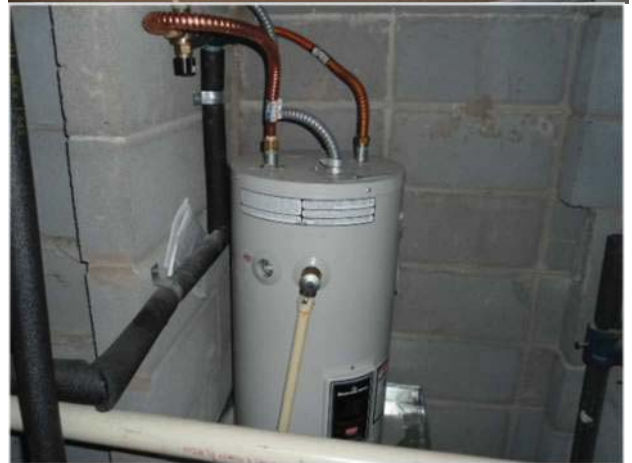
1. Lavatories appeared to be in serviceable condition; however, a few surface imperfections/damages were noted along with several service connection leaks. Most lavatories did not have ADA insulation kits on the water and waste piping.
2. Sinks appeared to be in serviceable condition.
3. Several faucets have superficial corrosion.
4. Urinals and water closets appeared to be in serviceable condition. Several associated flush valves have superficial corrosion.
5. Drinking fountains appear to be in serviceable condition; however, several have cosmetic damage and show signs of extensive wear.
6. It appeared that most, if not all, of the electric water heaters have been recently replaced and are in serviceable condition.
7. Above ceiling horizontal cast iron storm sewer piping, shows severe corrosion in existing Community Center.

1. Galvanized water pipes tend to rust on the inside and develop pin-hole leaks with age. The severity of these problems depends on the quality of the original piping and the quality of the water. I did not see indication of rust in the water and the visible piping did not show signs of leakage or repair. The piping system should be monitored and may require future replacement with other materials.

2. Underground cast iron pipe corrodes over time. If sewer stoppages occur fairly often, this may be a sign the pipes are cracked or collapsing. The condition of the piping was previously assessed by video camera and should be periodically monitored as necessary

3. Plumbing fixtures and valves are serviceable but replacement should be considered for appearance. Handicap protective wrap should be installed on sinks and lavatories. Note that contemporary codes limit the flow rates of flush valves so new valves will probably be incompatible with the existing water closets and urinals.

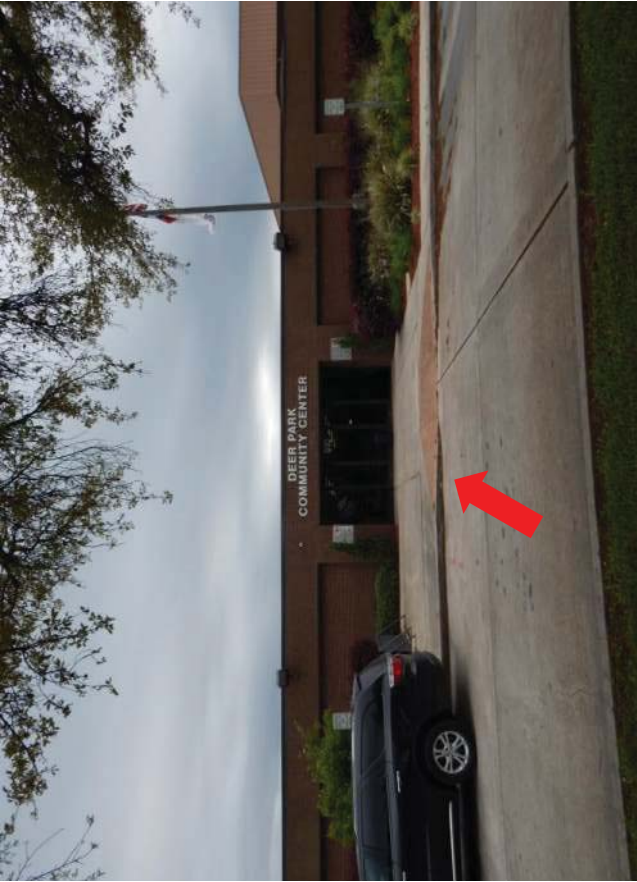
#1 Photo of front entry

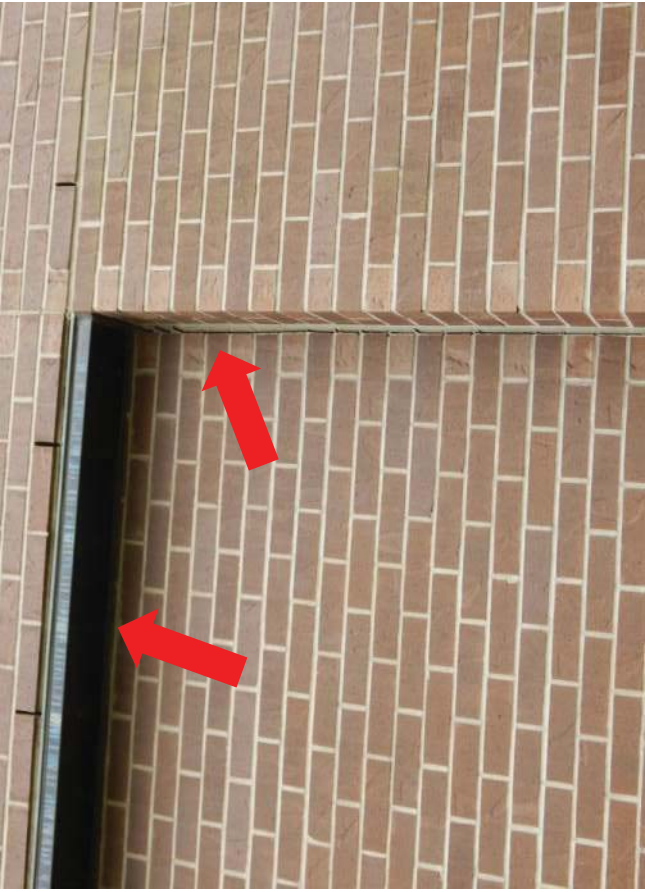
#2 Minor separation in caulk joint at end of inset brick panel.
No brick header per architect's detail.

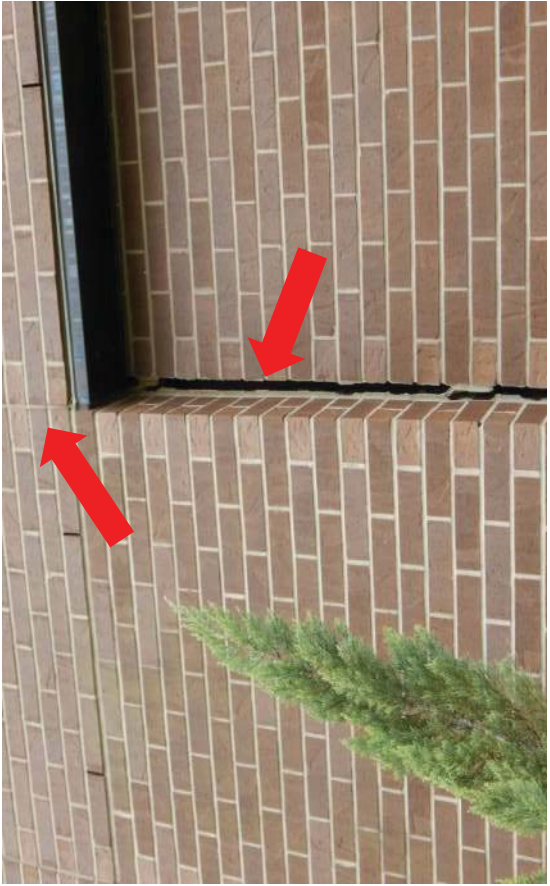
#3 Separation in caulk joint at end of inset brick panel of
approximately 1". No separation in brick control joint above.

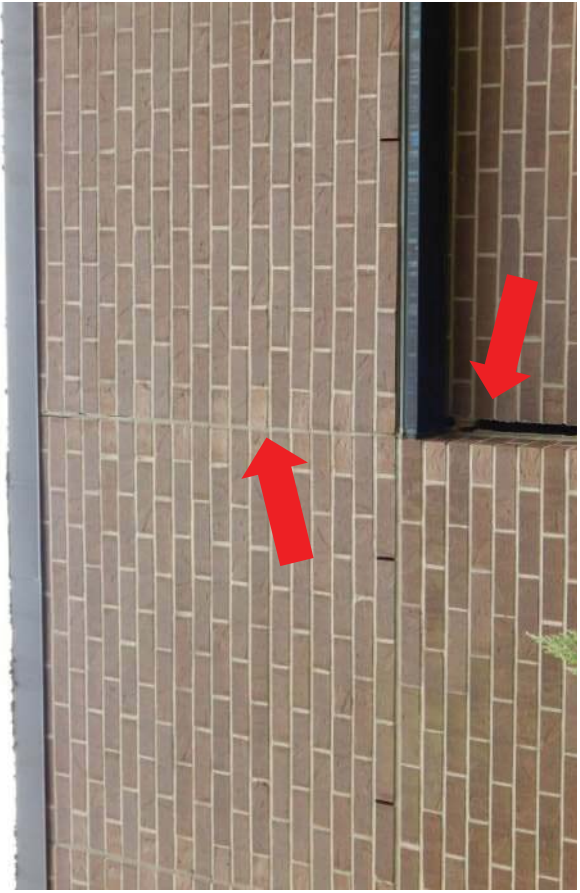
#4 Separation in caulk joint at end of inset brick panel of
approximately 1". No separation in brick control joint above.

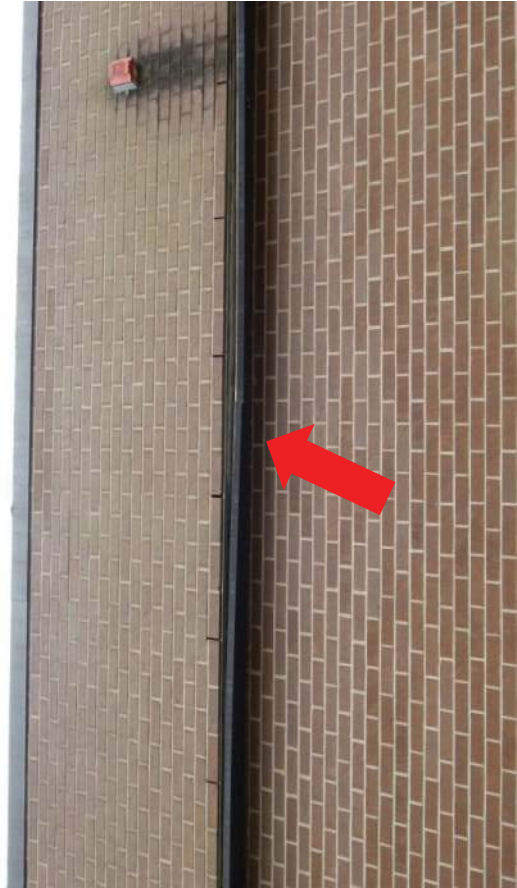
#7 Sheet metal soffit is sagging down. This is where the brick header was omitted and sheet metal added (typical).

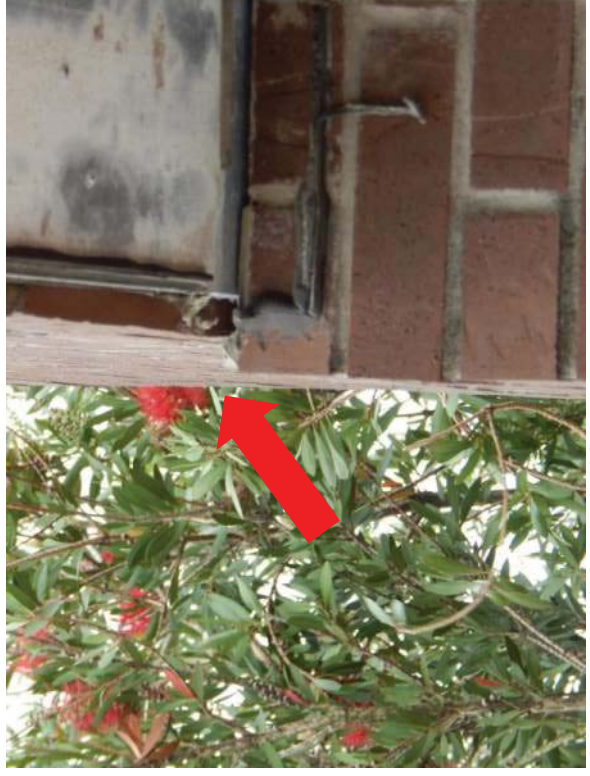
#20 Showing brick column has moved outward to south approximately 1"

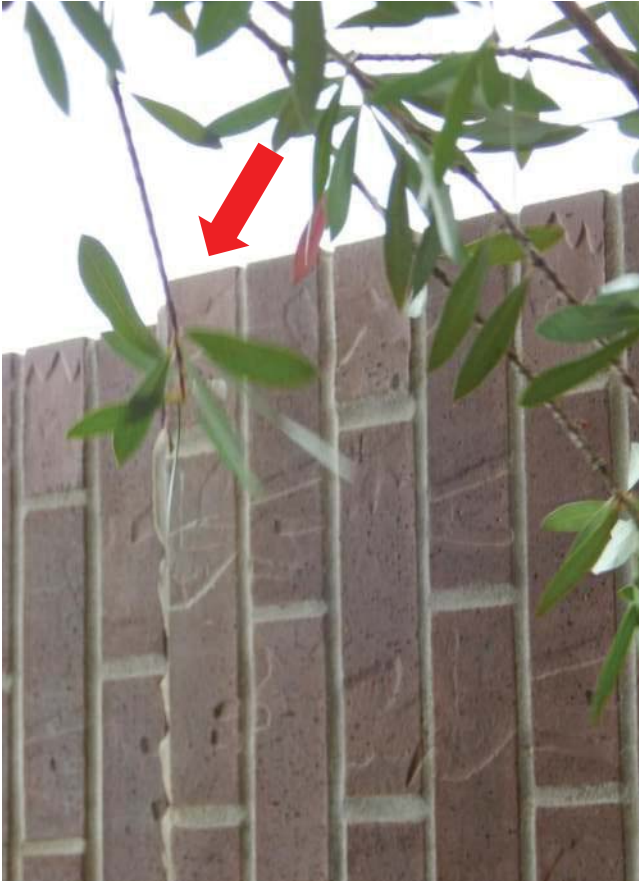
#21 Showing brick column has moved outward to the East approximately 1"

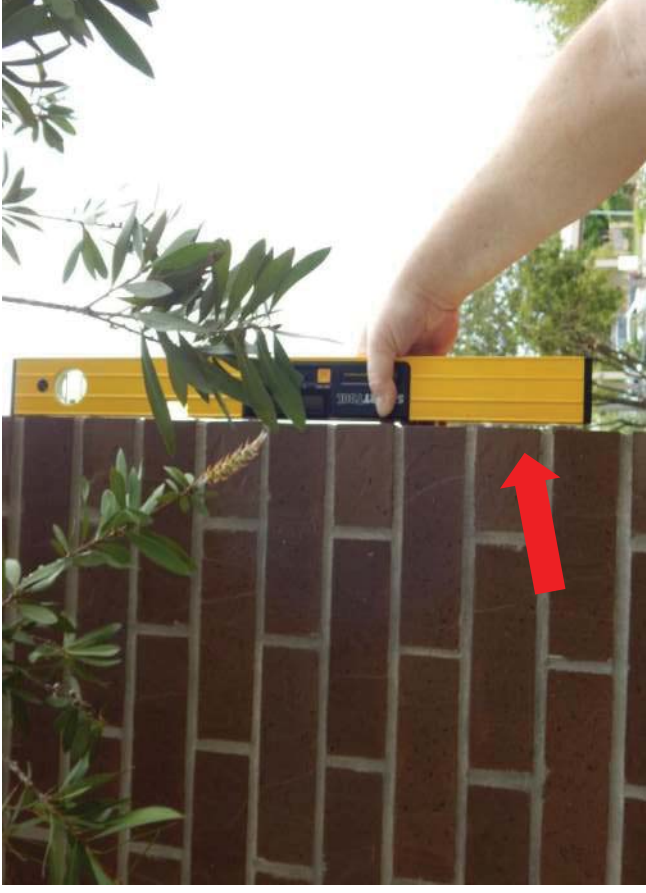
#22 Showing how brick column is leaning outward at the top of the East

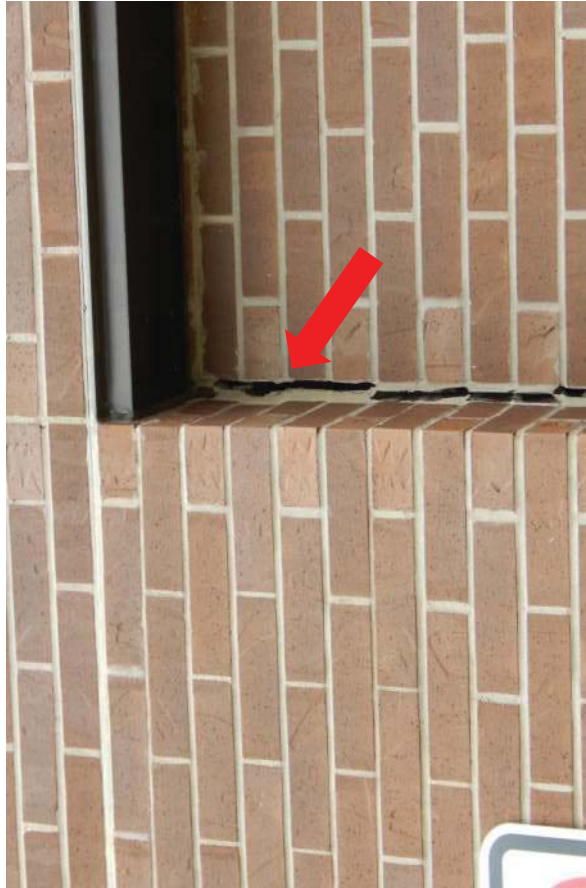
#23 Separation in caulk joint at end of inset brick panel of approximately 1/2".
No separation in control joint above.

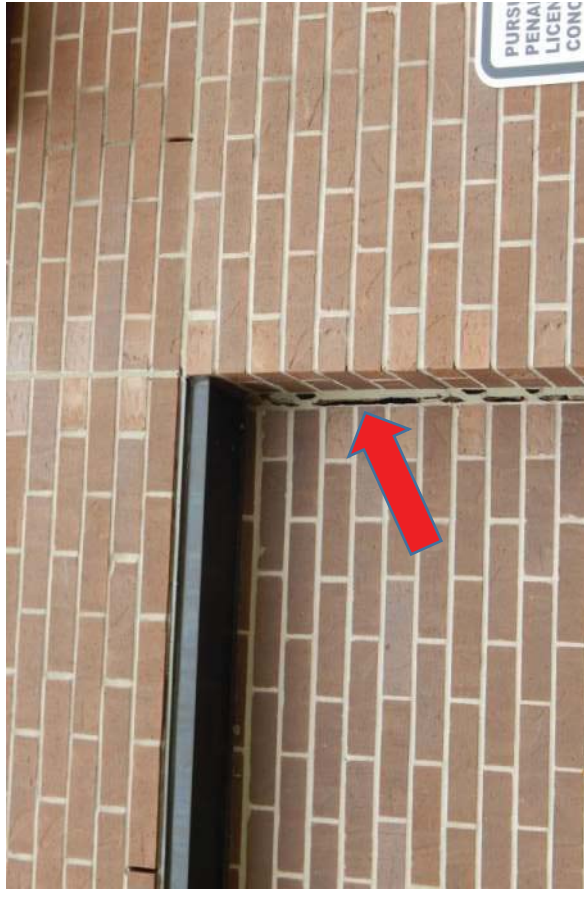
#24 Separation in caulk joint at end of inset brick panel of approximately 1/2".
No separation in control joint above.

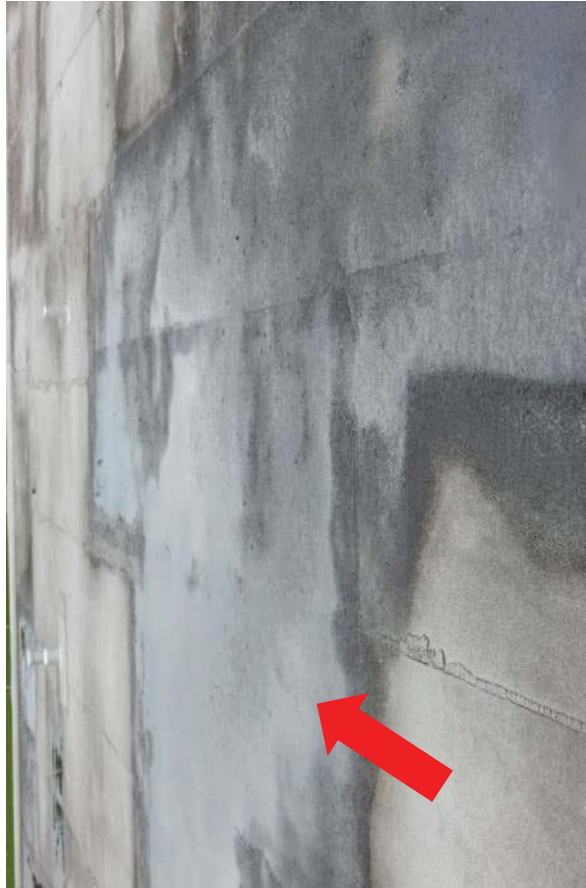
#52 Roof over phase one of community center showing standing water

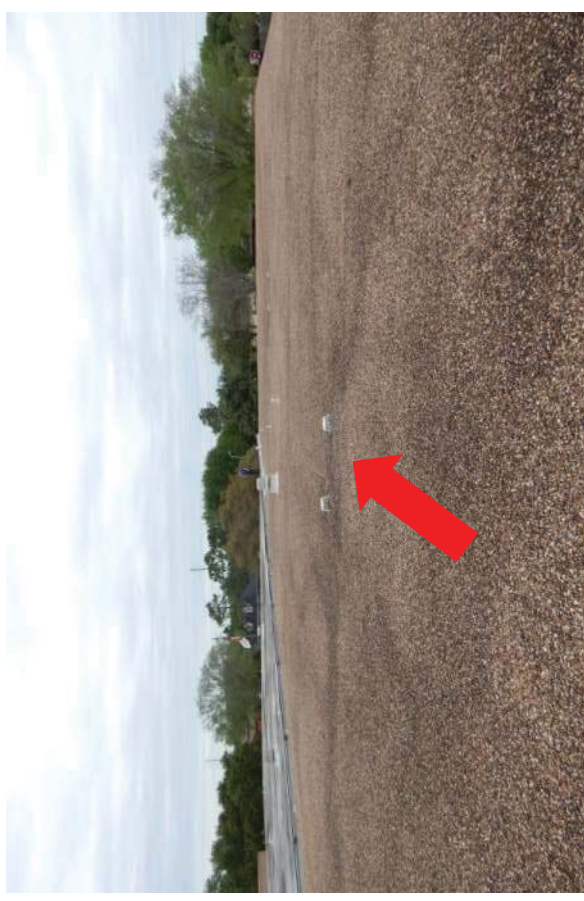
#53 Roof over phase two of community center showing roof drain and emergency drain

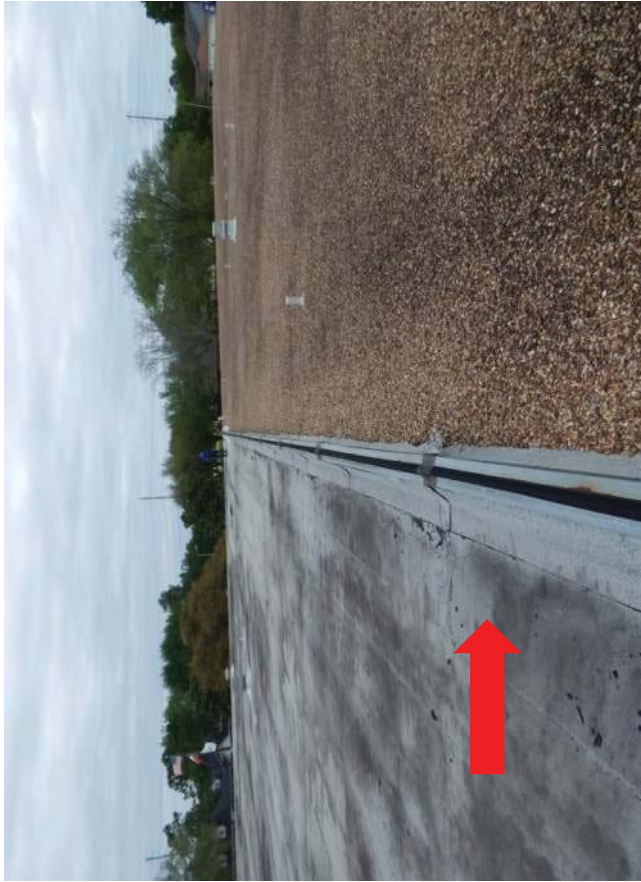
#54 Roof expansion joint cover between phase one and phase two

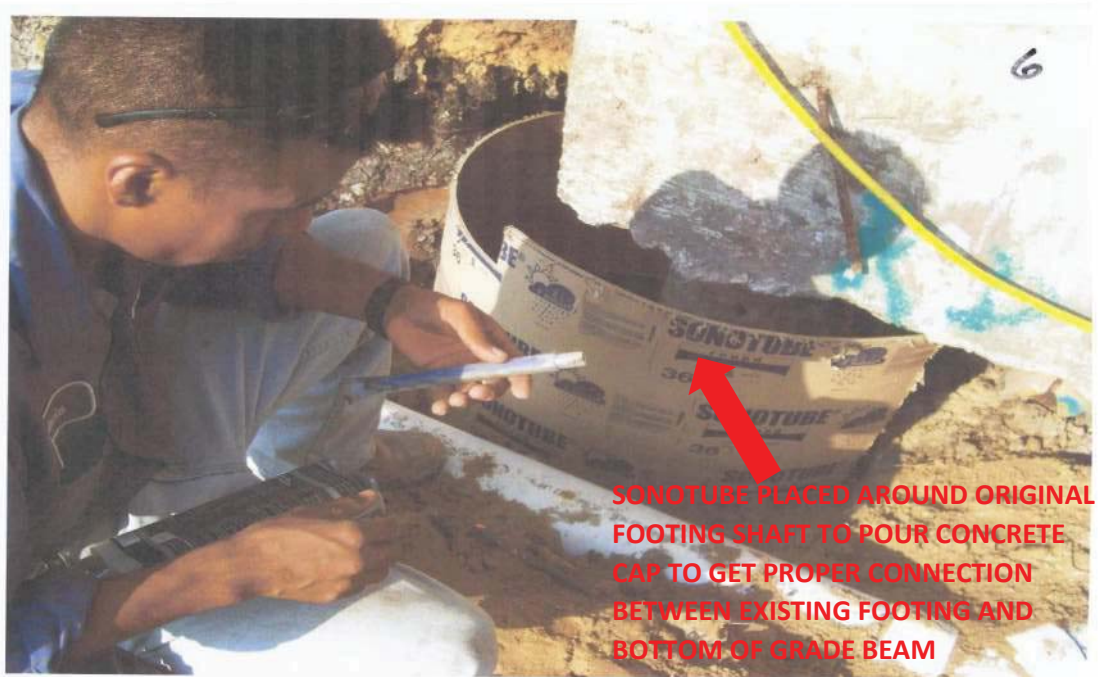
#5 Photo taken by contractor of Phase Two showing how concrete cap was being poured between existing footing and grade beam

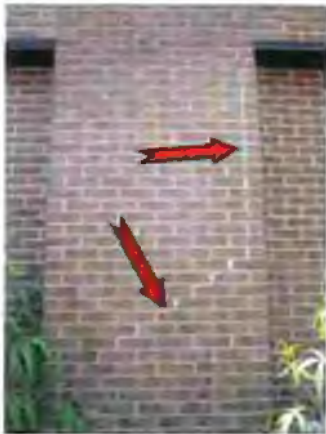
Photo #9 Masonry-mortar-joint crack

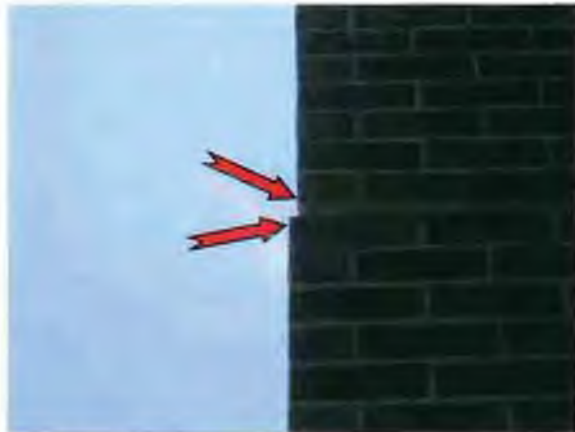
Photo #13 Lateral movement in brick veneer

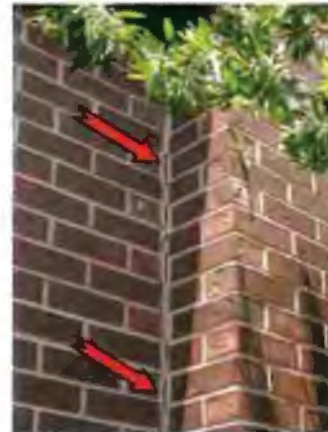
Photo #14 Separation at expansion joint

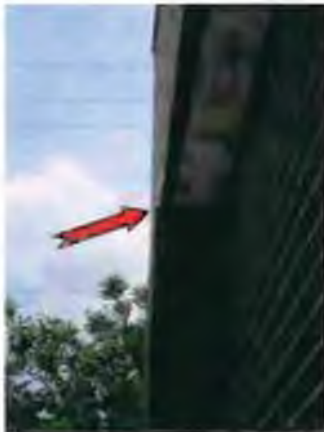
Photo #15 Lateral movement in brick veneer

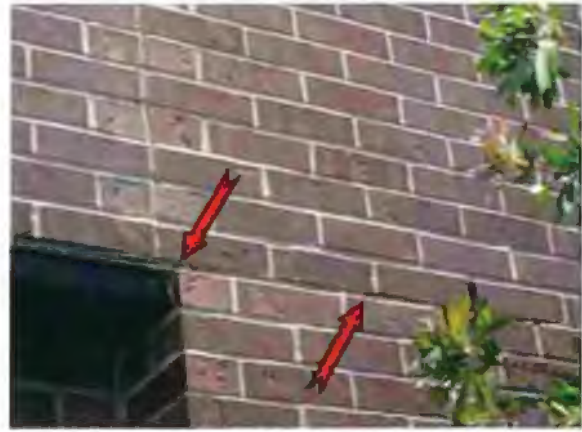
Photo #16 Separation at expansion joint

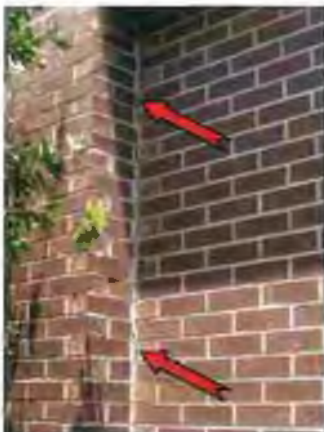
Photo #17 Separation at expansion joint

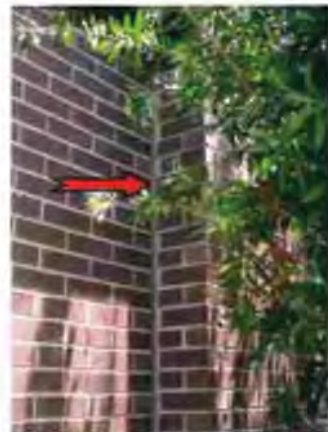
Photo #18 Separation at expansion joint

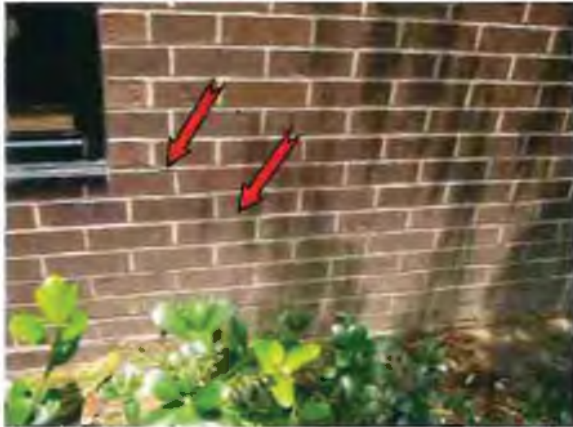
Photo #19 Masonry-mortar-joint crack

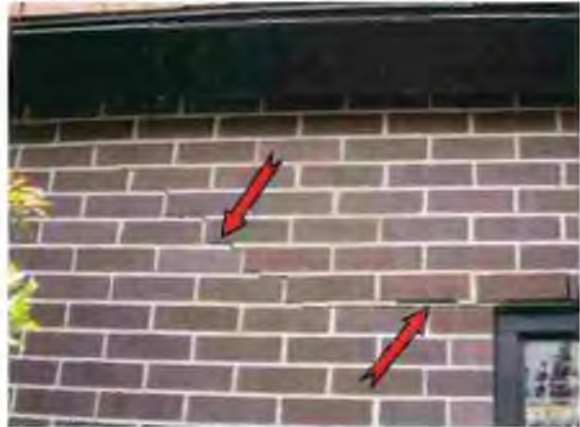
Photo #20 Masonry-mortar-joint crack

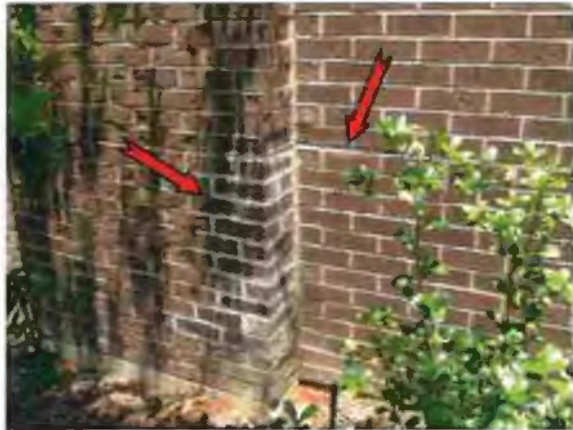
Photo #21 Masonry-mortar-joint crack

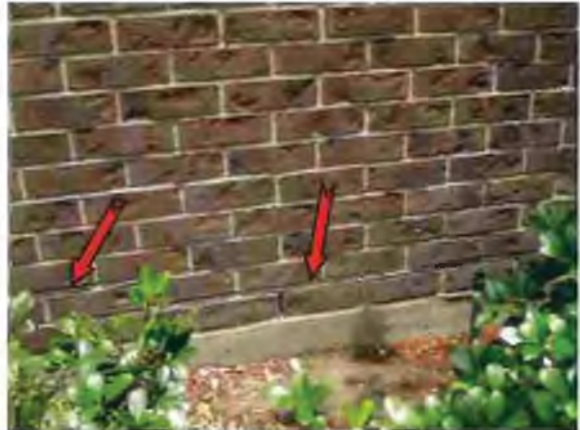
Photo #22 Masonry-mortar-joint crack

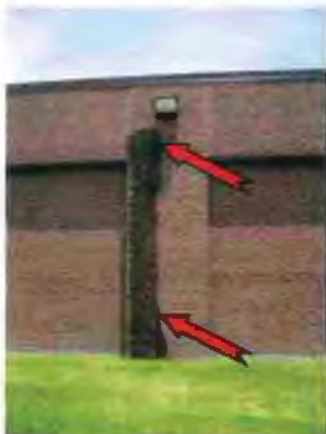
Photo #23 Staining on exterior brick veneer

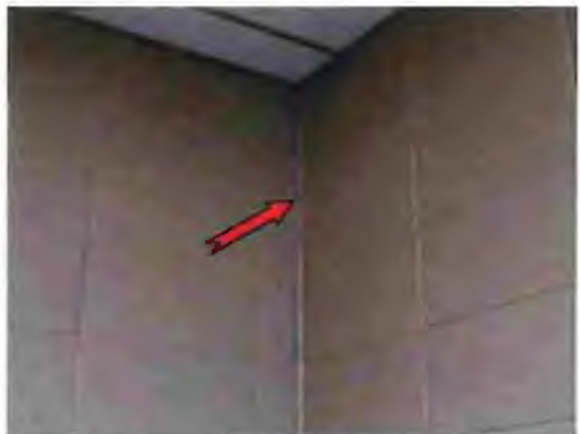
Photo #24 Crack at corner of concrete masonry unit walls

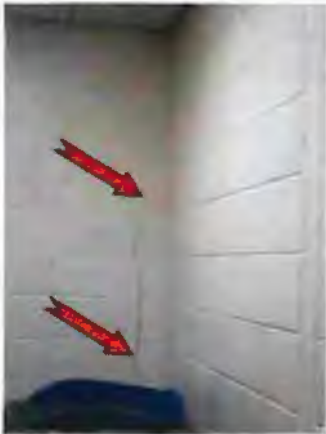
Photo #25 Crack through concrete masonry unit wall

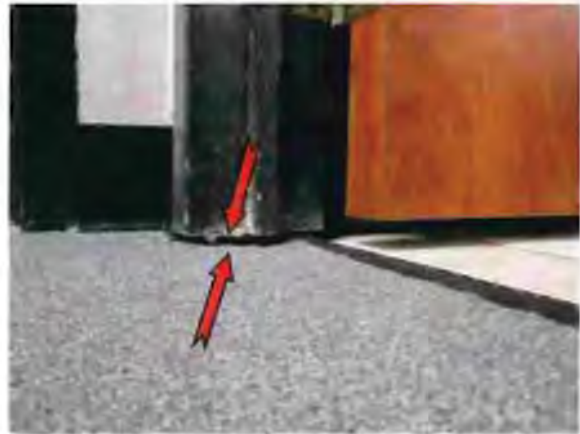
Photo #26 Separation between door frame and floor

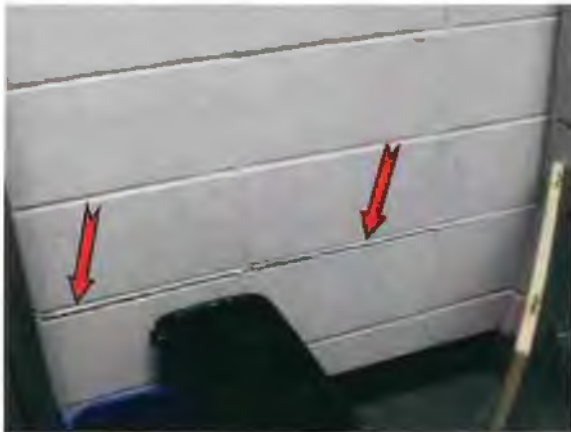
Photo #27 Joint crack in concrete masonry unit wall

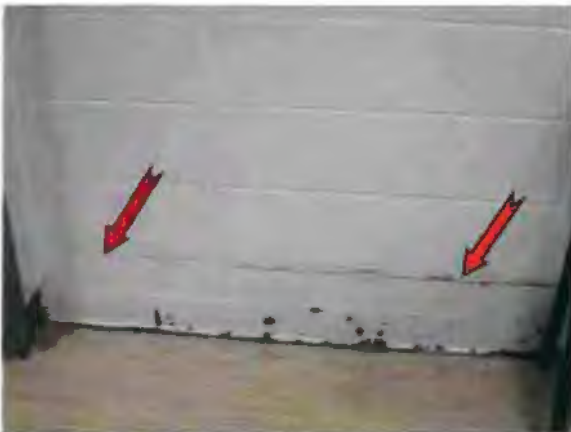
Photo #29 Joint crack in concrete masonry unit wall

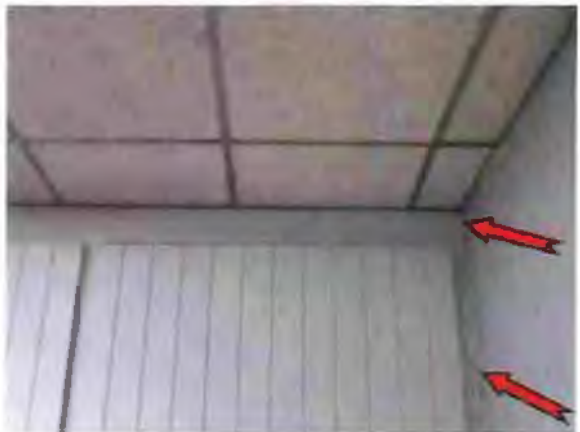
Photo #30 Crack at corner of concrete masonry unit walls

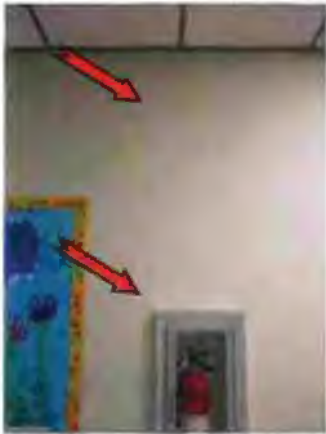
Photo #43 Crack in gypsum wallboard wall

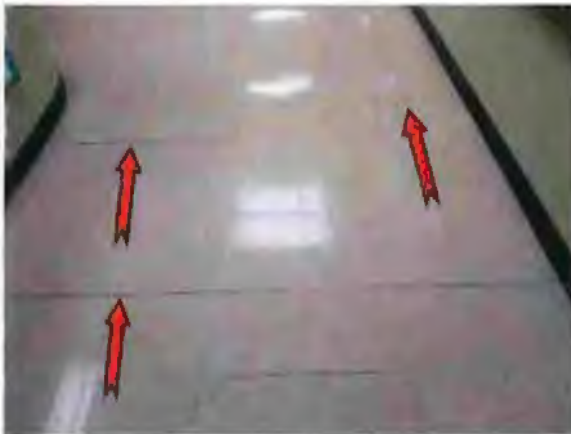
Photo #45 Separations in vinyl tile floor

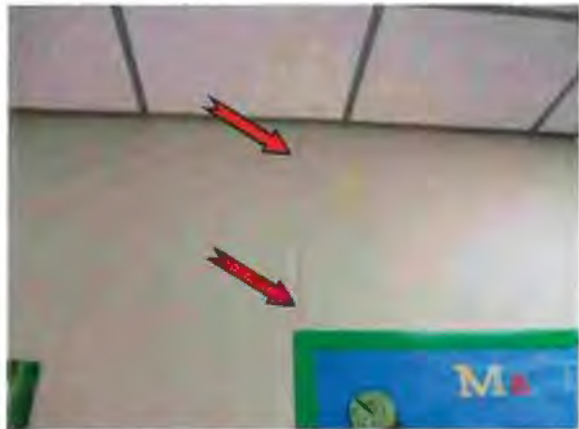
Photo #46 Crack in gypsum wallboard wall

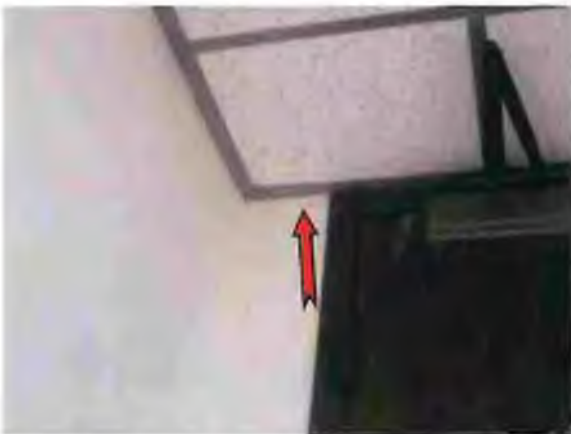
Photo #47 Crack in gypsum wallboard wall

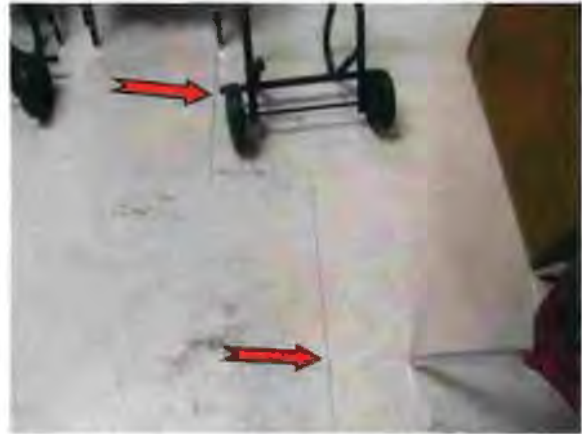
Photo #50 Separations in vinyl tile floor

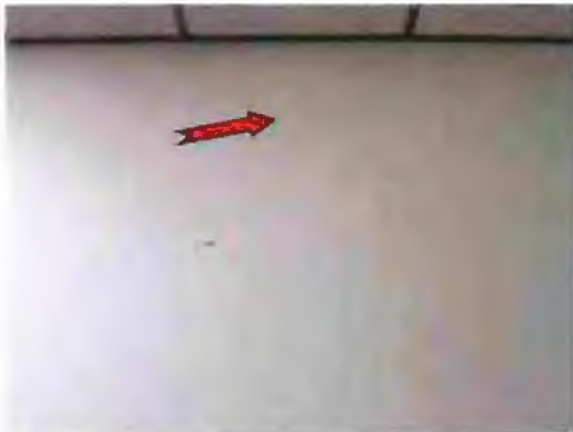
Photo #51 Crack in gypsum wallboard wall

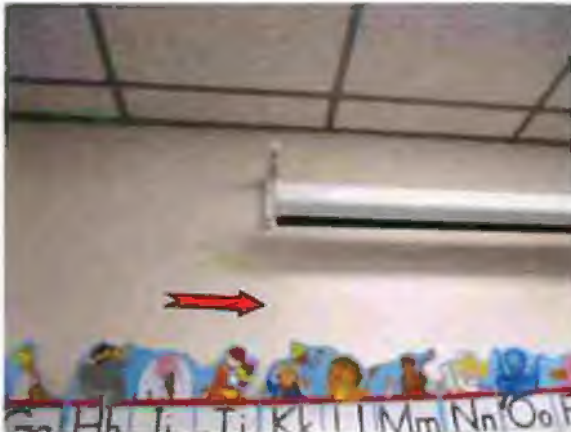
Photo #55 Crack in gypsum wallboard wall

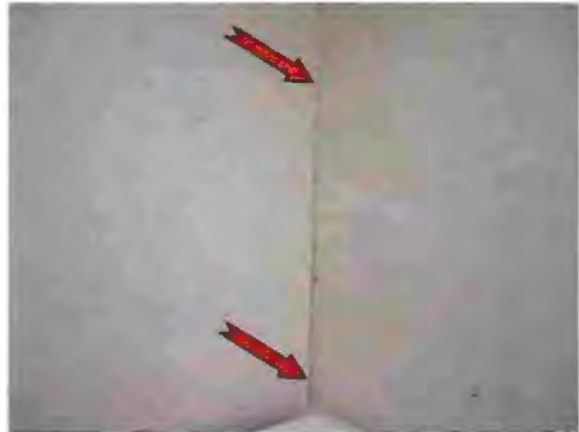
Photo #56 Crack in gypsum wallboard wall

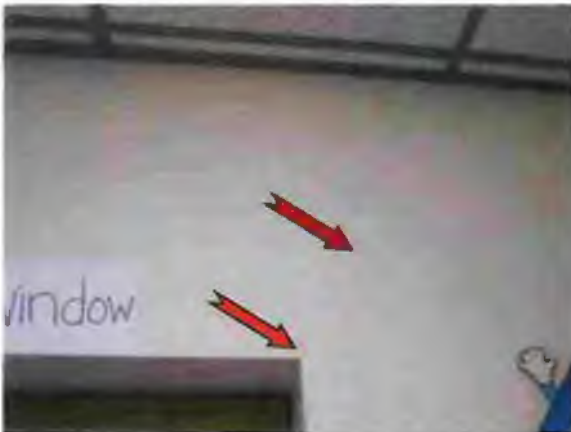
Photo #57 Crack in gypsum wallboard wall

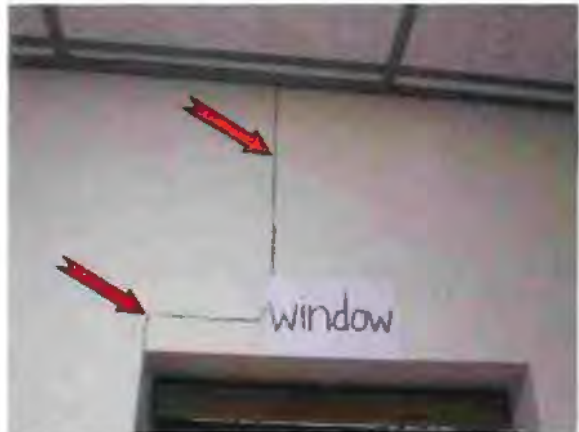
Photo #58 Crack in gypsum wallboard wall

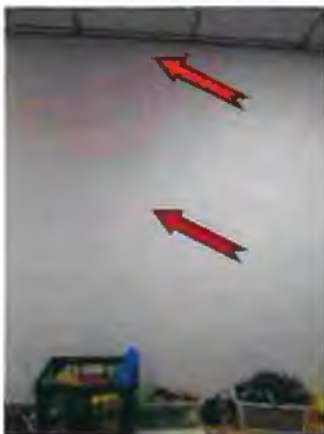
Photo #59 Crack in gypsum wallboard wall

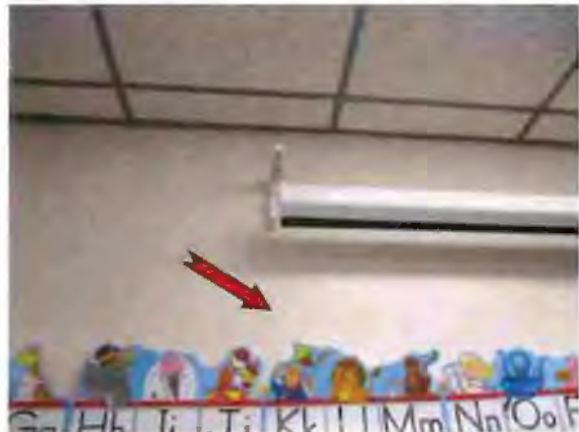
Photo #68 Crack in gypsum wallboard wall

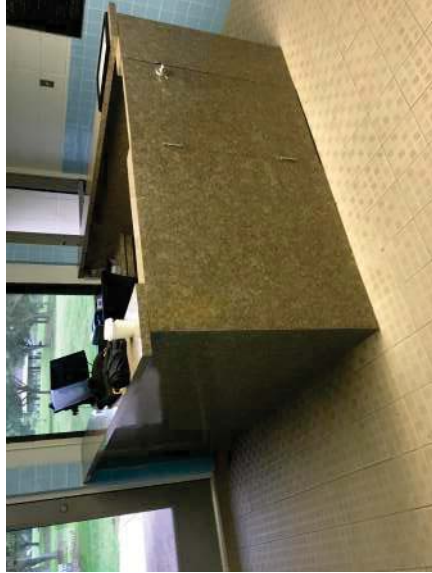
Subject: Shower House
Page: Birds Eye View
Status: Not Acceptable
Note: The service counter is too high to provide accessible access. It needs to be 36" high minimum above finished floor.
Element: Service Counter
Barrier: Height
TAS Codes: 904.4.1
Web Links: <http://www.tdlr.texas.gov/ab/2012abtas9.htm#904>
